# **Geotechnical Investigation**

**Slope Stability Assessment and Geotechnical Setback Study**

**Proposed Residential Developments**

**County Road 27, Barrie, Ontario**

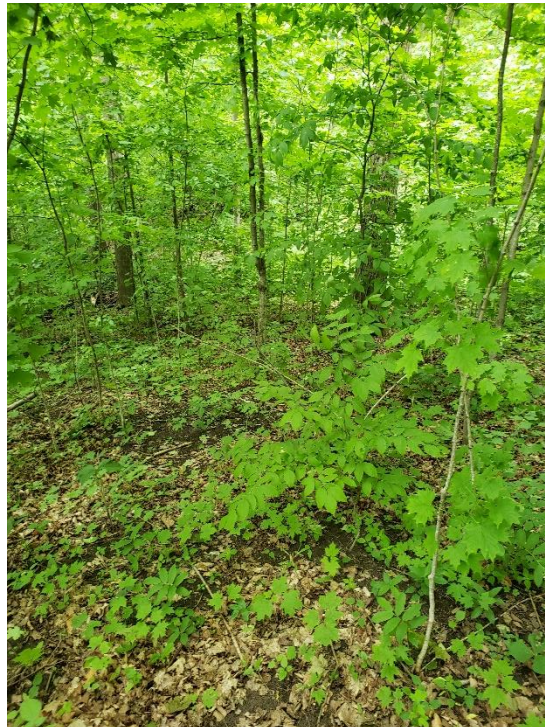
**Photo 1 – Looking downward, standing at the slope crest**

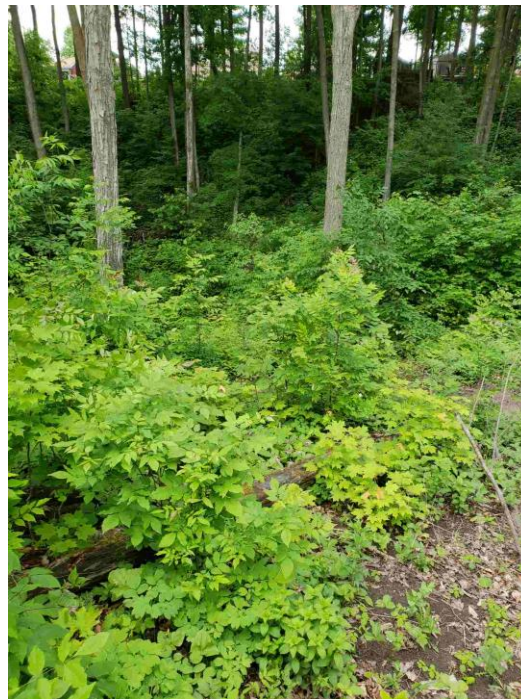
**Photo 2 – Looking downward, standing at the middle portion of the slope.**
