November 21, 2022

Reference No. 20-1014B

Re: Channel Slope Stability Analysis
664, 673 & 692 Essa Road and 320 Mapleview Drive West
Barrie, Ontario

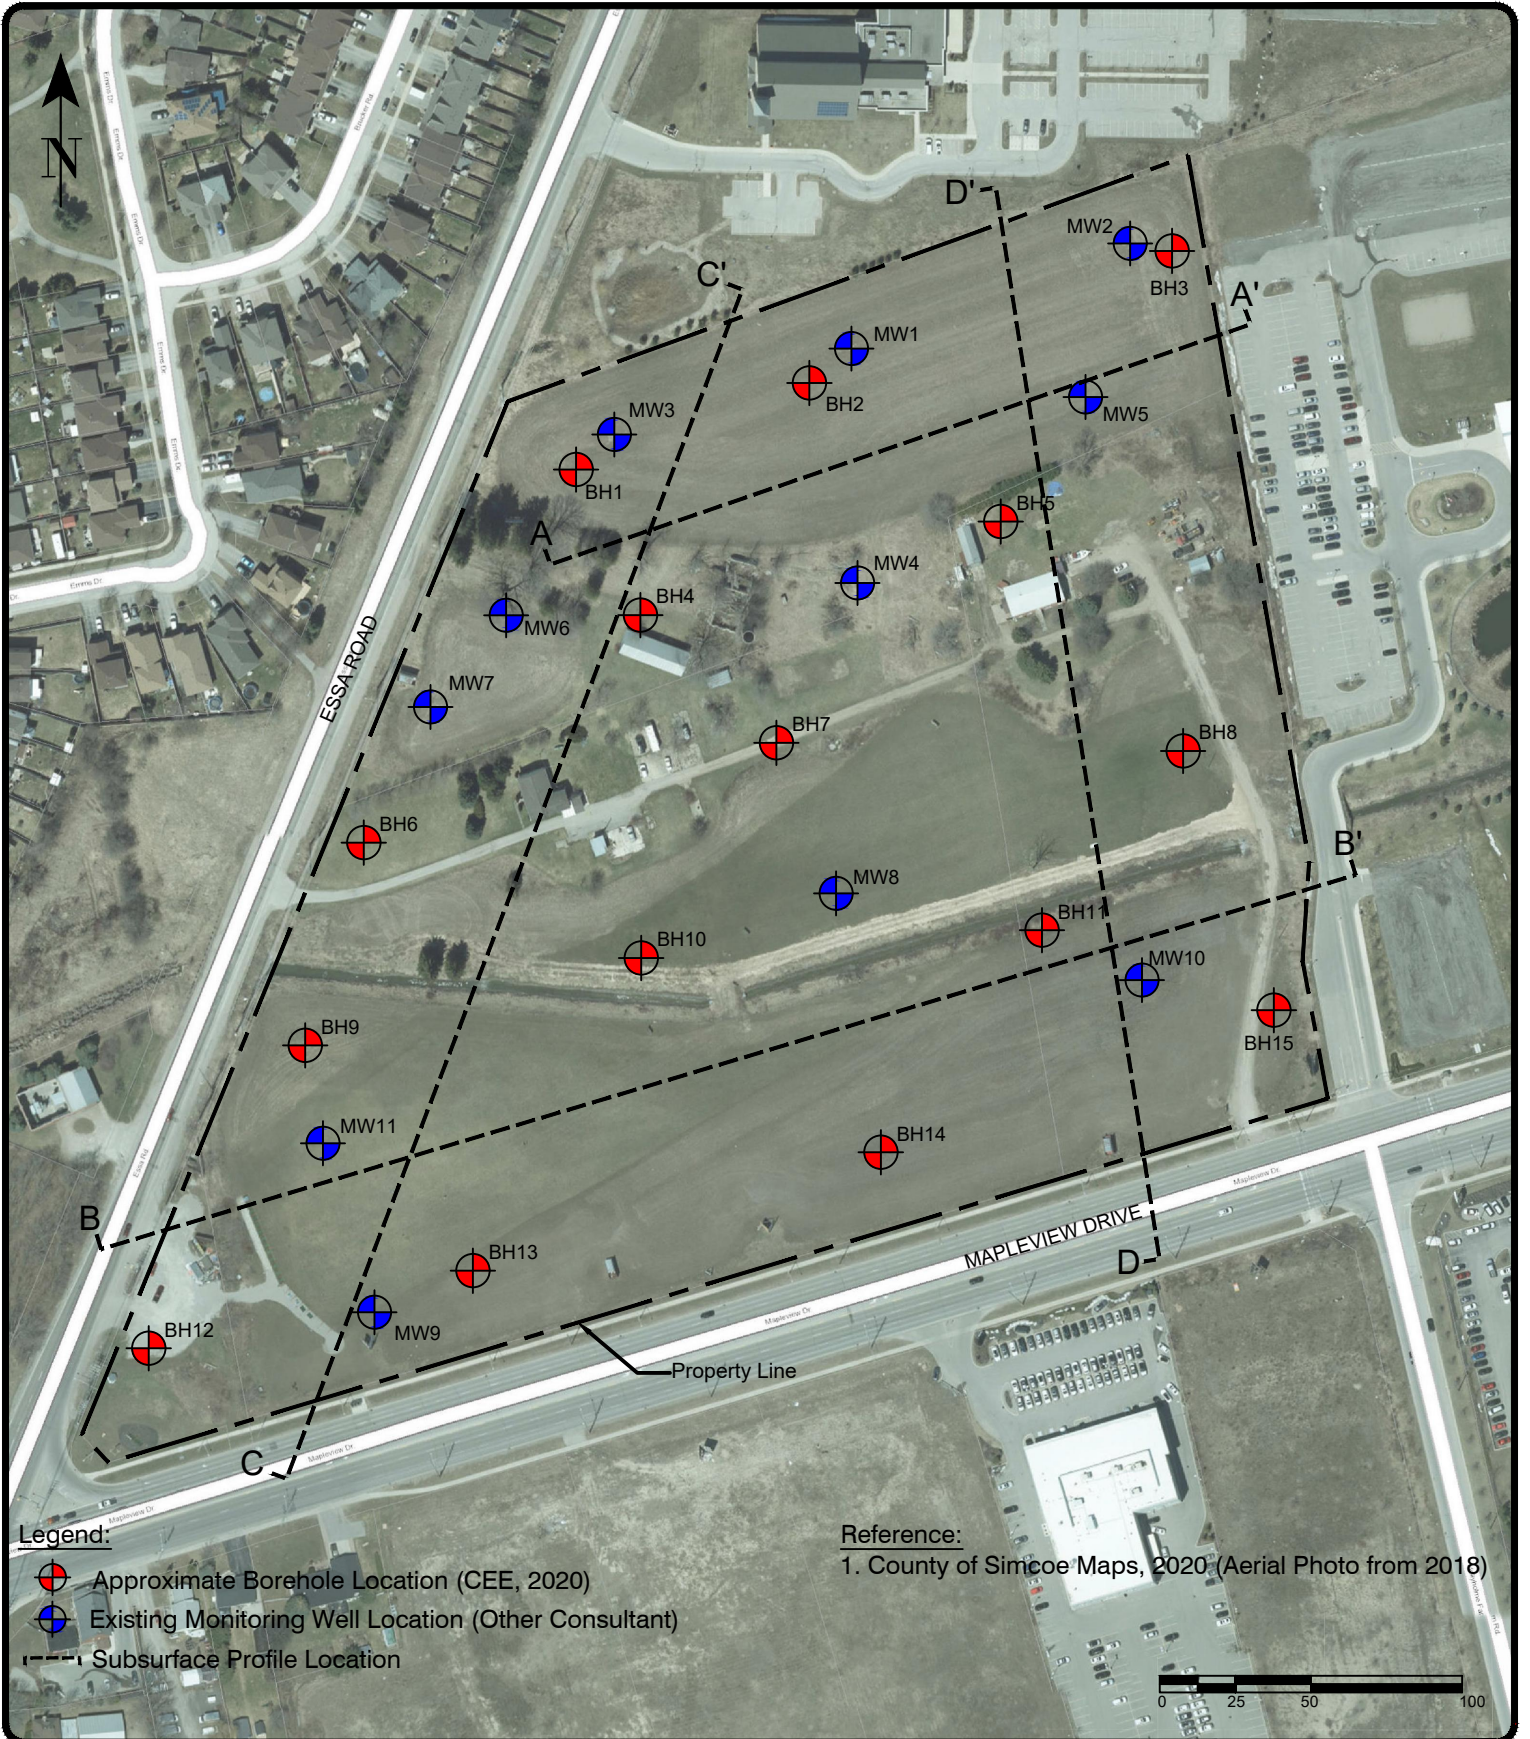
BOREHOLE LOCATION PLAN

- Approximate Borehole Location (CEE, 2020)
- Existing Monitoring Well Location (Other Consultant)
- Subsurface Profile Location

Boreholes 6, 8 and 9 to 11 were advanced near the channel location and were used to determine the subsurface stratigraphy for the analysis. The average stratigraphy expected to be encountered along the channel consists of an upper 0.8-metre-thick zone of earth fill, underlain by approximately 1.5 metres of loose cohesionless native soils typically consisting of silty sand glacial till, to sand, to silty sand. The loose soils are typically underlain by compact to dense cohesionless soils consisting of silty sand glacial till to gravelly sand, to sand. The dense soils extended beyond the vertical depth of investigation. The borehole logs and a borehole location plan are enclosed as Appendix A.

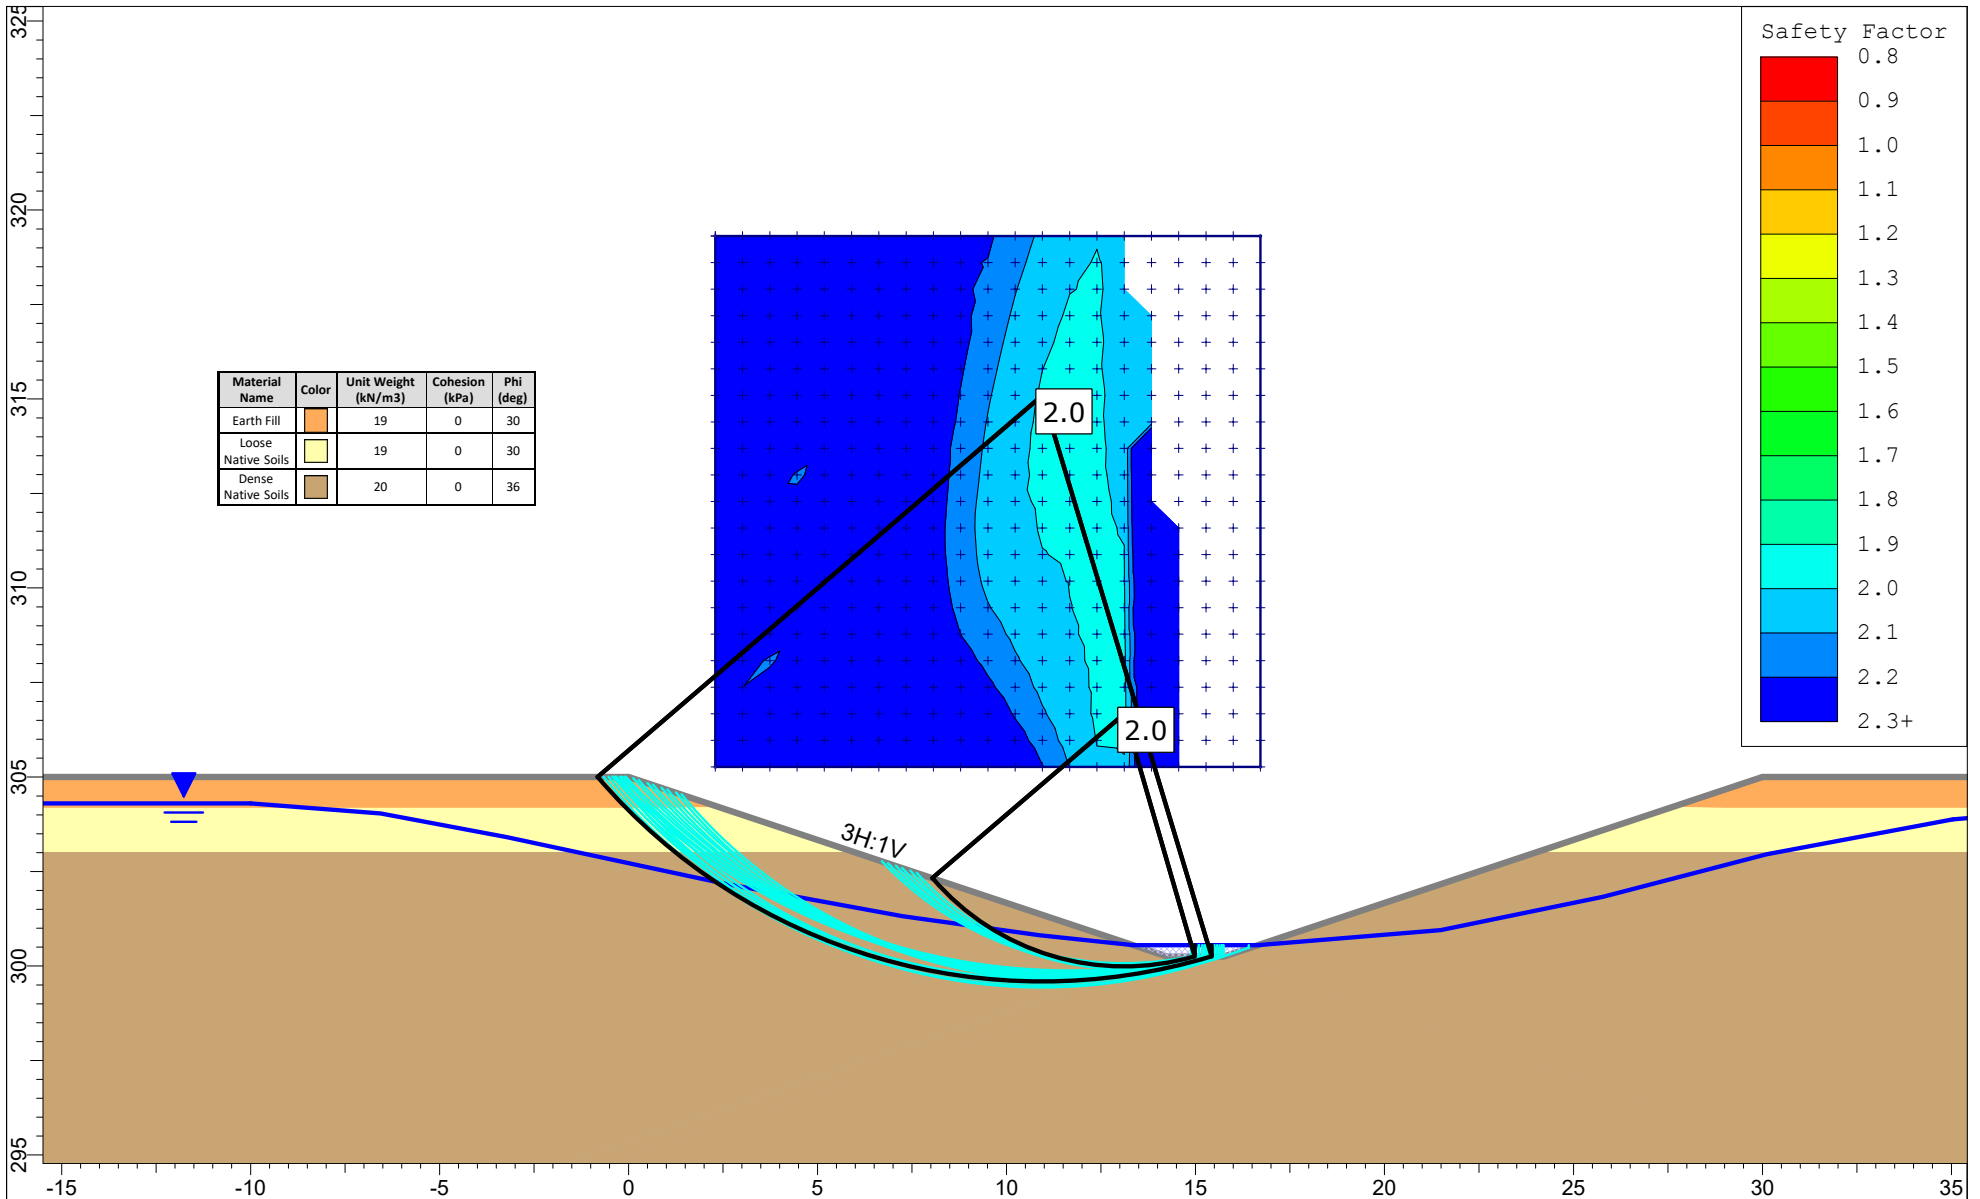
Material Name	Color	Unit Weight (kN/m ³)	Cohesion (kPa)	Phi (deg)
Earth Fill		19	0	30
Loose Native Soils		19	0	30
Dense Native Soils		20	0	36

<i>Project</i> 20-1014B 664, 674 & 692 Essa Road & 320 Mapleview Drive West, Barrie		
	<i>Analysis Description</i> Normal Conditions, 3H:1V Side Slopes		
	<i>Drawn By</i> RW	<i>Scale</i> 1:200	<i>Company</i>
	<i>Date</i> 2020-07-27	<i>File Name</i> Mapleview Essa Channel Stability.slmd

Channel Side Slope Inclination (H:V)	Scenario	Target Factor of Safety	Calculated Factor of Safety	Meets Target?
3.0 : 1	Normal Conditions	1.5	2.0	Yes
	100 Year Flood Level	1.3	1.7	Yes

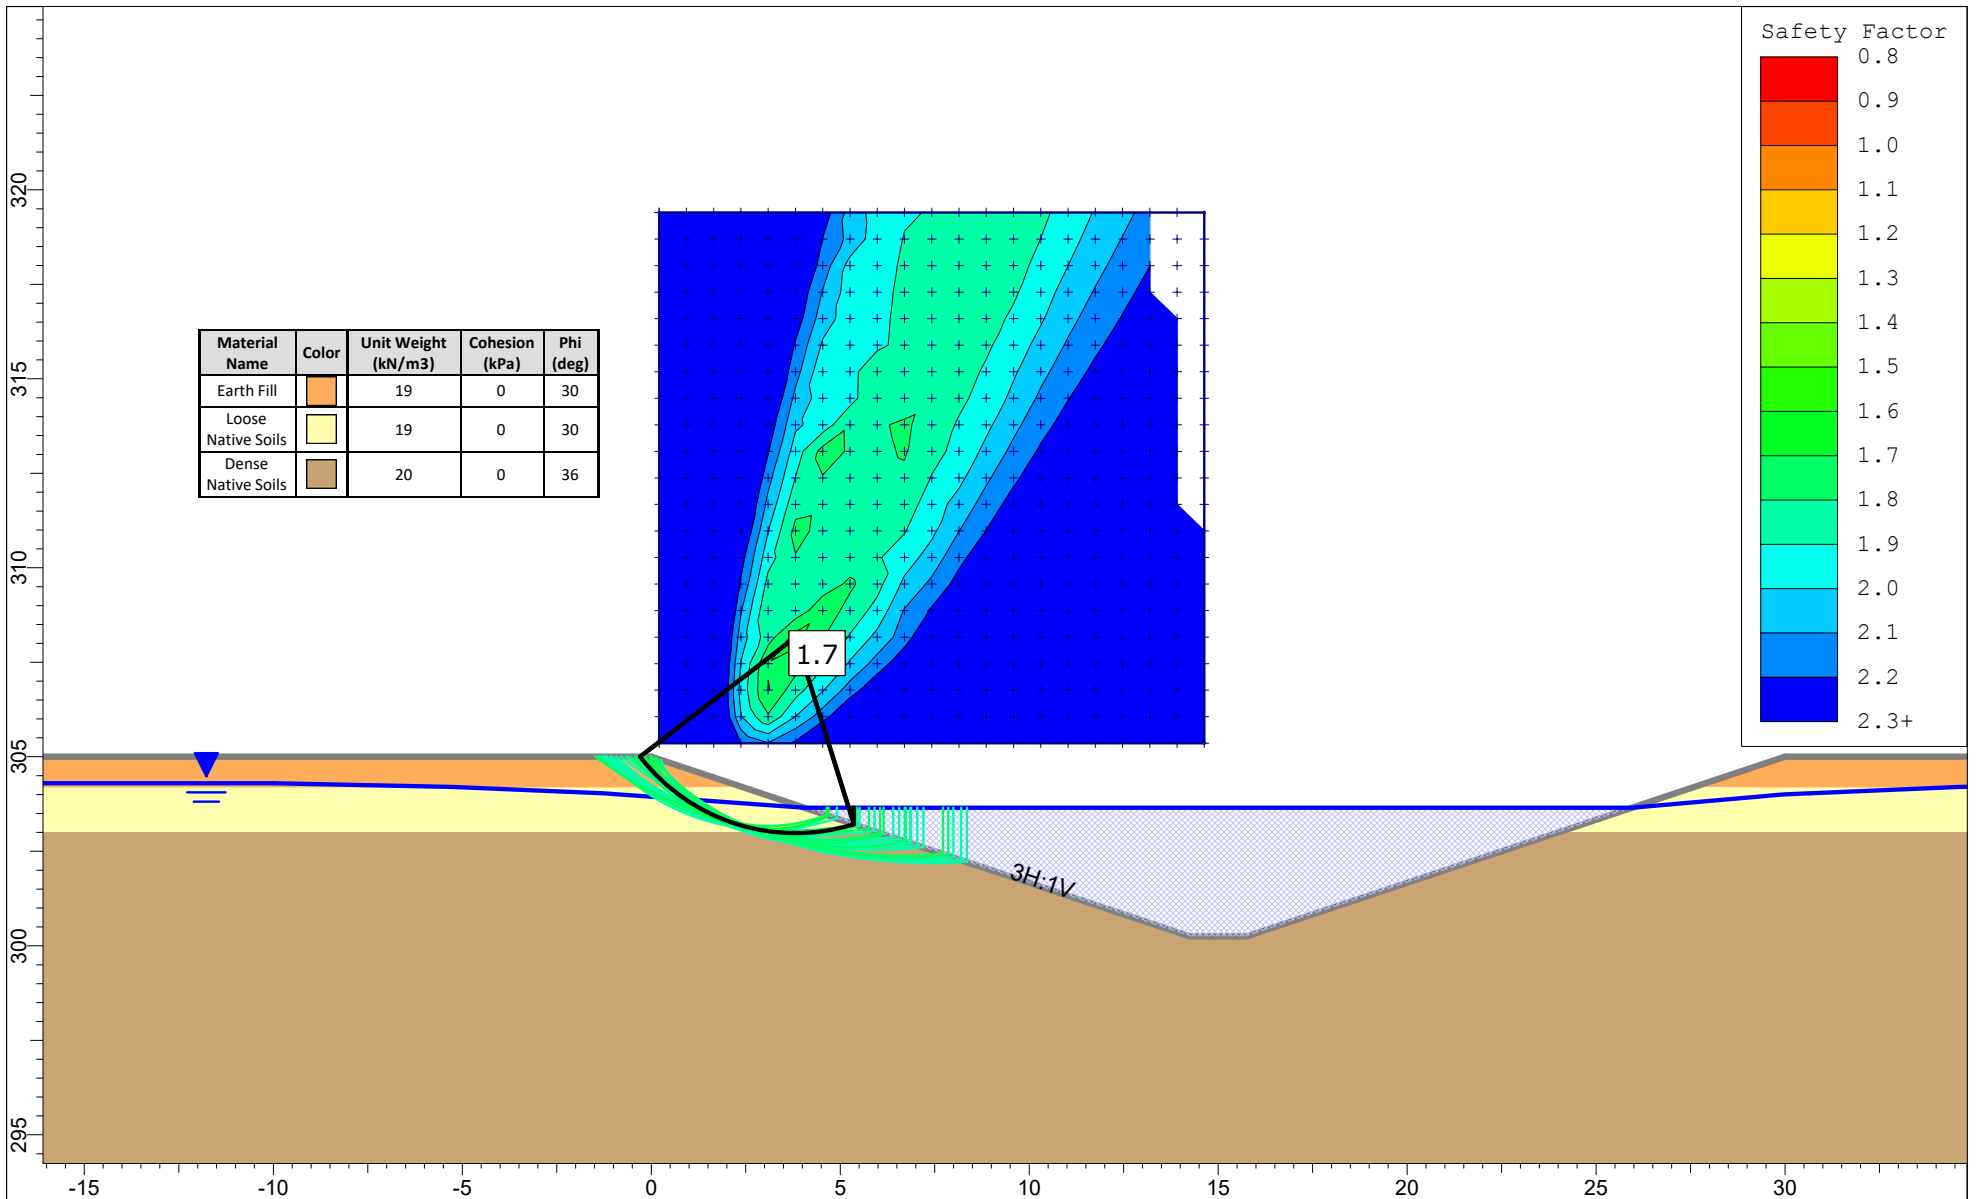
<i>Project</i> 20-1014B 664, 674 & 692 Essa Road & 320 Mapleview Drive West, Barrie		
	<i>Analysis Description</i> 100 Year Flood, 3H:1V Side Slopes		
	<i>Drawn By</i> RW	<i>Scale</i> 1:200	<i>Company</i>
	<i>Date</i> 2020-07-27	<i>File Name</i> Mapleview Essa Channel Stability.slmd

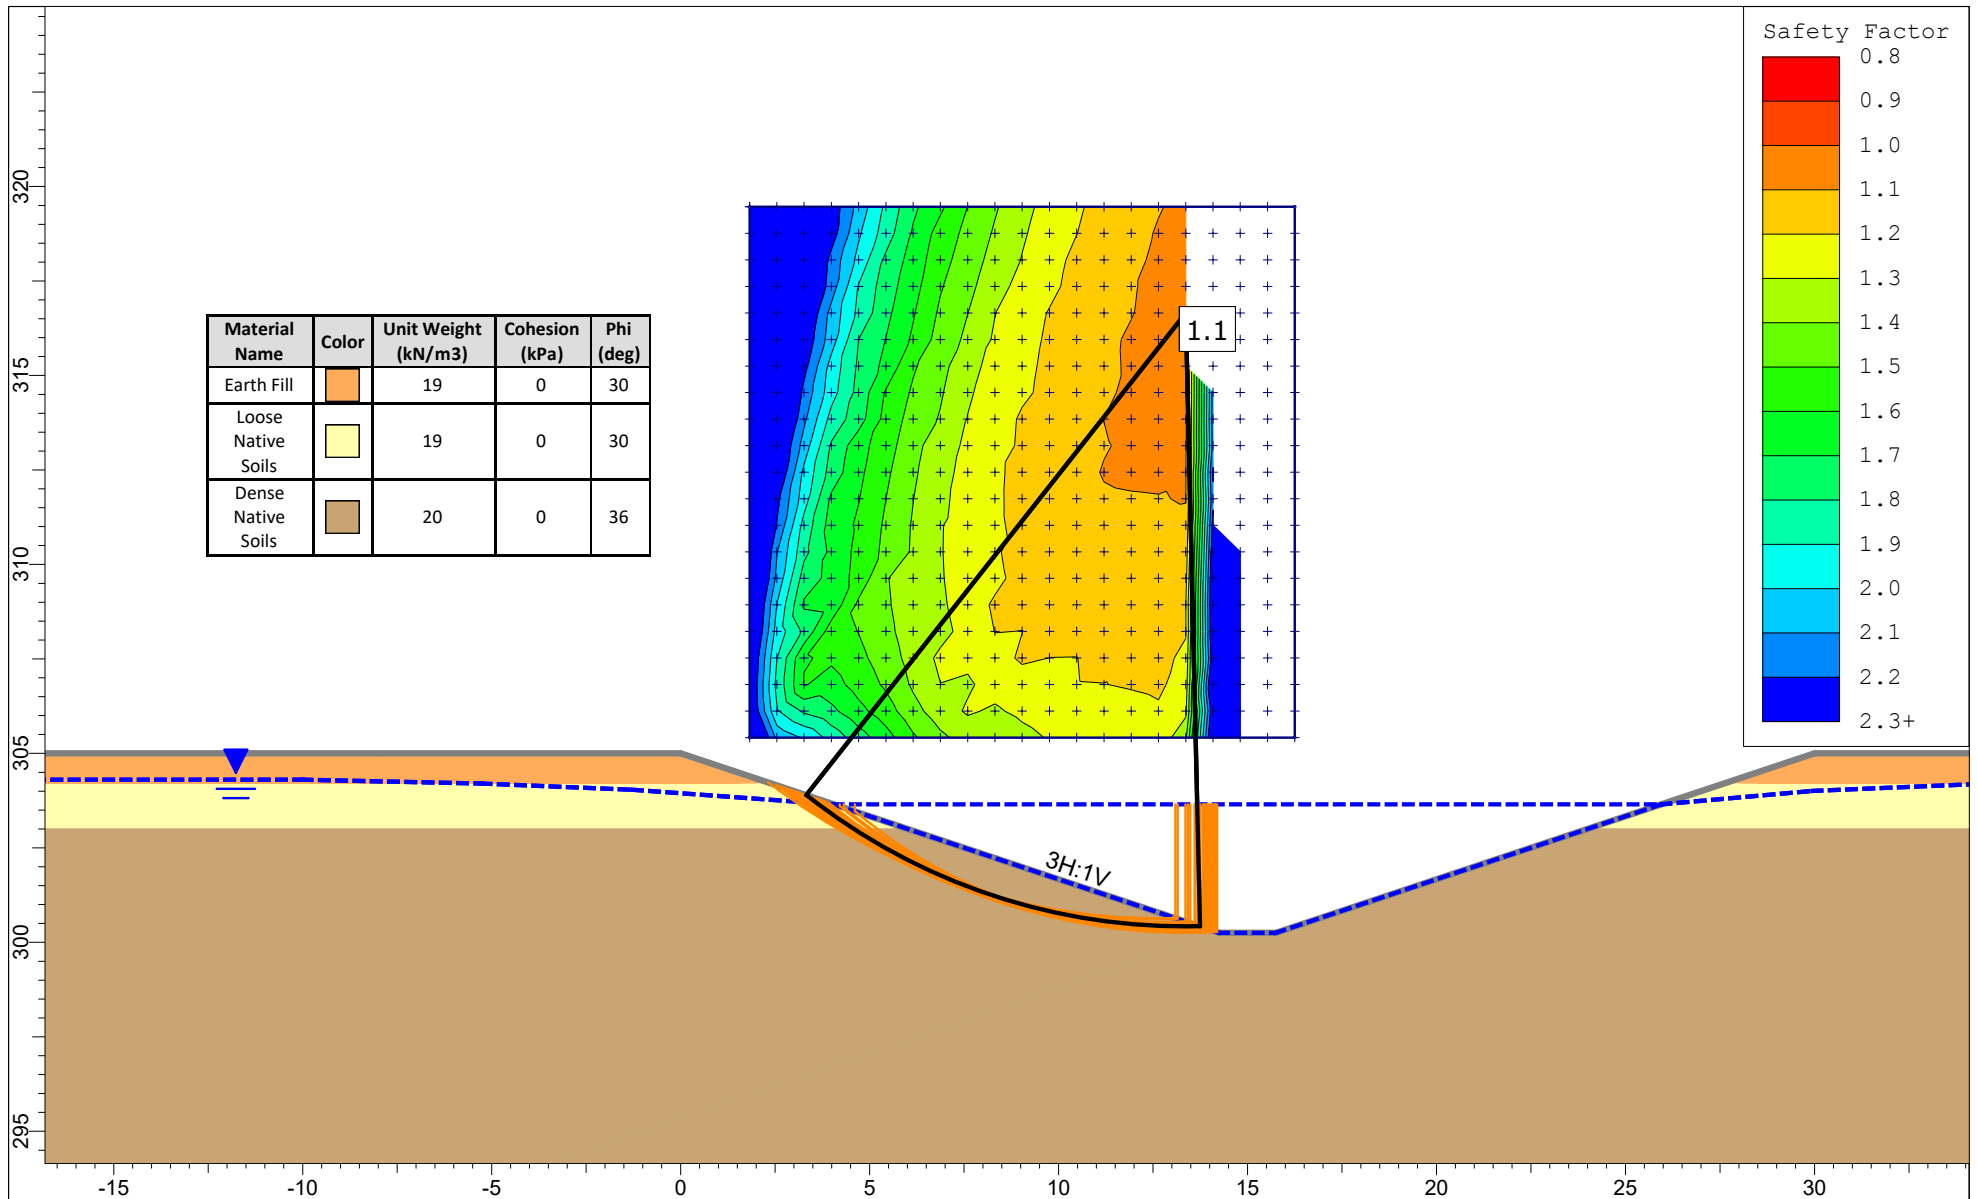
<i>Project</i> 20-1014B 664, 674 & 692 Essa Road & 320 Mapleview Drive West, Barrie		
	<i>Analysis Description</i> Rapid Drawdown from 100 Year Flood, 3H:1V Side Slopes		
	<i>Drawn By</i> RW	<i>Scale</i> 1:200	<i>Company</i>
	<i>Date</i> 2020-07-27	<i>File Name</i> Mapleview Essa Channel Stability.slmd

Channel Side Slope Inclination (H:V)	Scenario	Target Factor of Safety	Calculated Factor of Safety	Meets Target?
	Rapid Drawdown from 100 Year Flood Level	1.0	1.1	Yes
2.75 : 1	Normal Conditions	1.5	1.9	Yes
	100 Year Flood Level	1.3	1.6	Yes
	Rapid Drawdown from 100 Year Flood Level	1.0	1.0	Yes
2.5 : 1	Normal Conditions	1.5	1.8	Yes
	100 Year Flood Level	1.3	1.5	Yes
	Rapid Drawdown from 100 Year Flood Level	1.0	0.9	No
2.0 : 1	Normal Conditions	1.5	1.5	Yes
	100 Year Flood Level	1.3	1.3	Yes
	Rapid Drawdown from 100 Year Flood Level	1.0	0.7	No

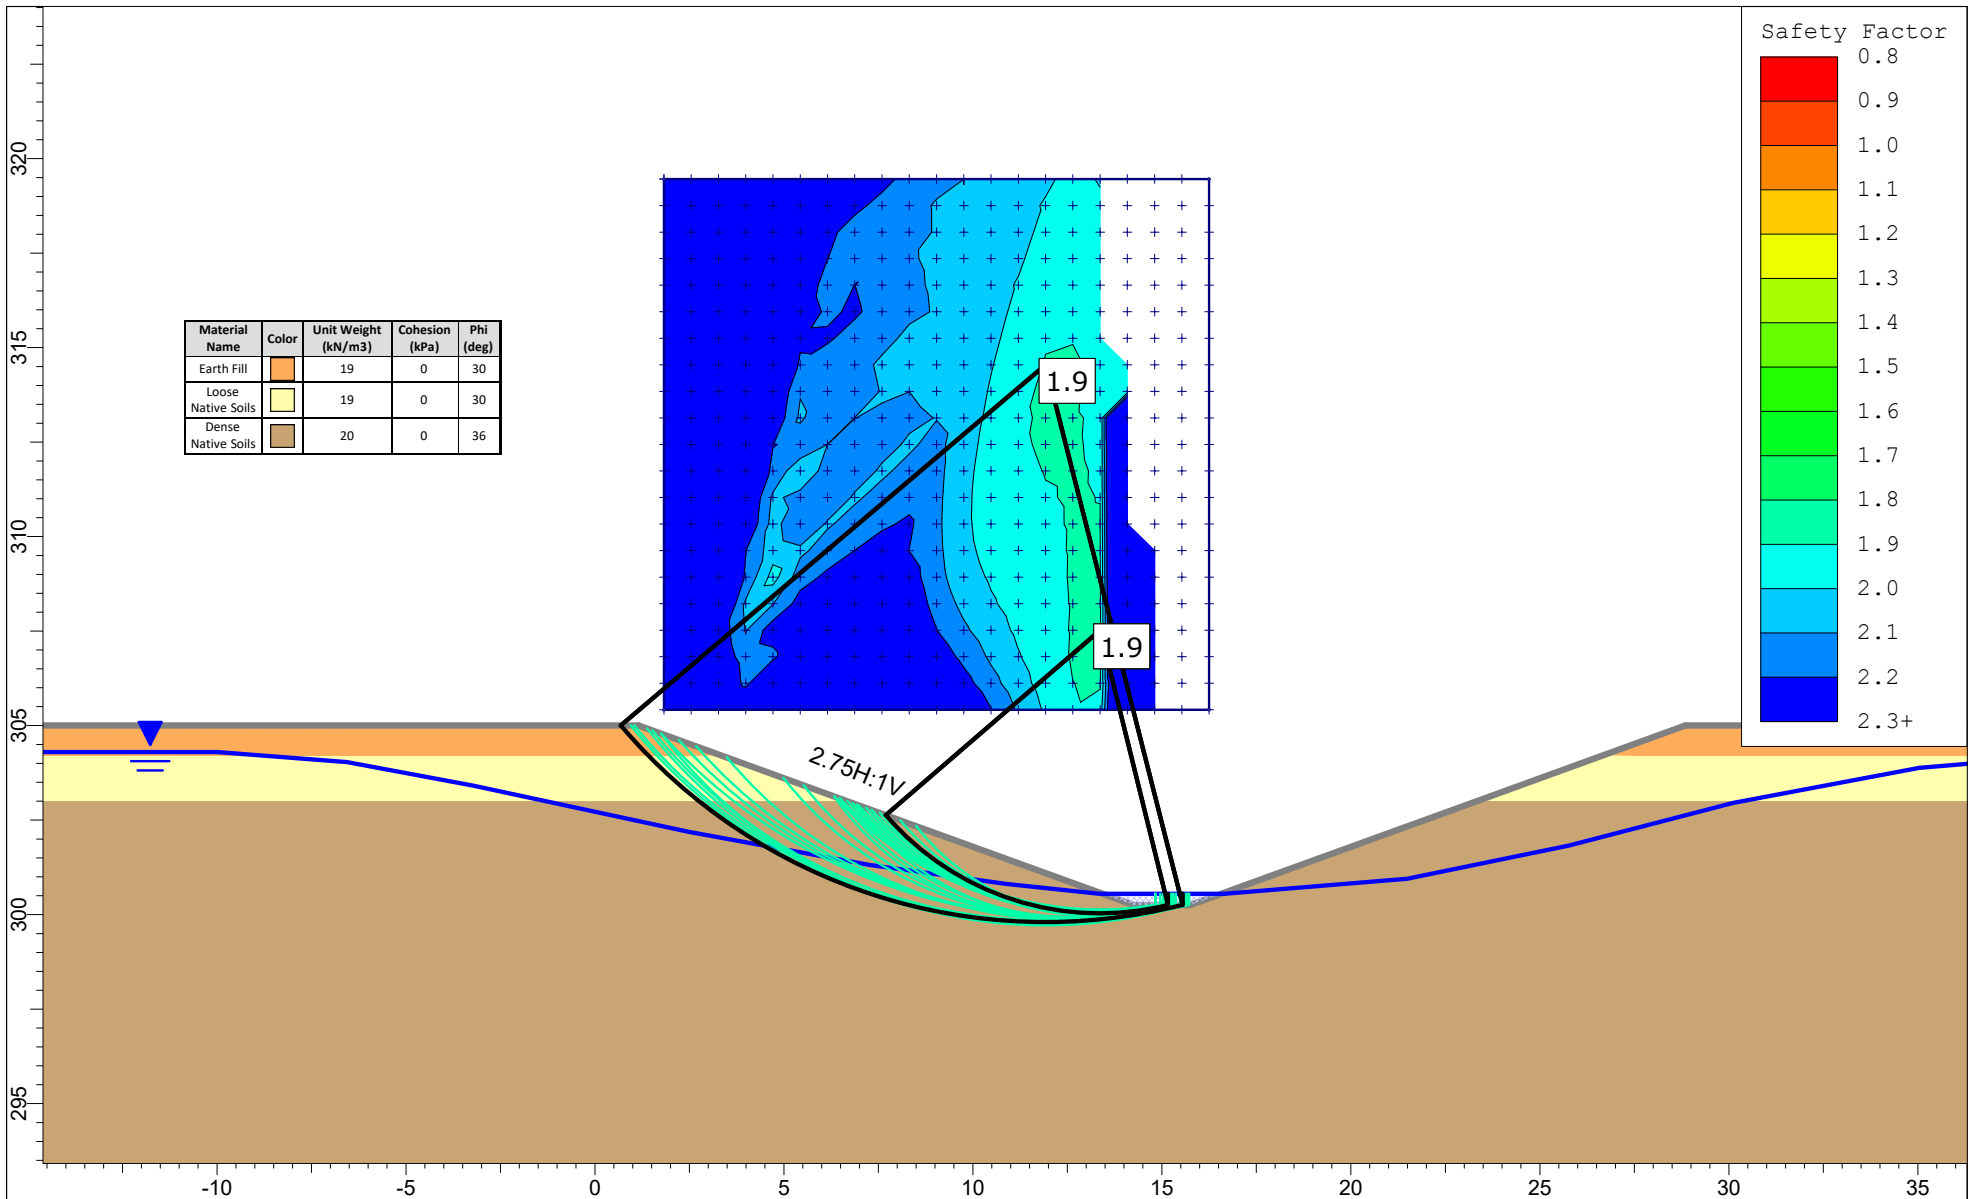
<i>Project</i>			
20-1014B 664, 674 & 692 Essa Road & 320 Maplevew Drive West, Barrie			
<i>Analysis Description</i>			
Normal Conditions, 2.75H:1V Side Slopes			
<i>Drawn By</i>	RW	<i>Scale</i>	1:200
<i>Date</i>	2020-07-27	<i>Company</i>	
		<i>File Name</i>	Maplevew Essa Channel Stability.slmd

Channel side slopes as steep as 2.75 horizontal to 1 vertical as currently proposed for the site meets the target factors of safety (FOS) for normal conditions, 100-year flood conditions, and rapid drawdown from the 100-year flood level. Side slopes steeper than 2.75 horizontal to 1 vertical meet the target FOS for normal and flooded conditions, but do not meet the target FOS during rapid drawdown.

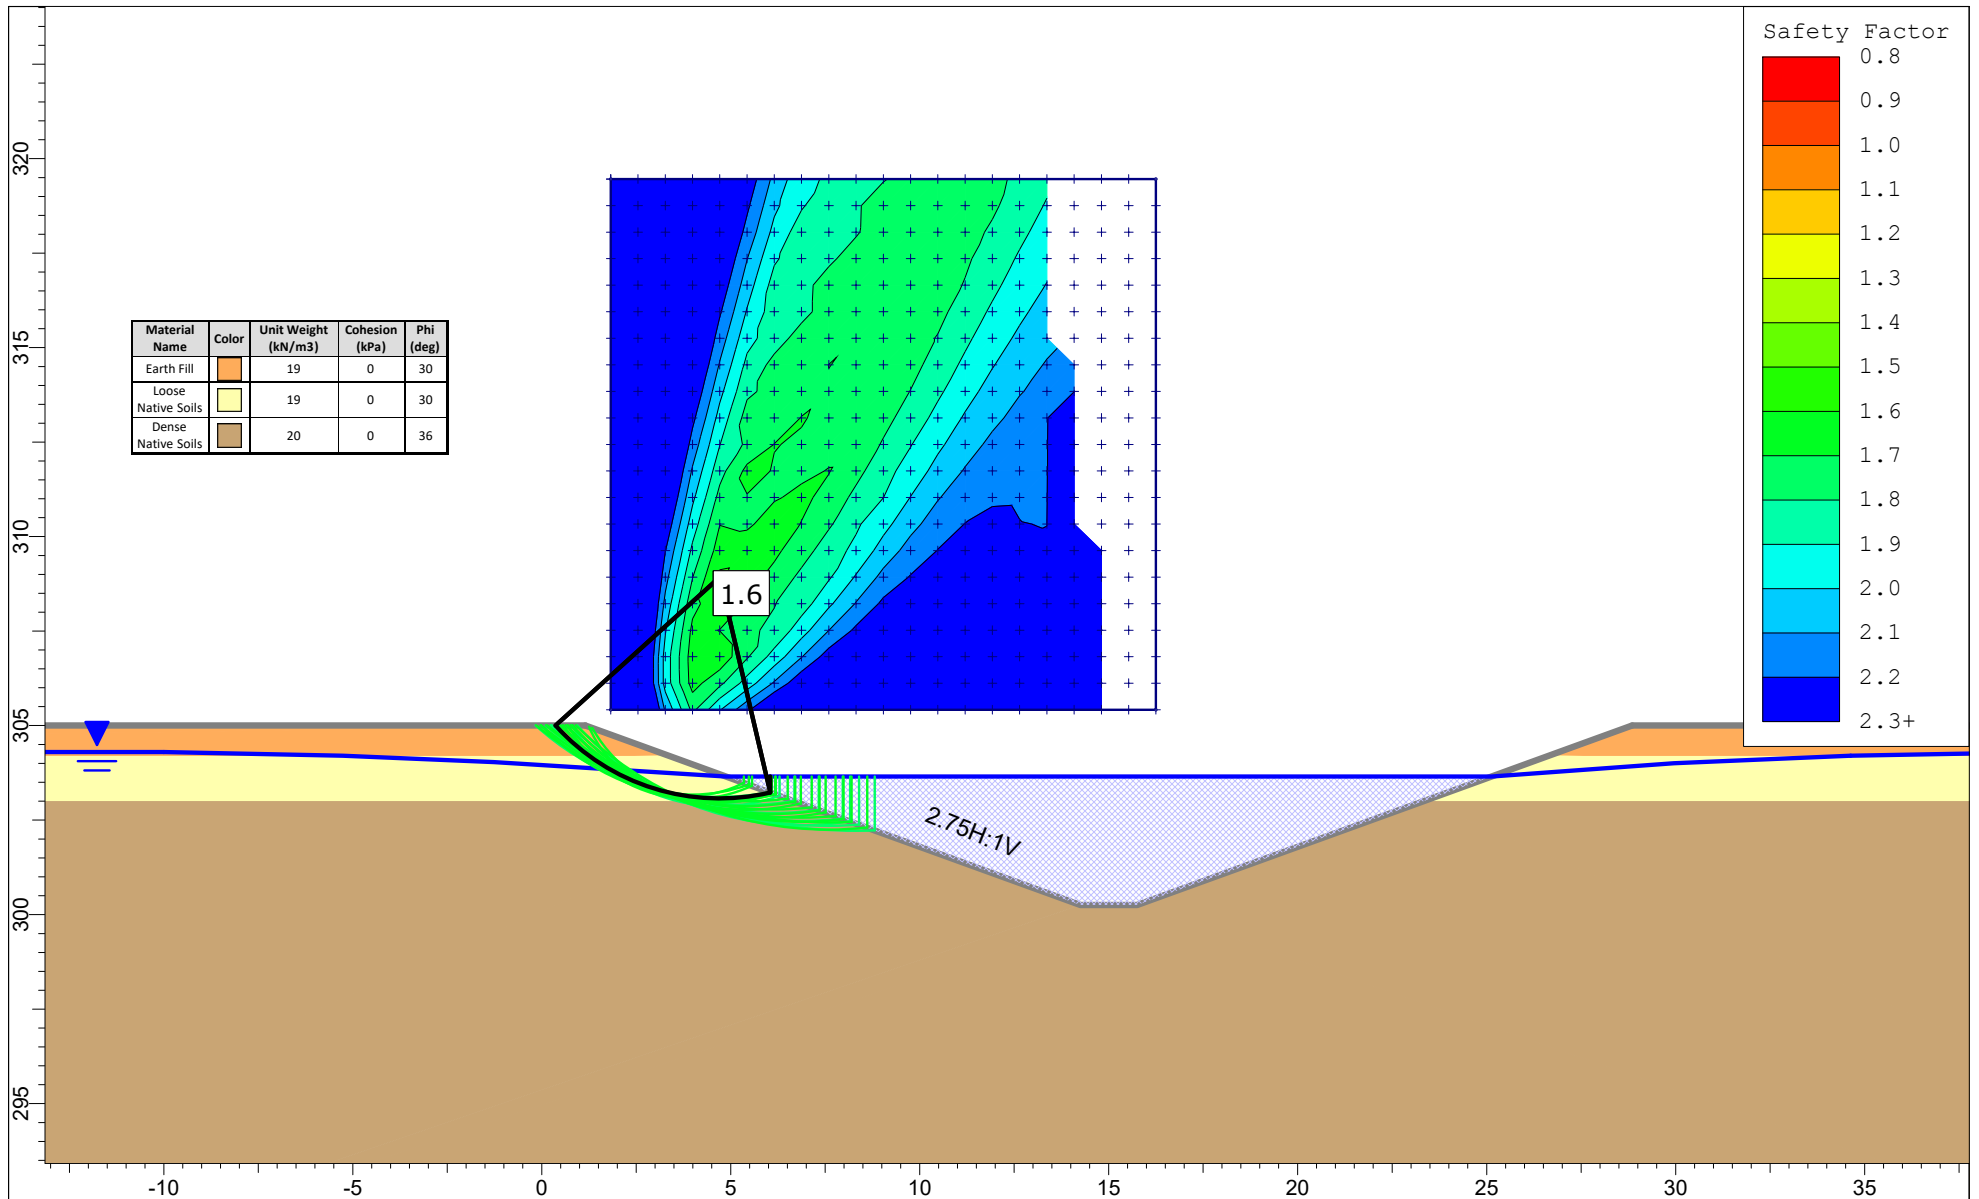
<i>Project</i> 20-1014B 664, 674 & 692 Essa Road & 320 Maplevew Drive West, Barrie		
	<i>Analysis Description</i> 100 Year Flood, 2.75H:1V Side Slopes		
	<i>Drawn By</i> RW	<i>Scale</i> 1:200	<i>Company</i>
	<i>Date</i> 2020-07-27	<i>File Name</i> Maplevew Essa Channel Stability.slmd

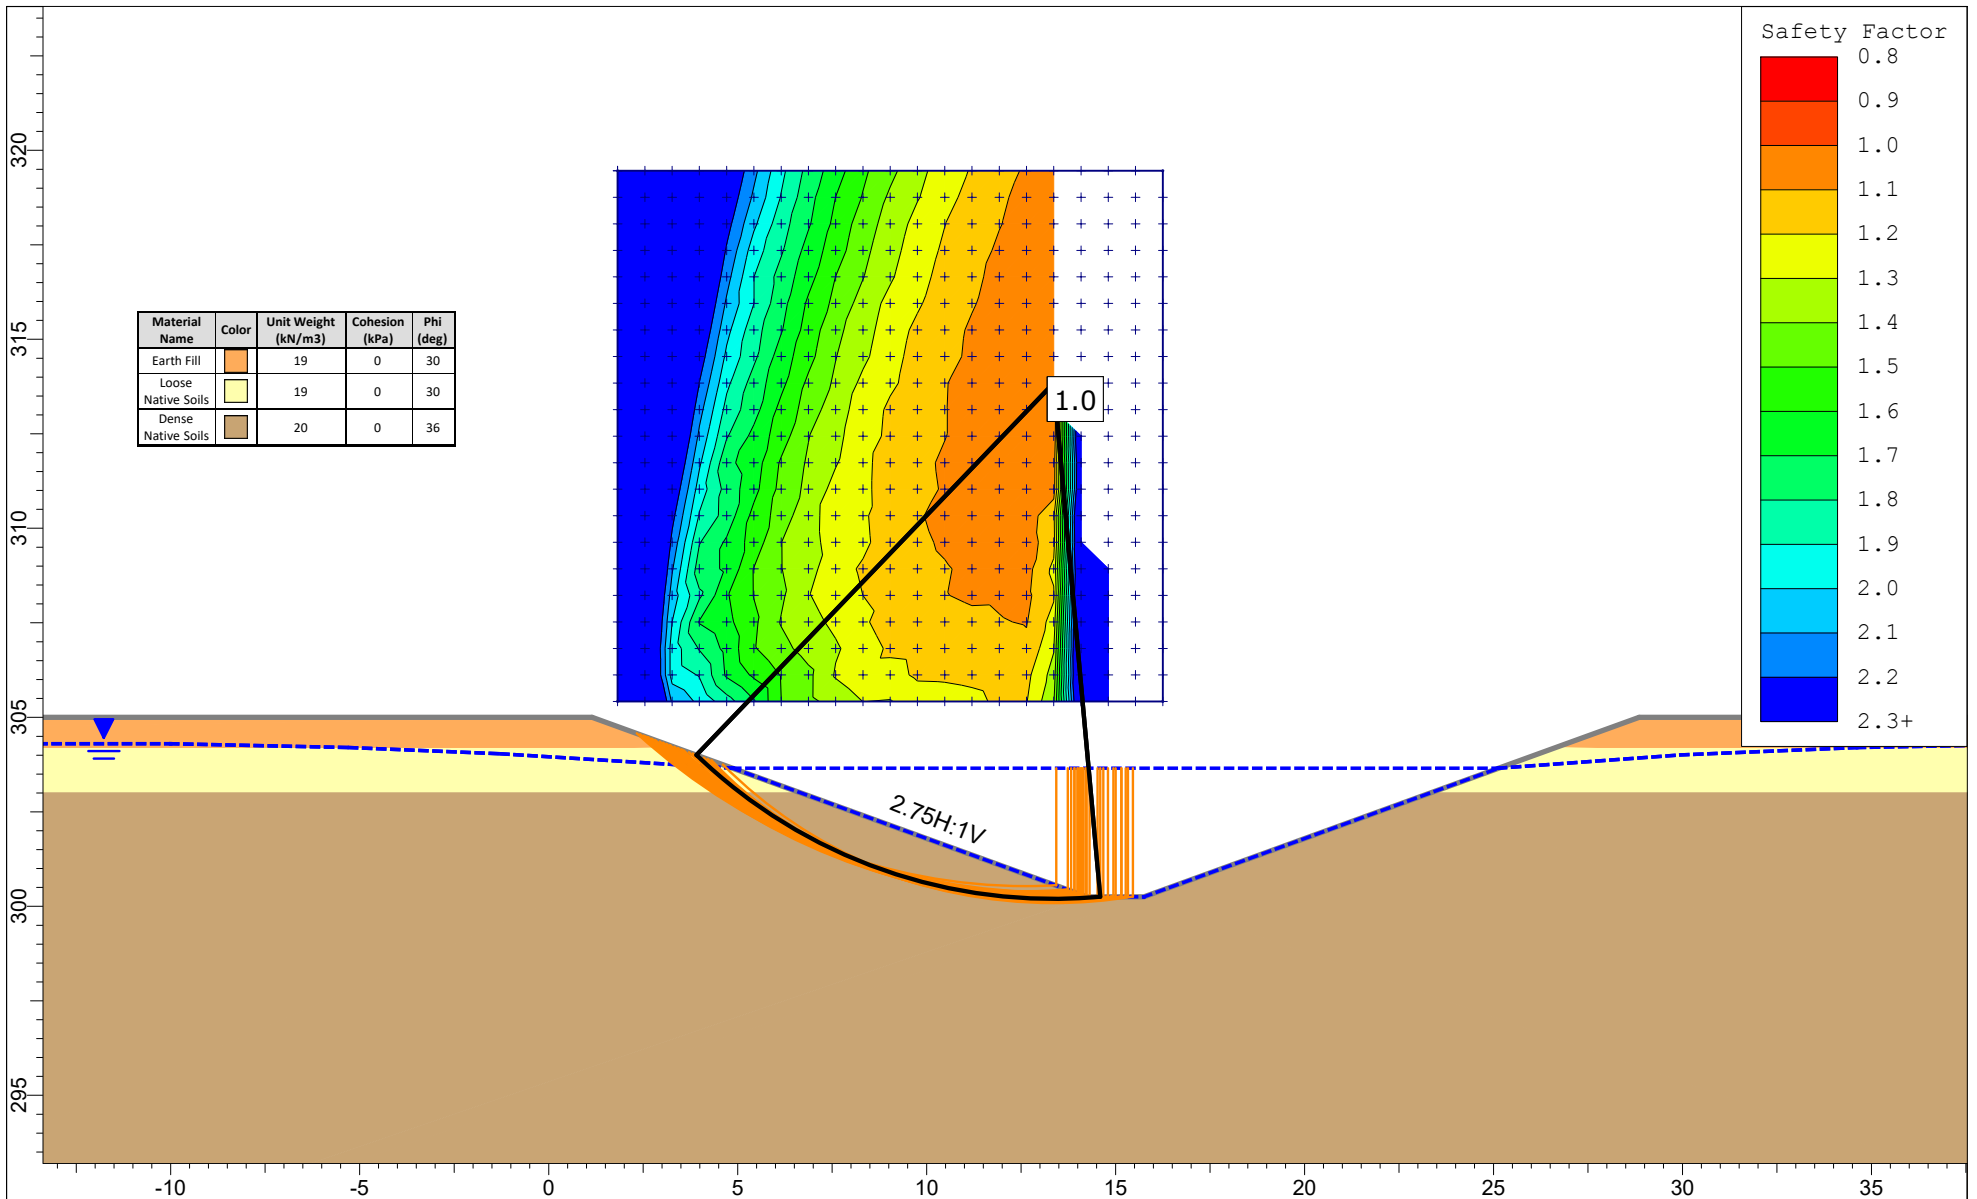
<i>Project</i> 20-1014B 664, 674 & 692 Essa Road & 320 Maplevew Drive West, Barrie		
	<i>Analysis Description</i> Rapid Drawdown from 100 Year Flood, 2.75H:1V Side Slopes		
	<i>Drawn By</i> RW	<i>Scale</i> 1:200	<i>Company</i>
	<i>Date</i> 2020-07-27	<i>File Name</i> Maplevew Essa Channel Stability.slmd

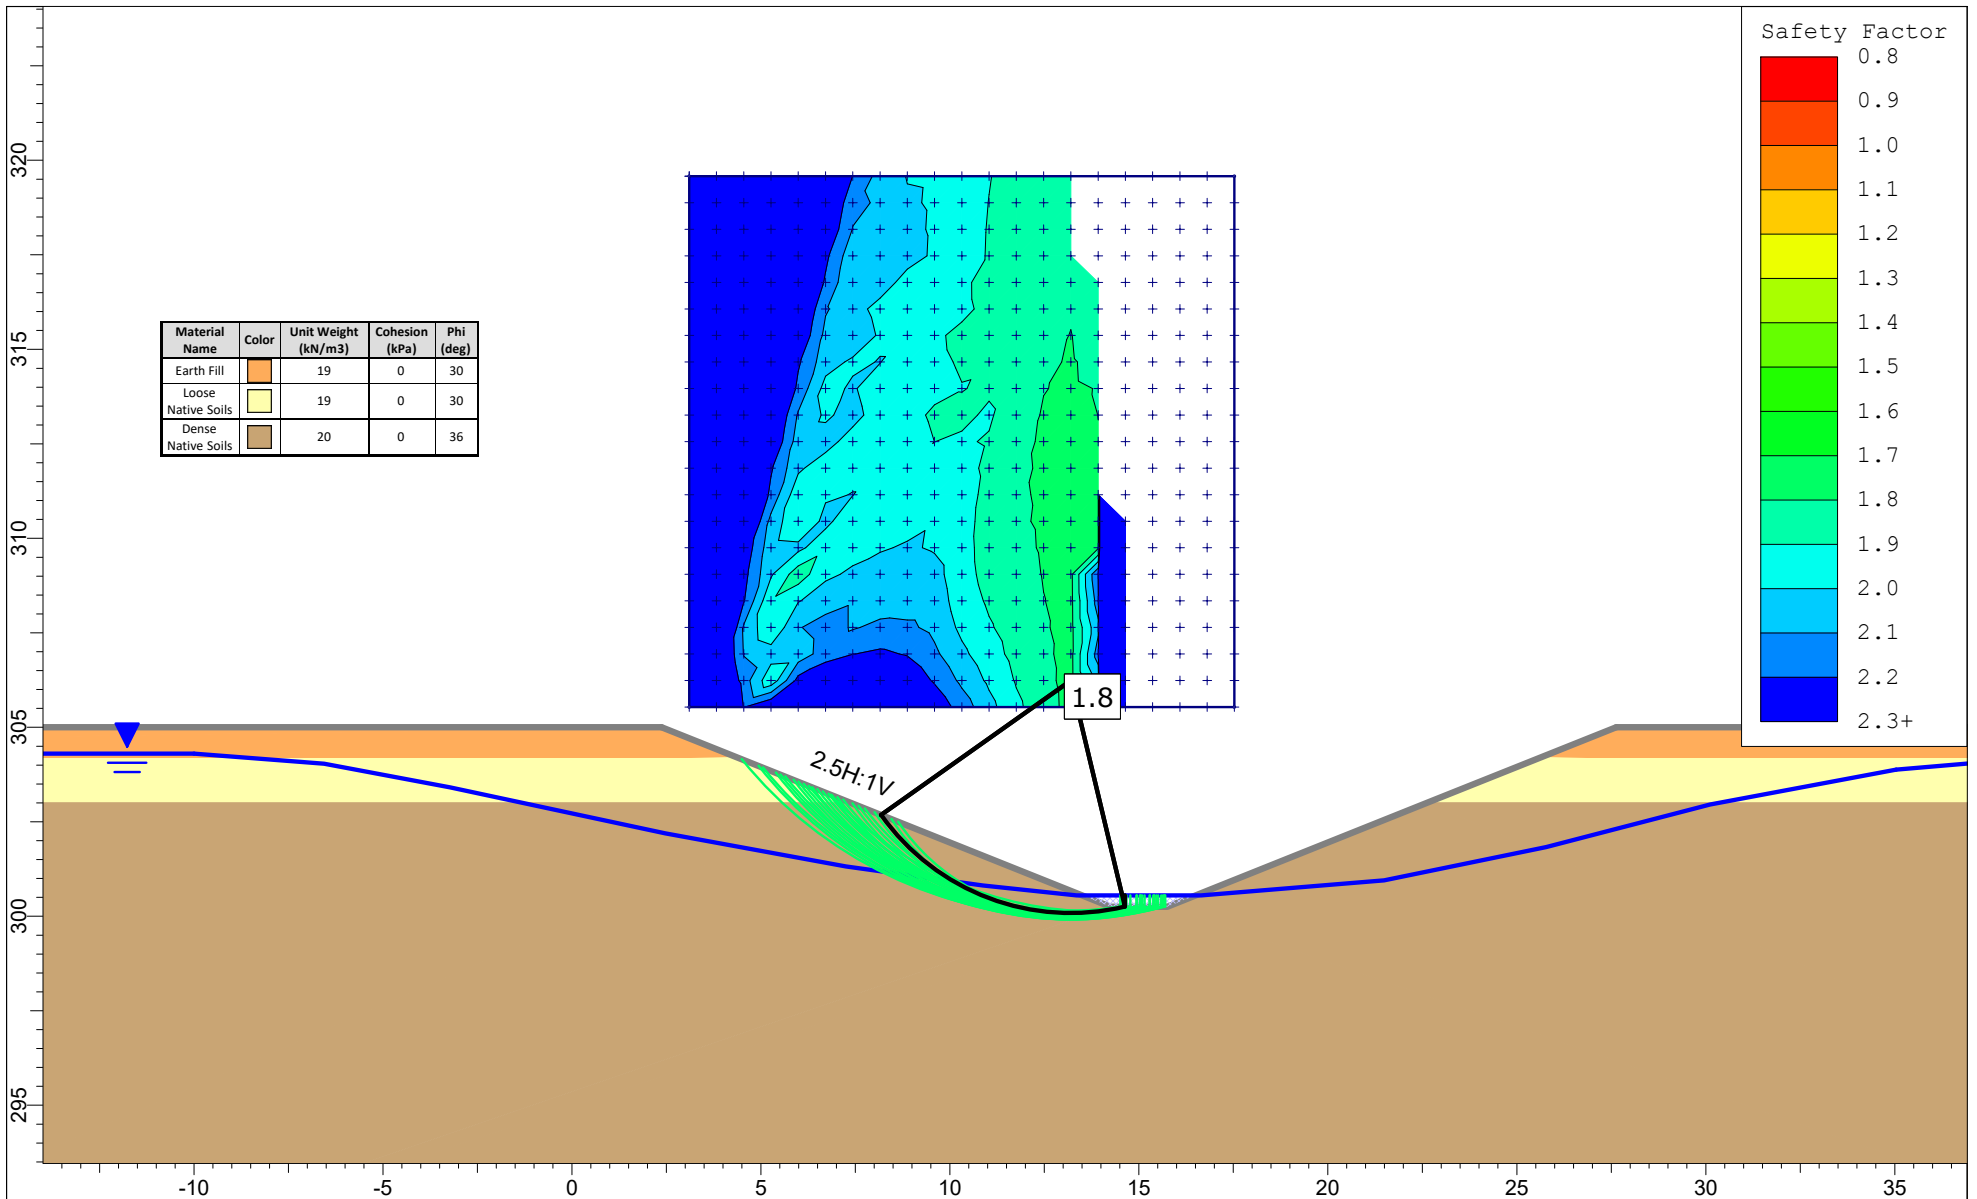
Material Name	Color	Unit Weight (kN/m ³)	Cohesion (kPa)	Phi (deg)
Earth Fill	Orange	19	0	30
Loose Native Soils	Yellow	19	0	30
Dense Native Soils	Brown	20	0	36

<i>Project</i> 20-1014B 664, 674 & 692 Essa Road & 320 Mapleview Drive West, Barrie		
	<i>Analysis Description</i> Normal Conditions, 2.5H:1V Side Slopes		
	<i>Drawn By</i> RW	<i>Scale</i> 1:200	<i>Company</i>
	<i>Date</i> 2020-07-27	<i>File Name</i> Mapleview Essa Channel Stability.slmd

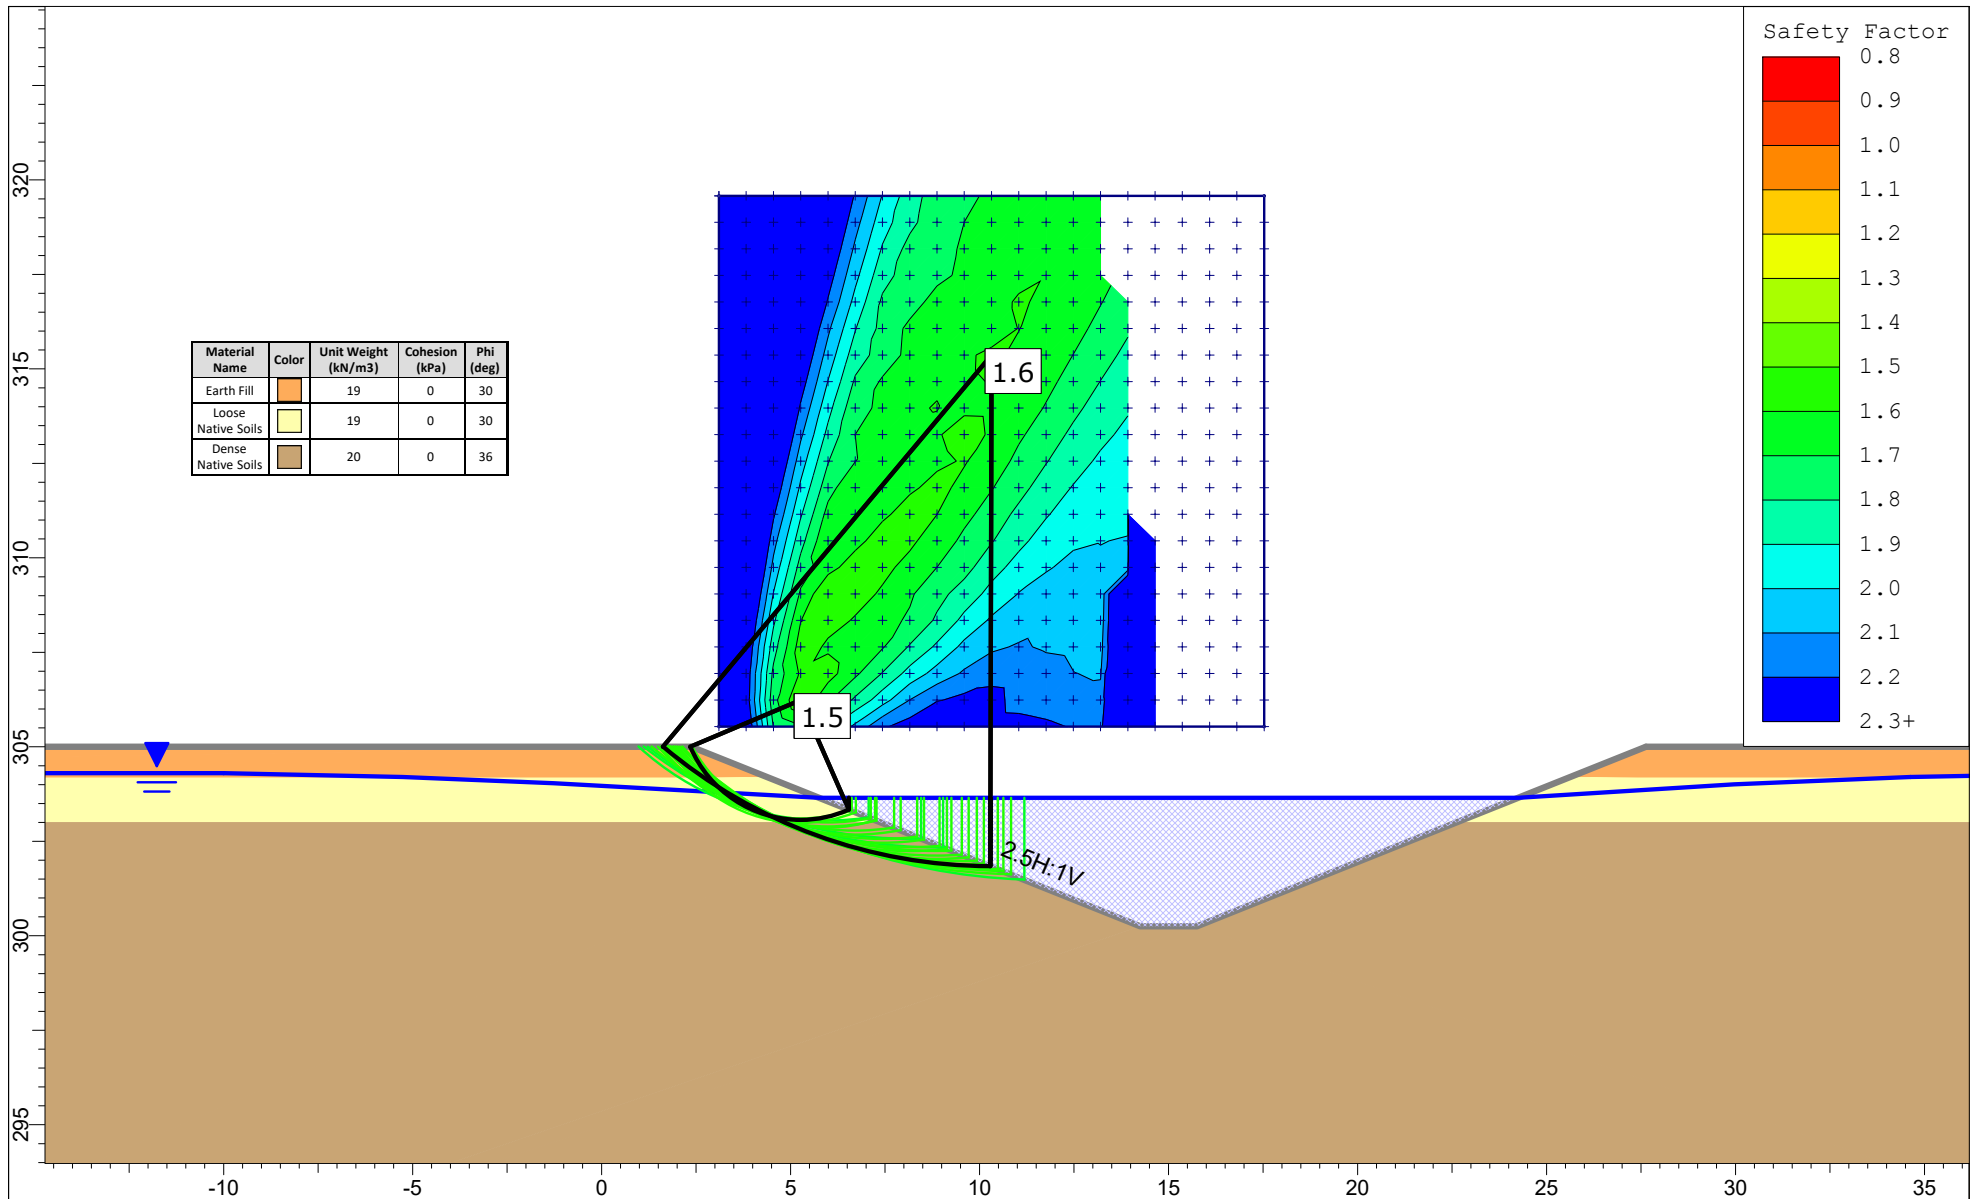
<i>Project</i> 20-1014B 664, 674 & 692 Essa Road & 320 Mapleview Drive West, Barrie		
	<i>Analysis Description</i> 100 Year Flood, 2.5H:1V Side Slopes		
	<i>Drawn By</i> RW	<i>Scale</i> 1:200	<i>Company</i>
	<i>Date</i> 2020-07-27	<i>File Name</i> Mapleview Essa Channel Stability.slmd
