November 21, 2022

Reference No. 20-1014B

Re: Channel Slope Stability Analysis
664, 673 & 692 Essa Road and 320 Mapleview Drive West
Barrie, Ontario

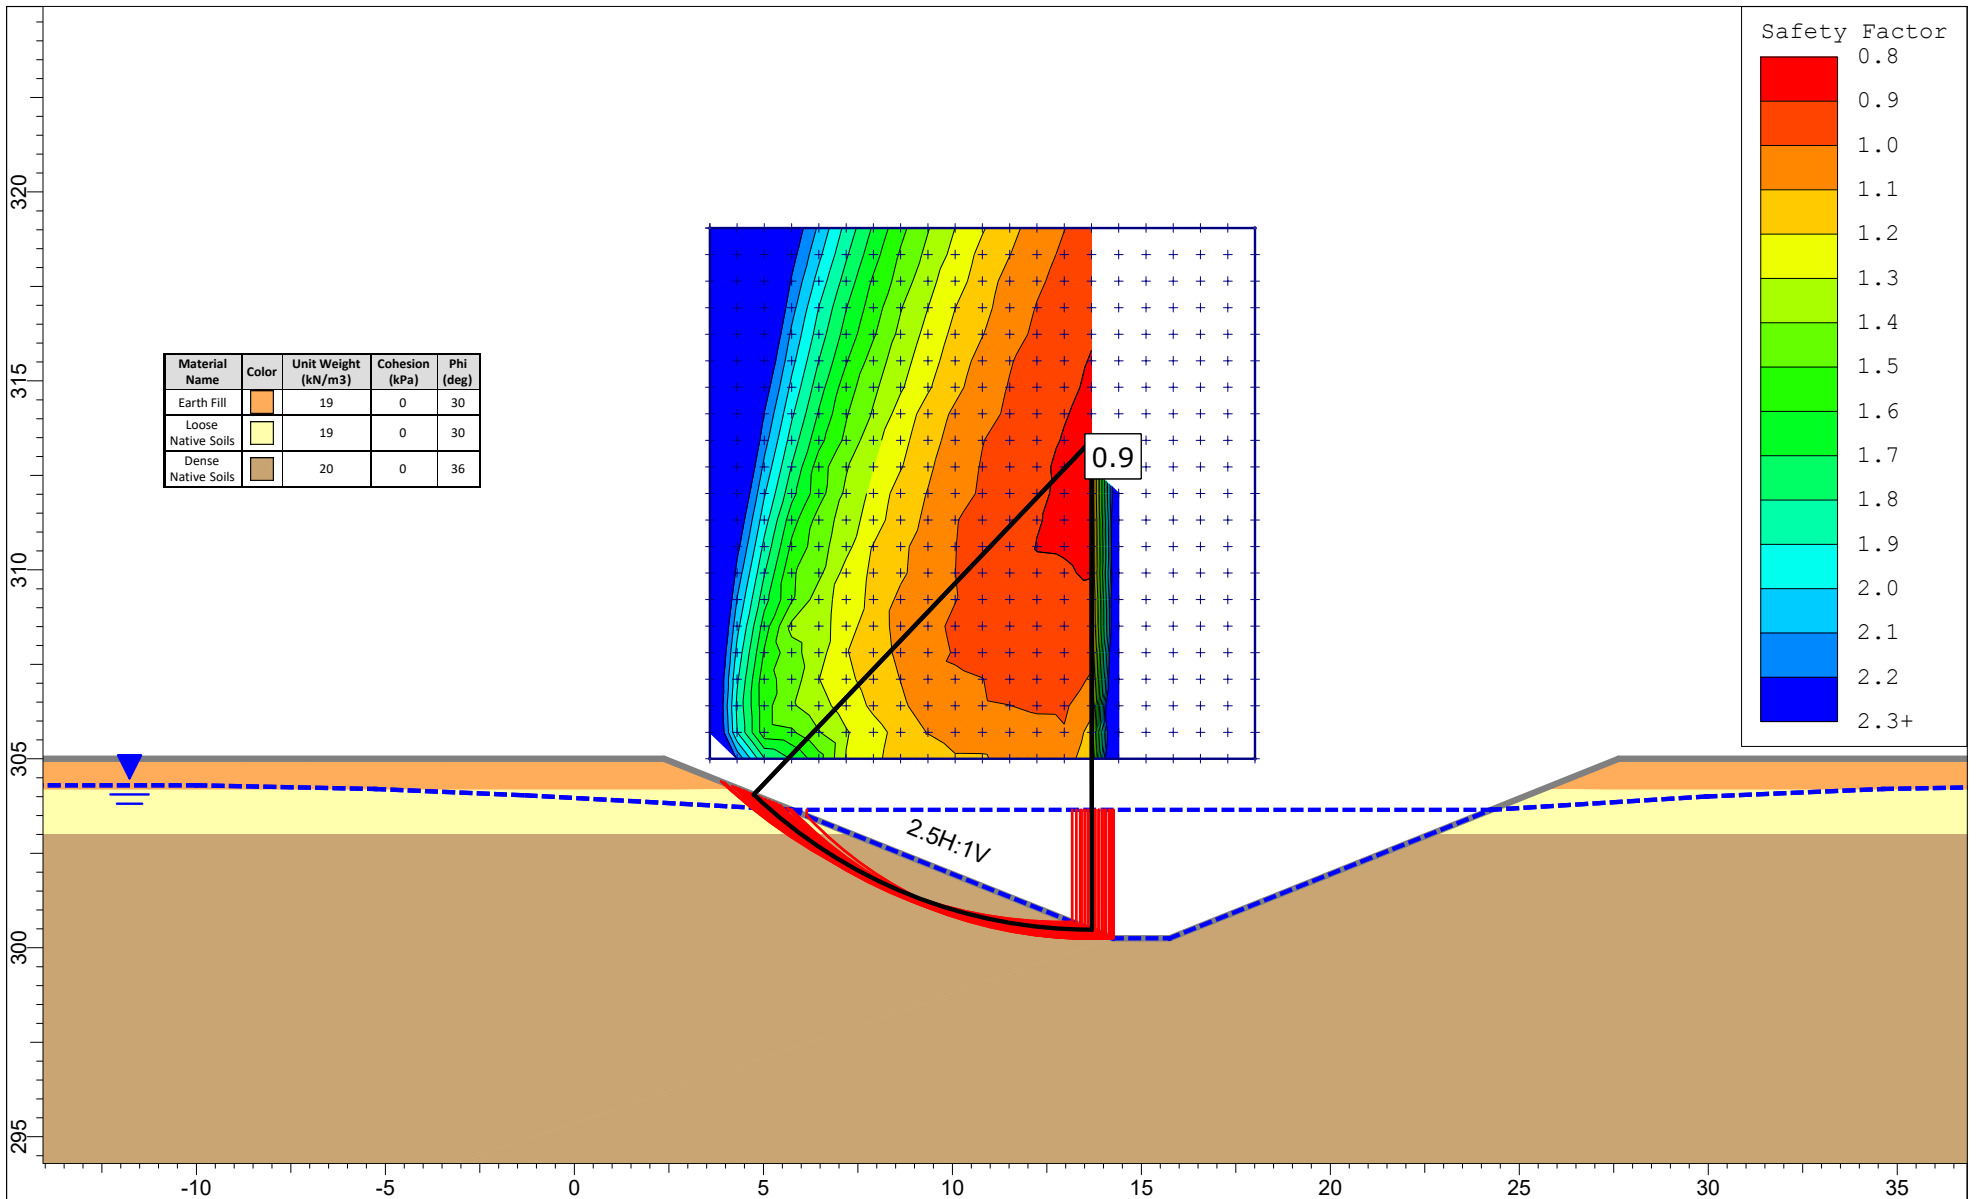
<i>Project</i> 20-1014B 664, 674 & 692 Essa Road & 320 Maplevew Drive West, Barrie		
	<i>Analysis Description</i> Rapid Drawdown from 100 Year Flood, 2.5H:1V Side Slopes		
	<i>Drawn By</i> RW	<i>Scale</i> 1:200	<i>Company</i>
	<i>Date</i> 2020-07-27	<i>File Name</i> Maplevew Essa Channel Stability.slmd

Channel Side Slope Inclination (H:V)	Scenario	Target Factor of Safety	Calculated Factor of Safety	Meets Target?
	Rapid Drawdown from 100 Year Flood Level	1.0	1.1	Yes
2.75 : 1	Normal Conditions	1.5	1.9	Yes
	100 Year Flood Level	1.3	1.6	Yes
	Rapid Drawdown from 100 Year Flood Level	1.0	1.0	Yes
2.5 : 1	Normal Conditions	1.5	1.8	Yes
	100 Year Flood Level	1.3	1.5	Yes
	Rapid Drawdown from 100 Year Flood Level	1.0	0.9	No
2.0 : 1	Normal Conditions	1.5	1.5	Yes
	100 Year Flood Level	1.3	1.3	Yes
	Rapid Drawdown from 100 Year Flood Level	1.0	0.7	No

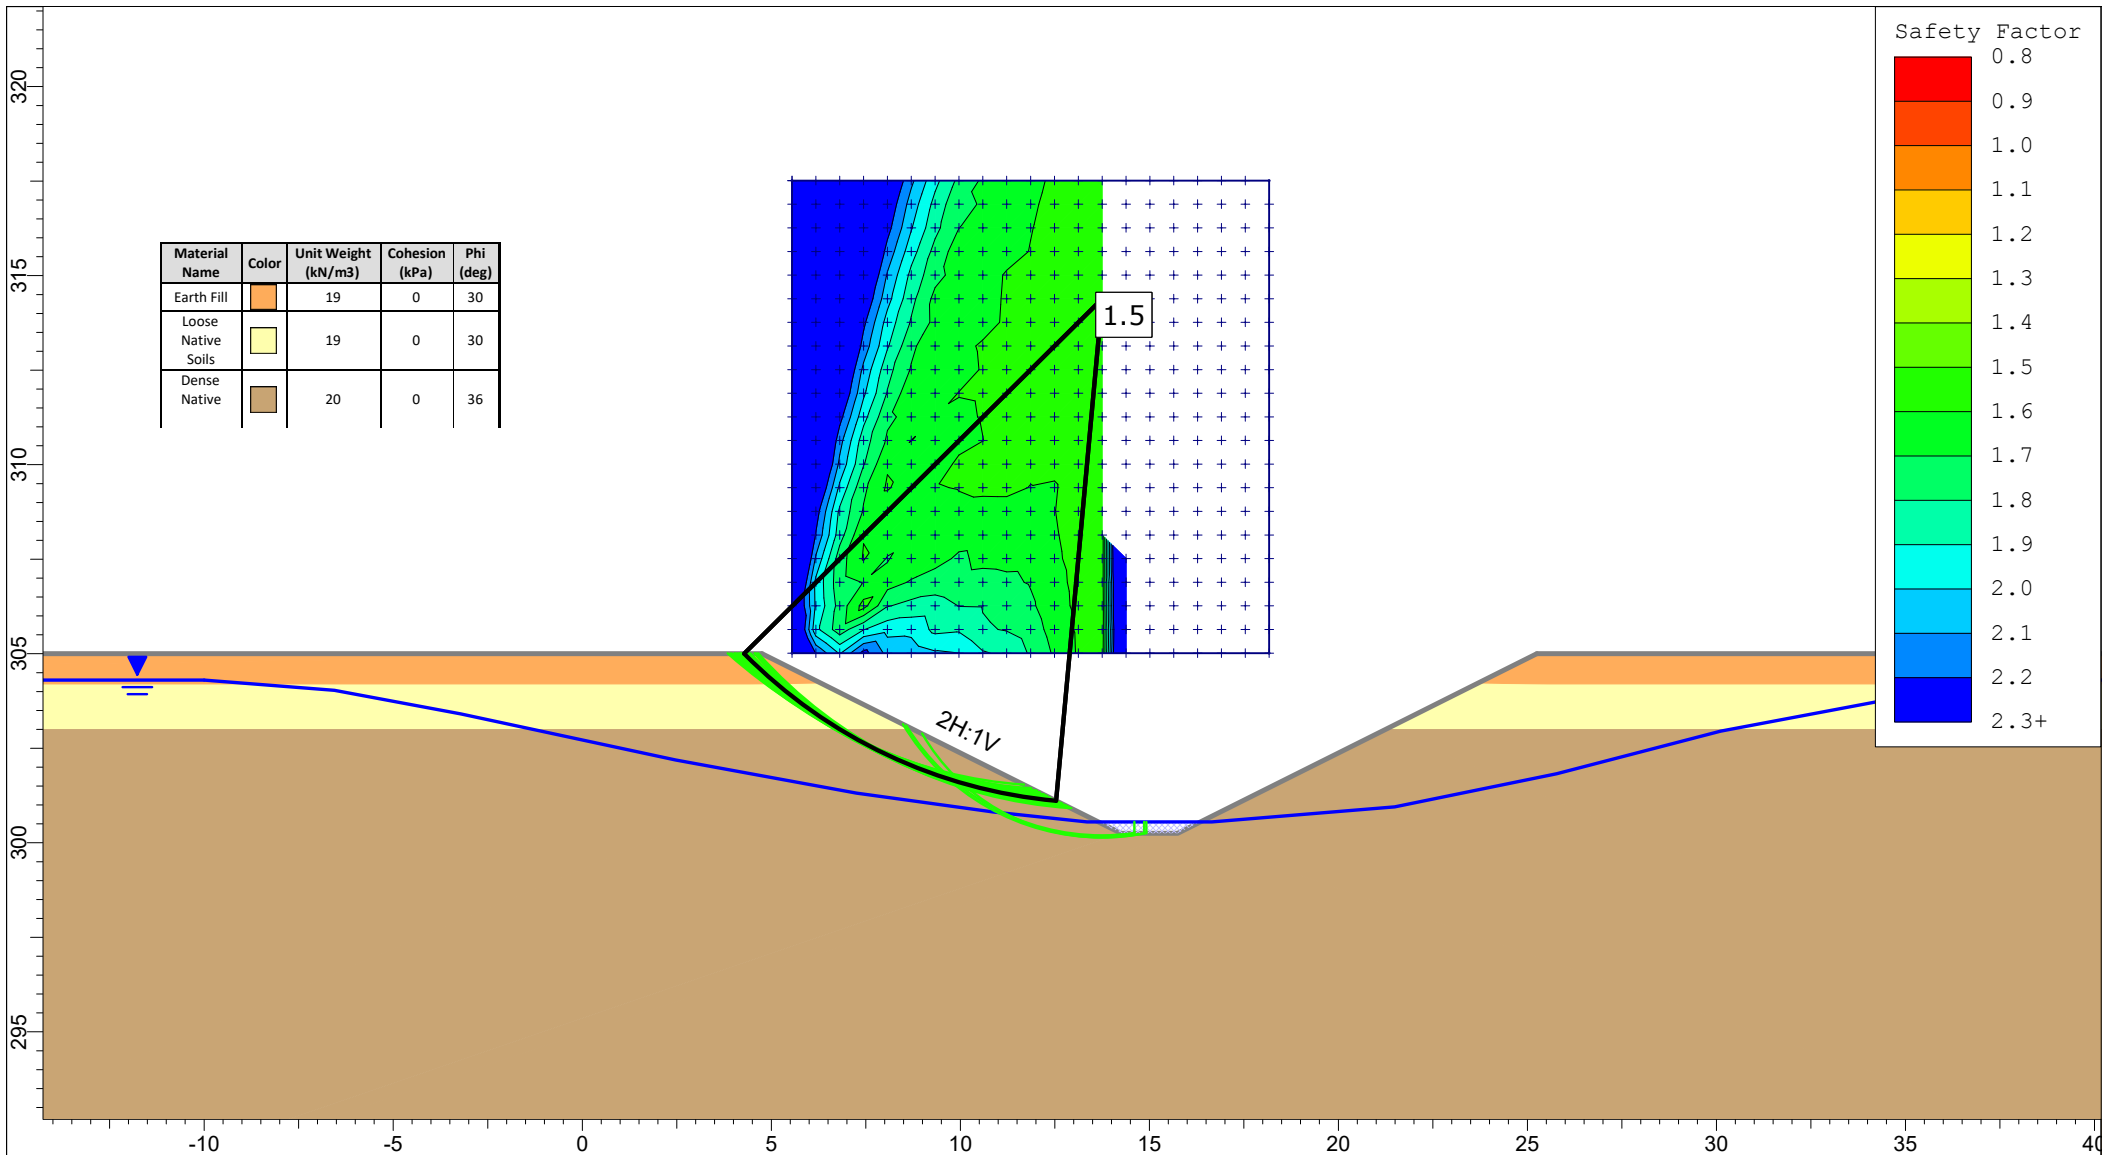
Material Name	Color	Unit Weight (kN/m3)	Cohesion (kPa)	Phi (deg)
Earth Fill		19	0	30
Loose Native Soils		19	0	30
Dense Native		20	0	36

<i>Project</i> 20-1014B 664, 674 & 692 Essa Road & 320 Mapleview Drive West, Barrie		
	<i>Analysis Description</i> Normal Conditions, 2H:1V Side Slopes		
	<i>Drawn By</i> RW	<i>Scale</i> 1:200	<i>Company</i>
	<i>Date</i> 2020-07-27		<i>File Name</i> Mapleview Essa Channel Stability.slmd

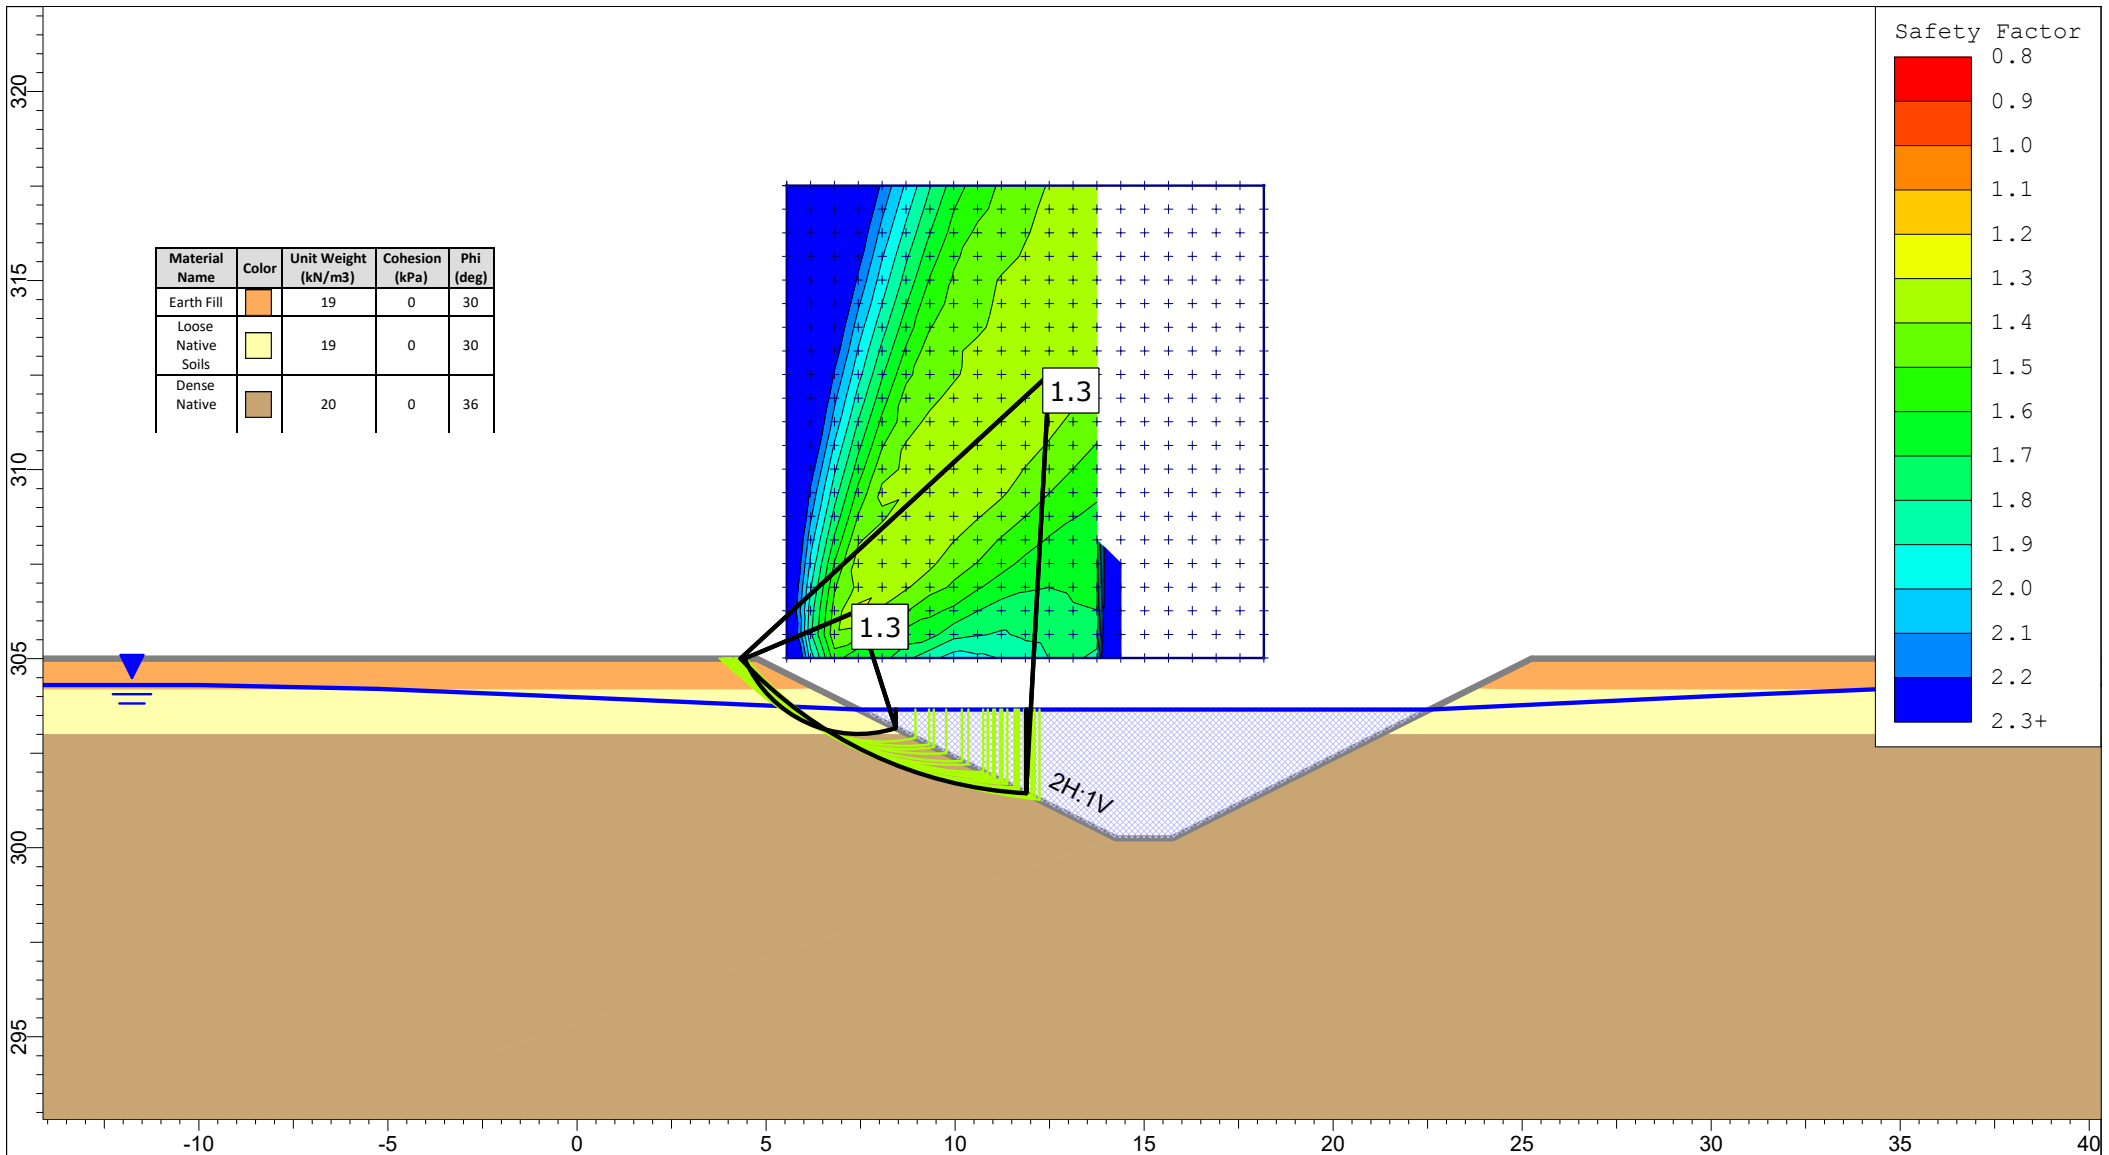
<i>Project</i> 20-1014B 664, 674 & 692 Essa Road & 320 Mapleview Drive West, Barrie		
	<i>Analysis Description</i> 100 Year Flood, 2H:1V Side Slopes		
	<i>Drawn By</i> RW	<i>Scale</i> 1:200	<i>Company</i>
	<i>Date</i> 2020-07-27		<i>File Name</i> Mapleview Essa Channel Stability.slmd

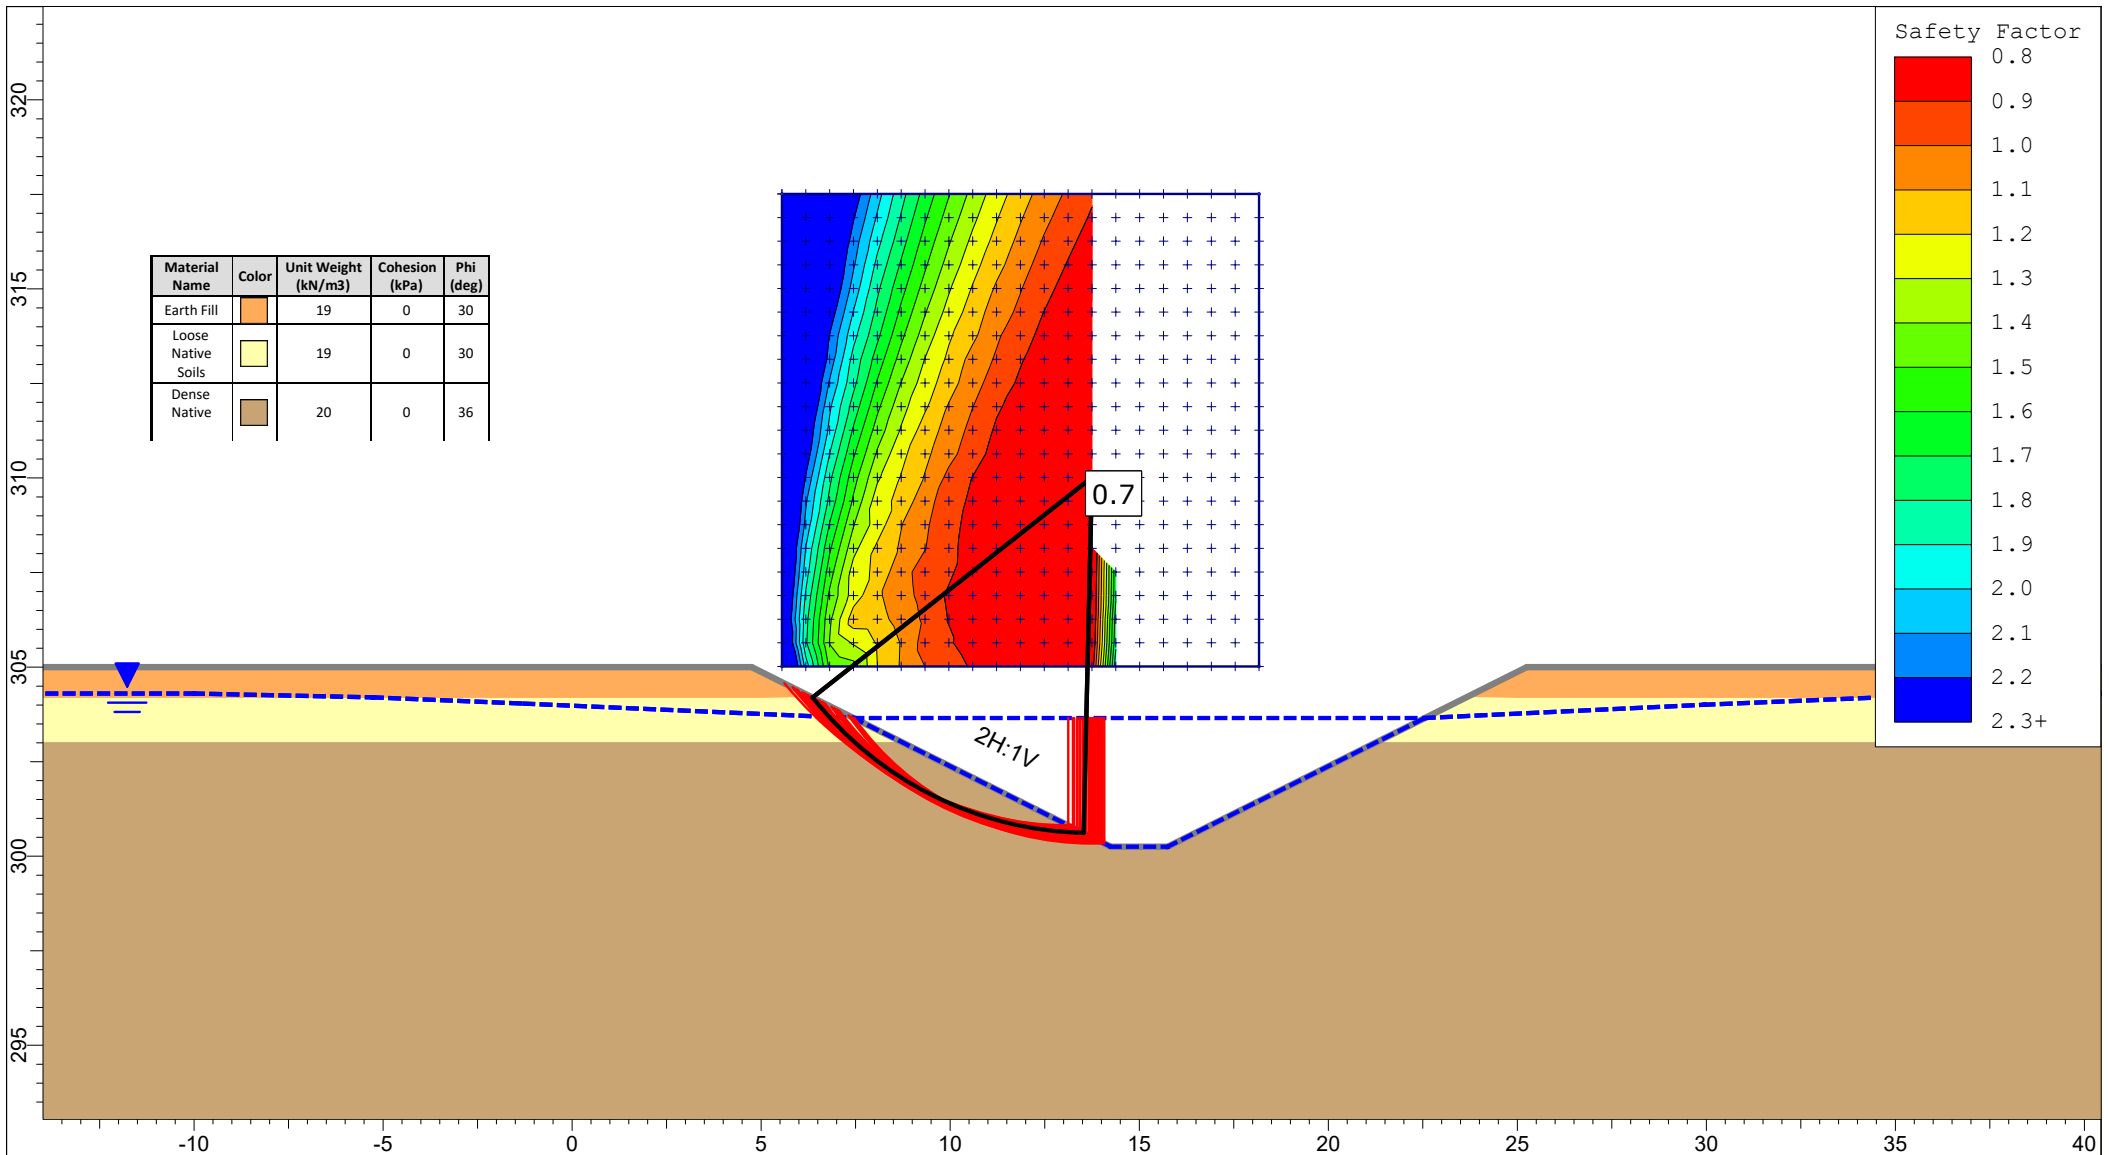
<i>Project</i> 20-1014B 664, 674 & 692 Essa Road & 320 Mapleview Drive West, Barrie		
	<i>Analysis Description</i> Rapid Drawdown from 100 Year Flood, 2H:1V Side Slopes		
	<i>Drawn By</i> RW	<i>Scale</i> 1:200	<i>Company</i>
	<i>Date</i> 2020-07-27		<i>File Name</i> Mapleview Essa Channel Stability.slmd

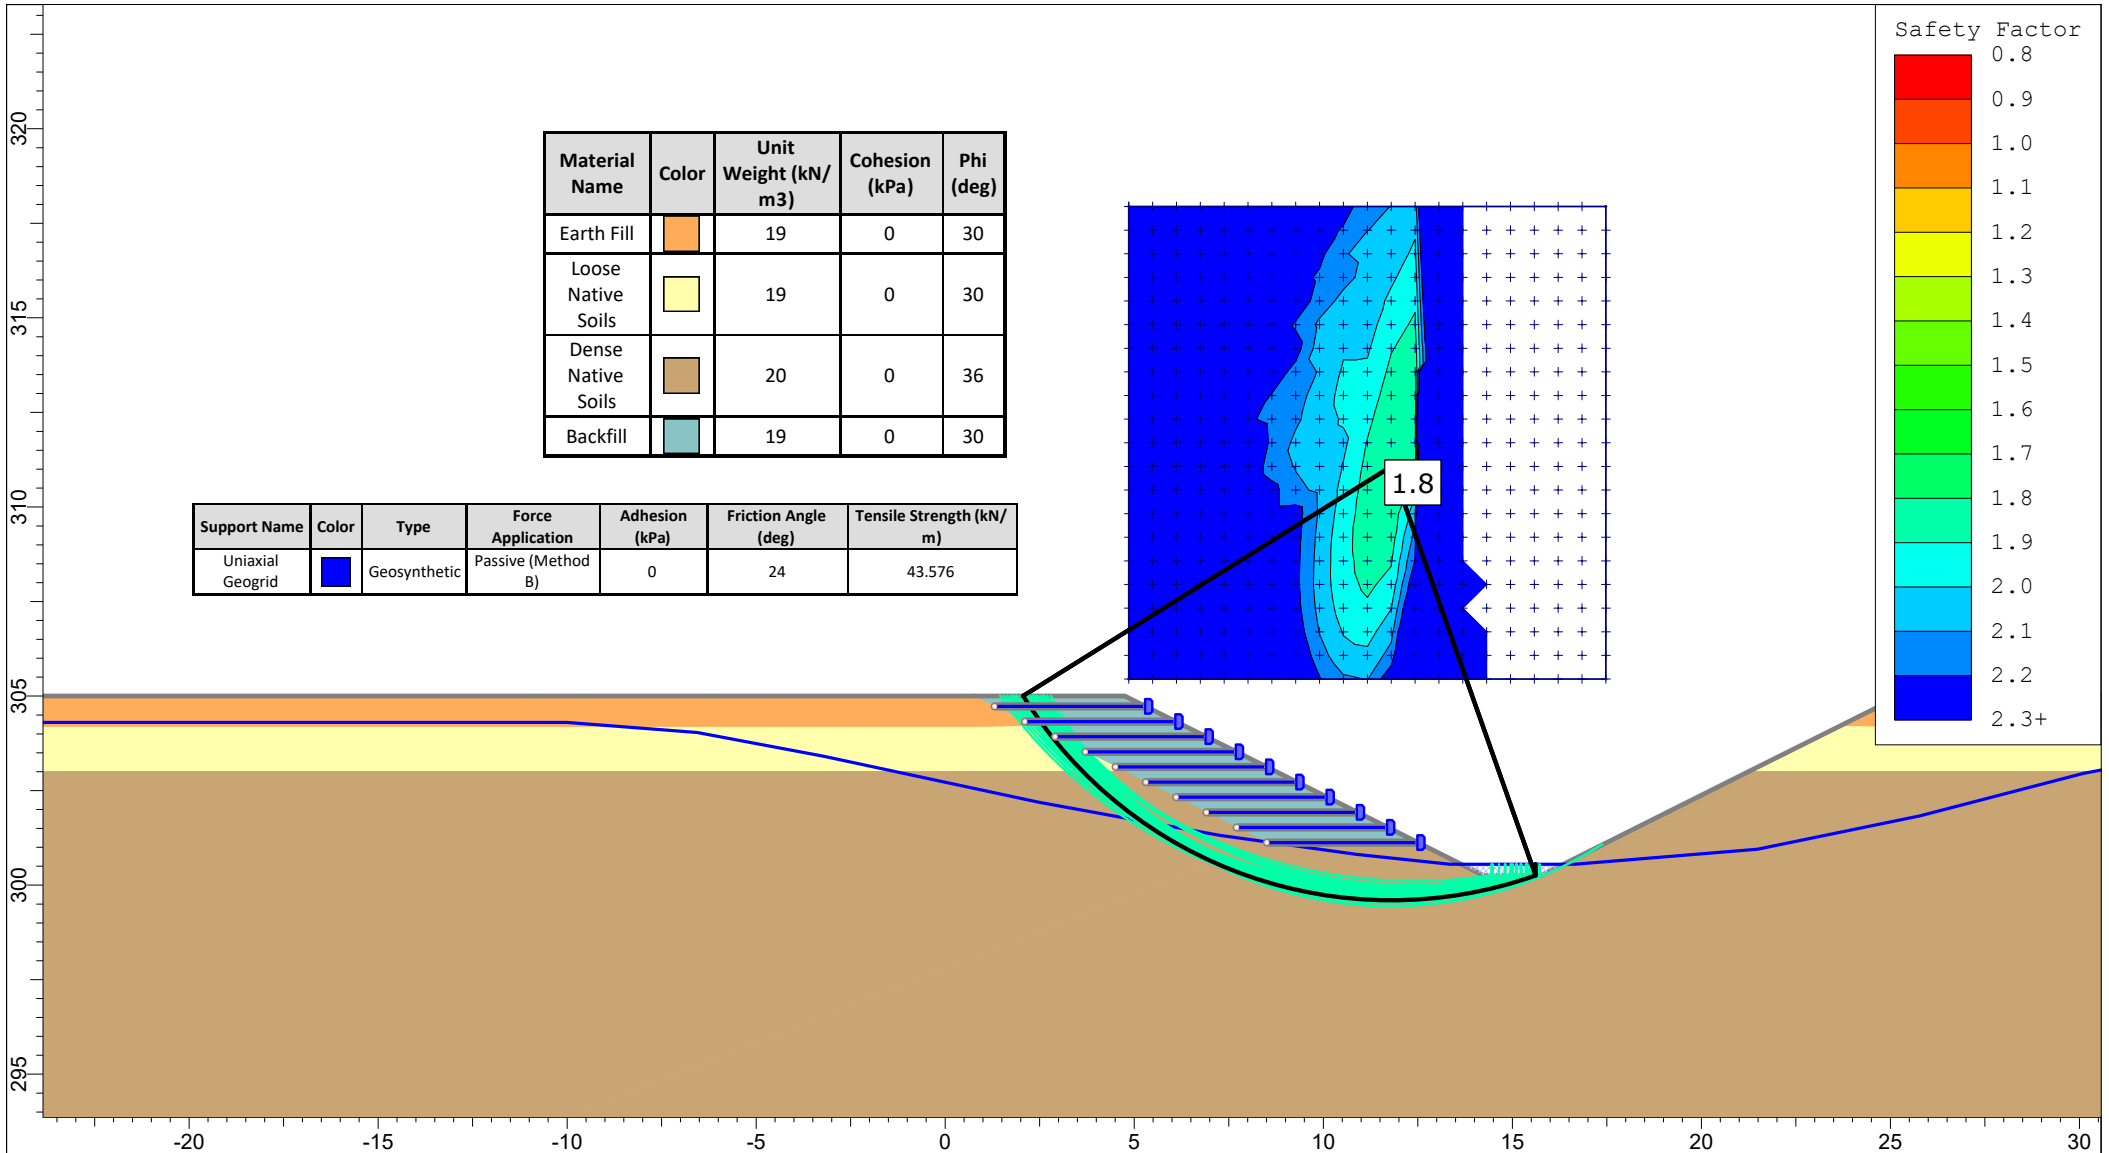
<i>Project</i> 20-1014B 664, 674 & 692 Essa Road & 320 Mapleview Drive West, Barrie		
	<i>Analysis Description</i> RSS Structure - Normal Conditions, 2H:1V Side Slopes		
	<i>Drawn By</i> RW	<i>Scale</i> 1:200	<i>Company</i>
	<i>Date</i> 2020-07-27	<i>File Name</i> Mapleview Essa Channel Stability.slm

GEI carried out preliminary slope stability analysis for a 2 horizontal to 1 vertical channel slope that includes geogrid reinforcement to determine the feasibility of using an RSS structure at the site to increase tableland space. The geogrid was modelled to consist of Tensar UX1100 uniaxial geogrid with a horizontal length of 4 metres from the slope face, 0.4 metre vertical spacing, and extended down most of the channel face. It was assumed that the existing cohesionless soils would be sub-excavated and re-used as the engineered backfill material. Preliminary analysis shows that an RSS structure with 2H : 1V side slopes can be designed to meet the target factors of safety. The results from *Slide2* are enclosed as Appendix D and are summarized below.

Channel Side Slope Inclination (H:V)	Scenario	Target Factor of Safety	Calculated Factor of Safety	Meets Target?
2.0 : 1 with RSS	RSS – Normal Conditions	1.5	1.8	Yes
	RSS – 100 Year Flood Level	1.3	1.7	Yes
	RSS – Rapid Drawdown from 100 Year Flood Level	1.0	1.1	Yes

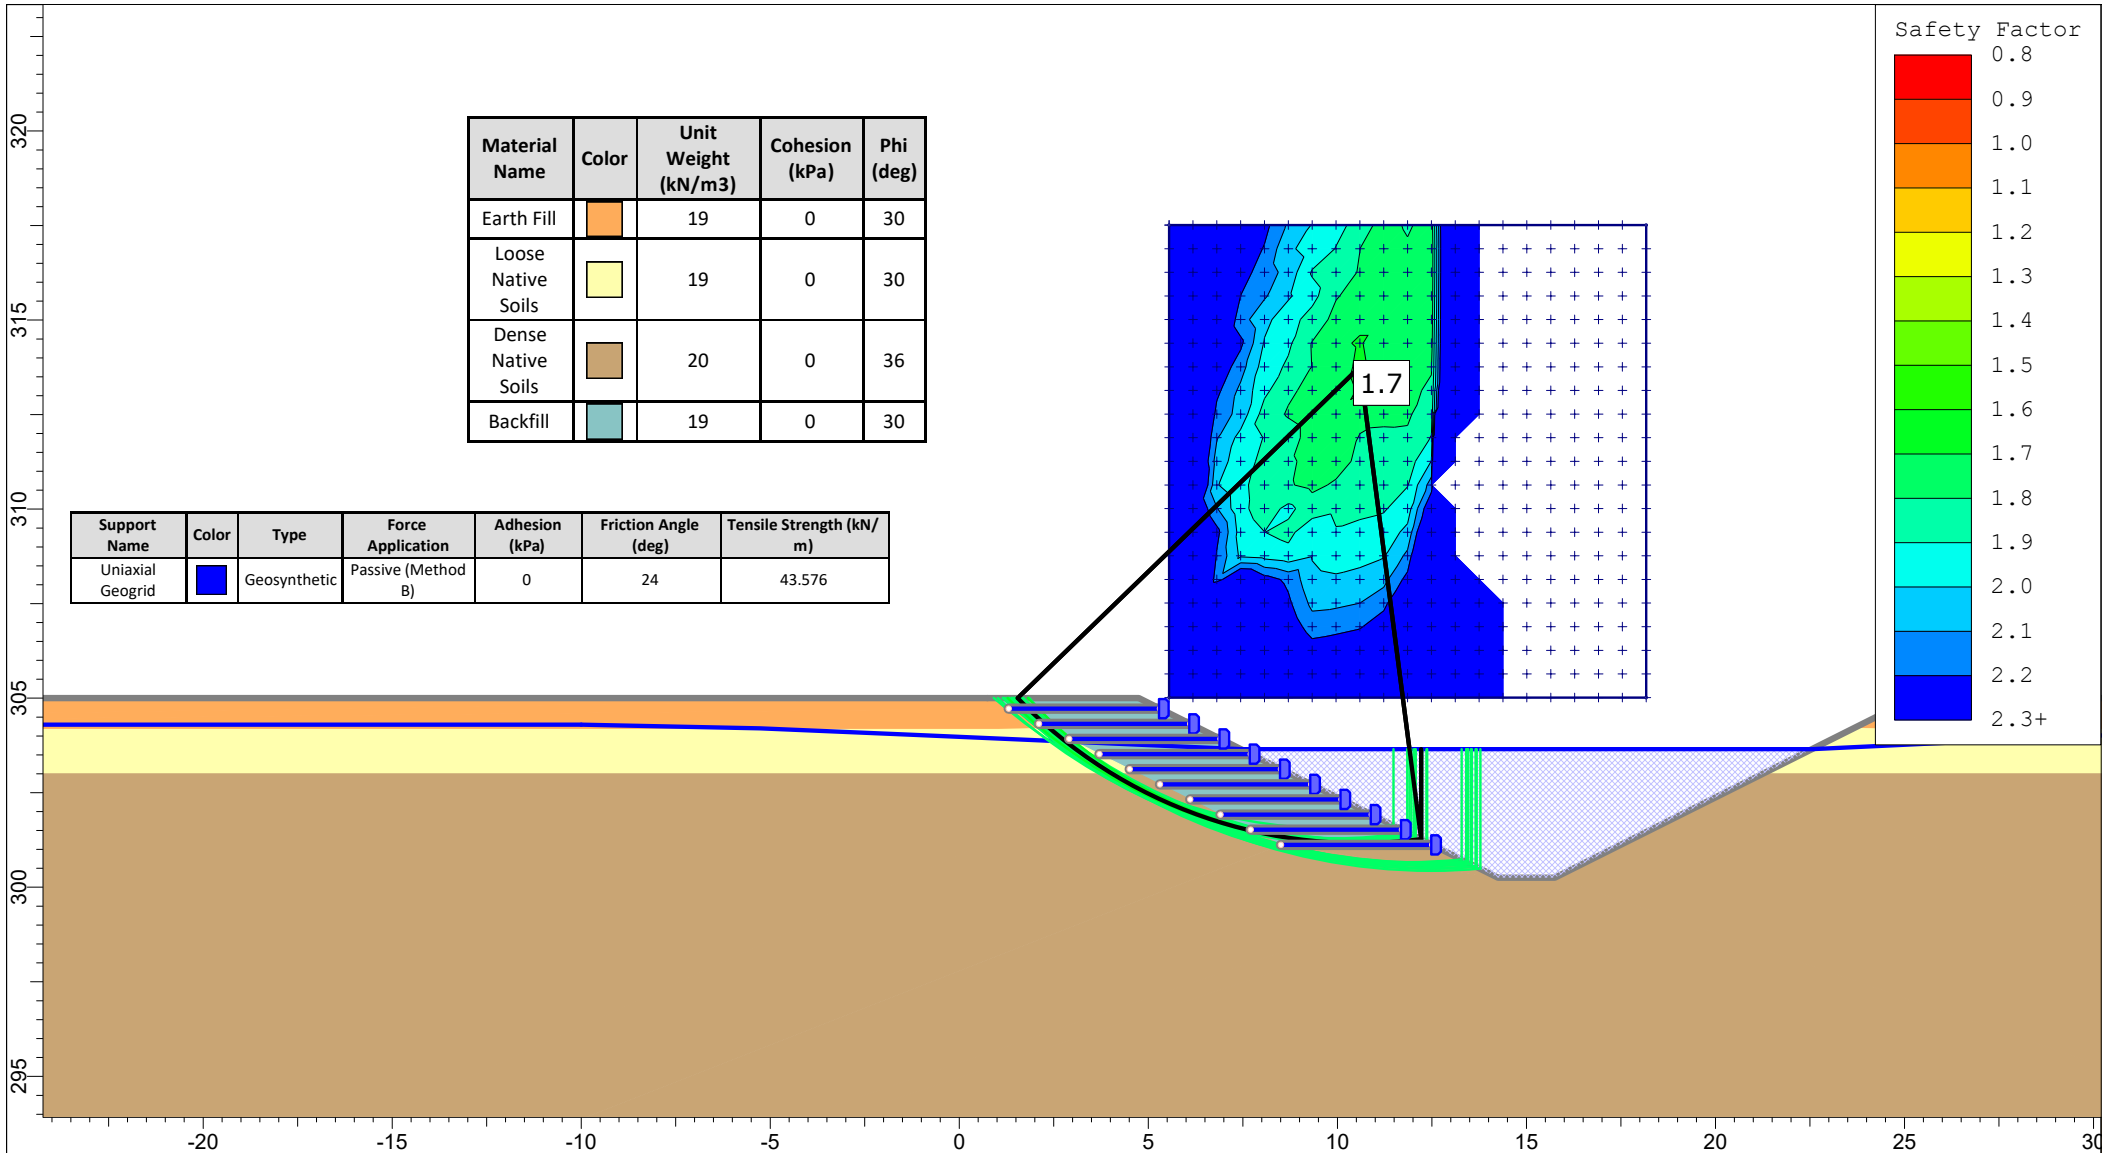
<i>Project</i> 20-1014B 664, 674 & 692 Essa Road & 320 Mapleview Drive West, Barrie		
	<i>Analysis Description</i> RSS Structure - 100 Year Flood, 2H:1V Side Slopes		
	<i>Drawn By</i> RW	<i>Scale</i> 1:200	<i>Company</i>
	<i>Date</i> 2020-07-27		<i>File Name</i> Mapleview Essa Channel Stability.slmd

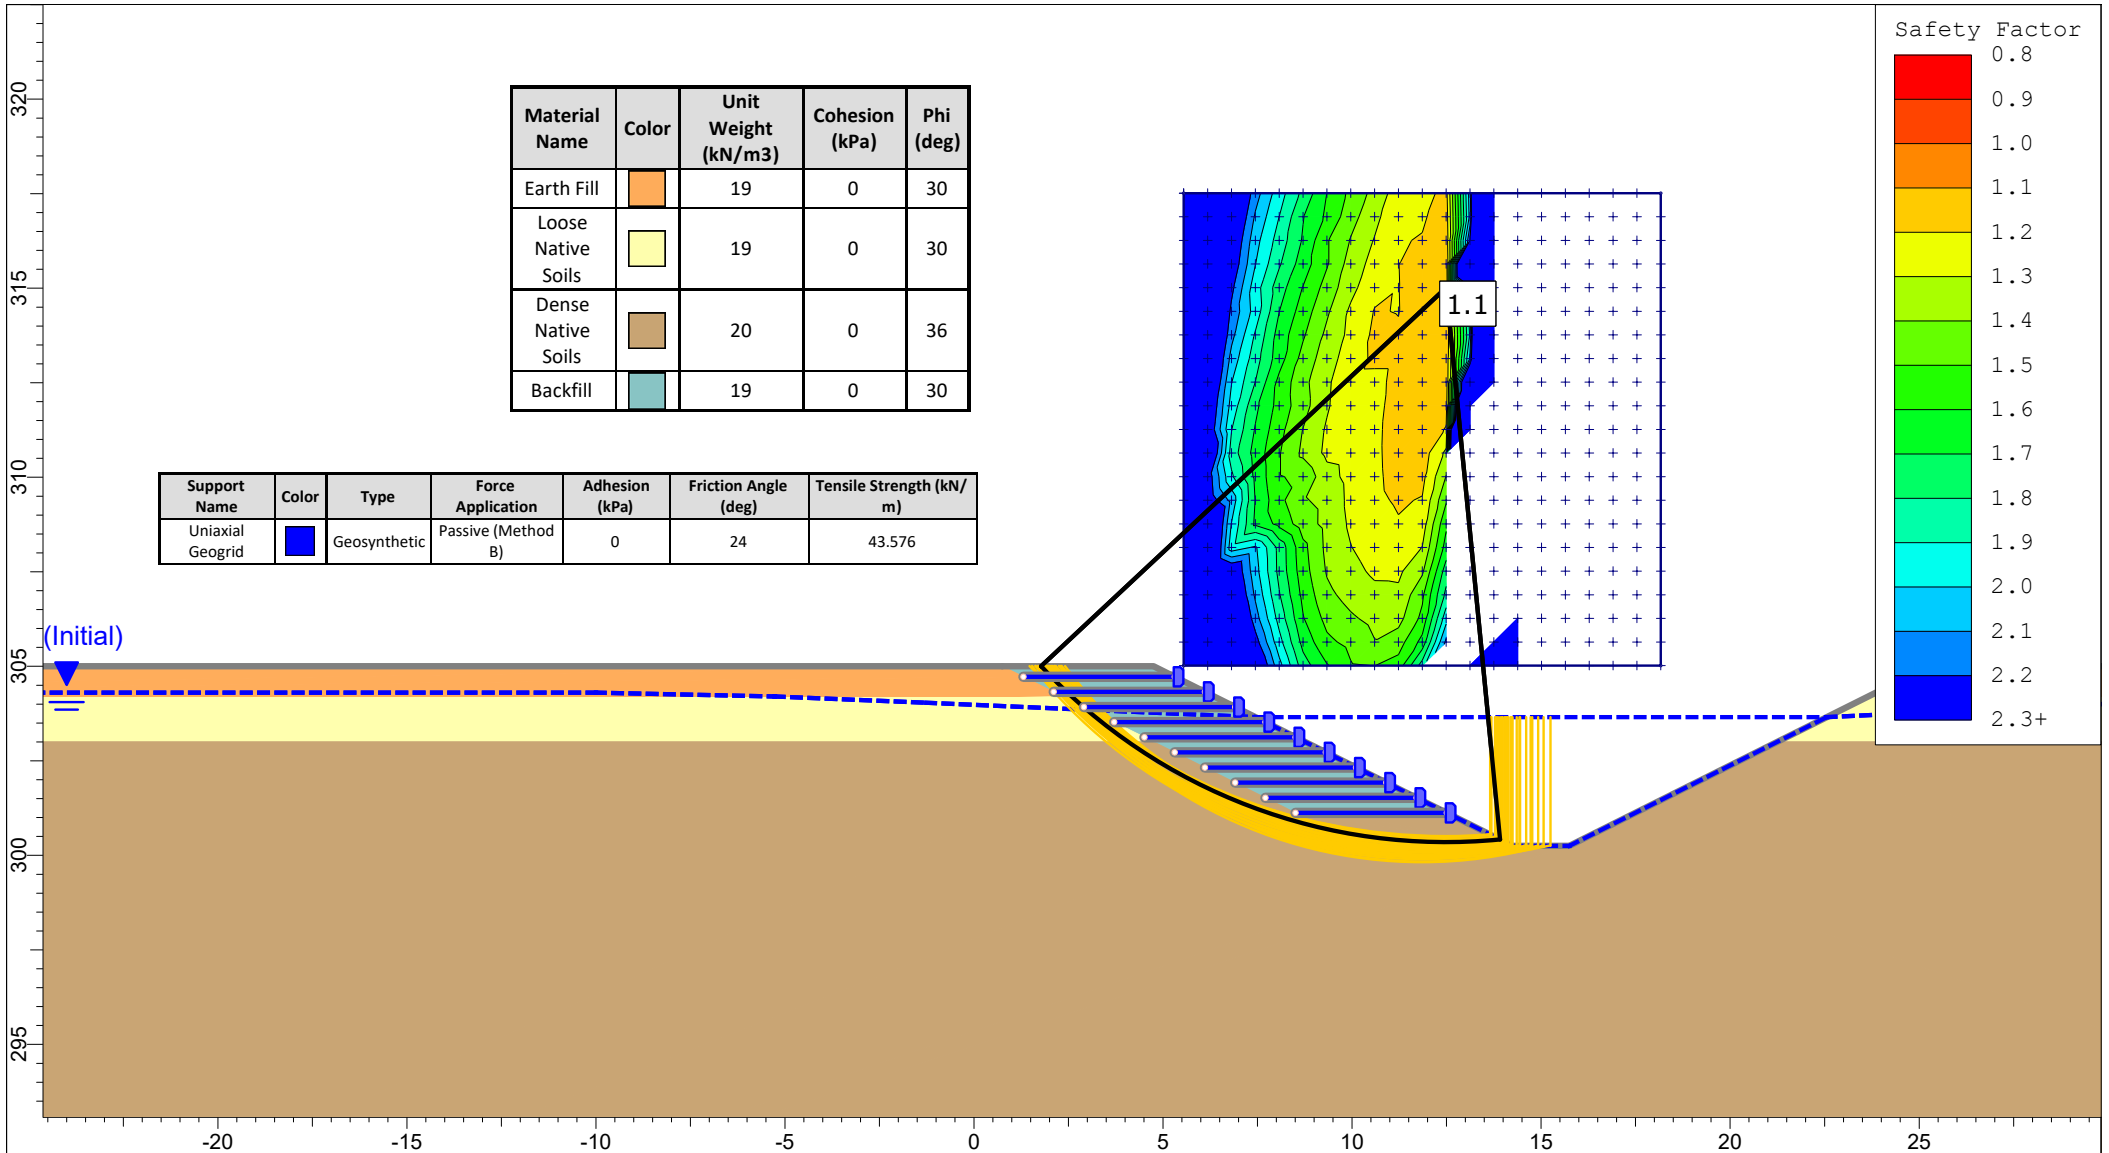
<i>Project</i>			20-1014B 664, 674 & 692 Essa Road & 320 Mapleview Drive West, Barrie		
<i>Analysis Description</i>			RSS Structure - Rapid Drawdown from 100 Year Flood, 2H:1V Side Slopes		
<i>Drawn By</i>	RW	<i>Scale</i>	1:200	<i>Company</i>	
<i>Date</i>	2020-07-27			<i>File Name</i>	Mapleview Essa Channel Stability.slmd
