Appendix M

Railway Crossing Assessment

**City of Barrie
Hewitt's Grade Separations**

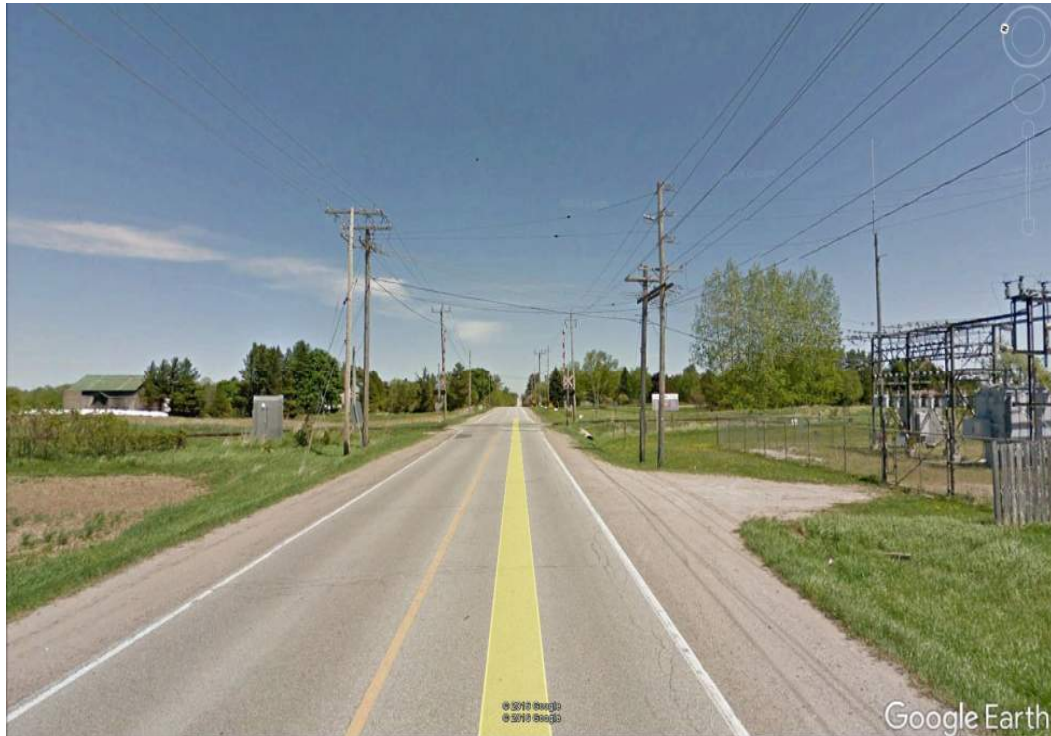
Figure 2: Looking east along Lockhart Road toward existing level crossing.

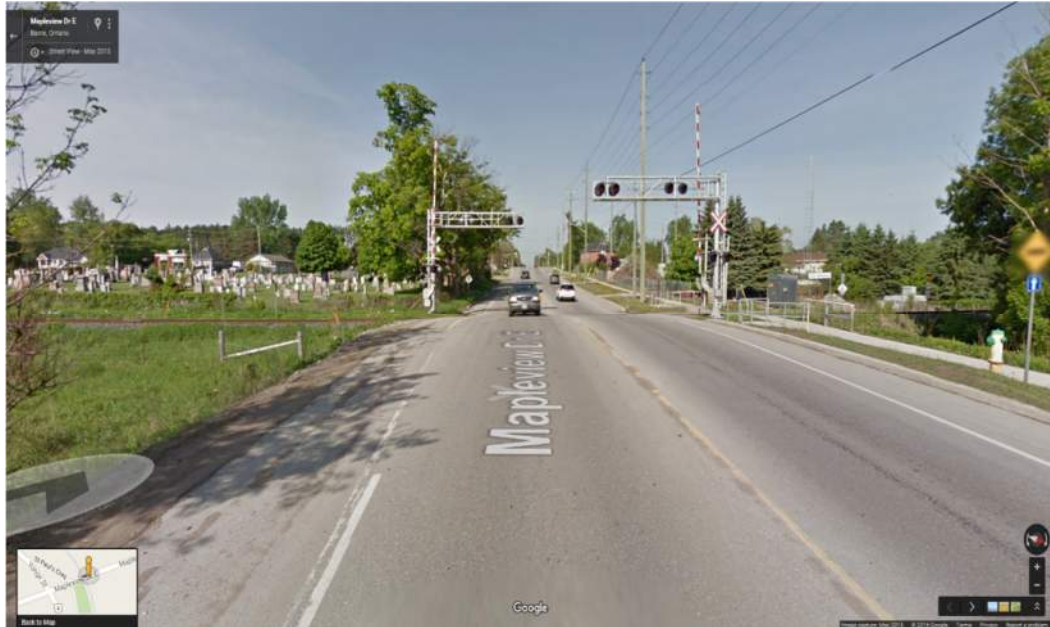
Figure 4: Looking west along Mapleview Drive East toward existing level crossing.
