## 2024 Sanitary Collection System Annual Report

Environmental Compliance Approval 014-W601

March 26, 2025

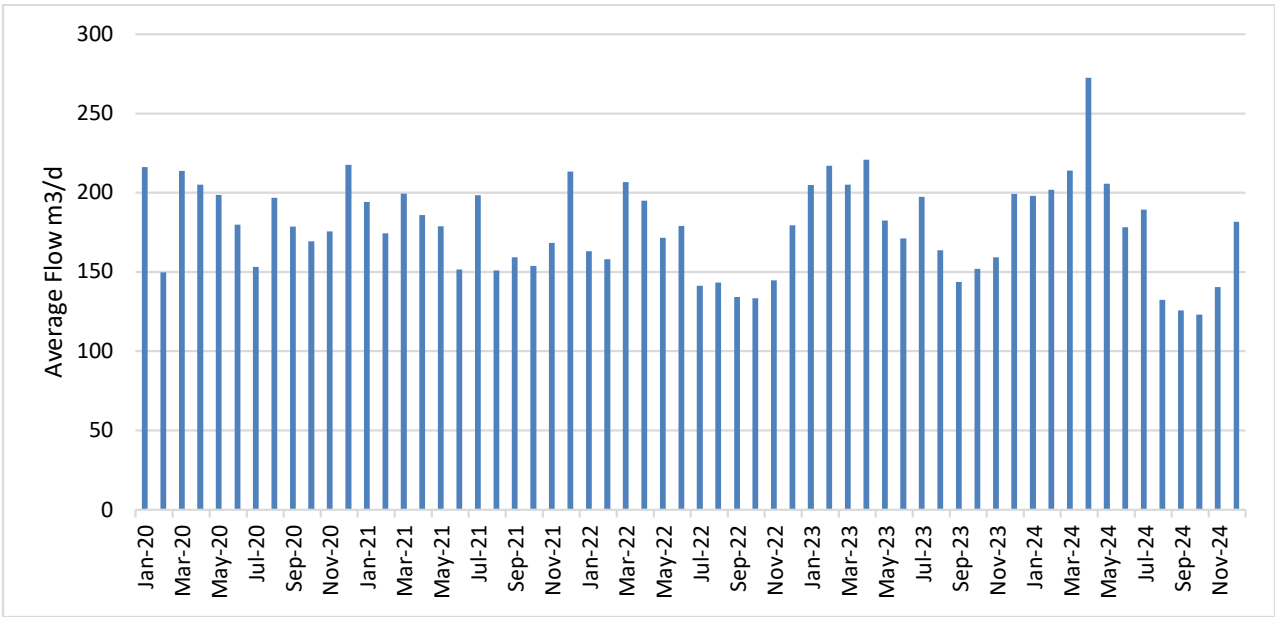
Figure 9 Tyndale Park SPS Monthly Average Daily Flows

| Date | Repair Detail | Resolution and Closing Comments | Pump Station |
|---|---|---|---|
| October 29, 2024 | Repair pump #2 | Pump failed to start and lockout status. Pump shows a leak detection alarm and there's no power going to the hour meter. Installed spare pump and sent original pump for repairs. | Tyndale |
