# 211 DOCK ROAD TREE PRESERVATION PLAN BARRIE, ON

MUNICIPAL FILE: D30-036-2023

LANDMARK ENVIRONMENTAL GROUP LTD.

PROJECT NO. LA 832-23

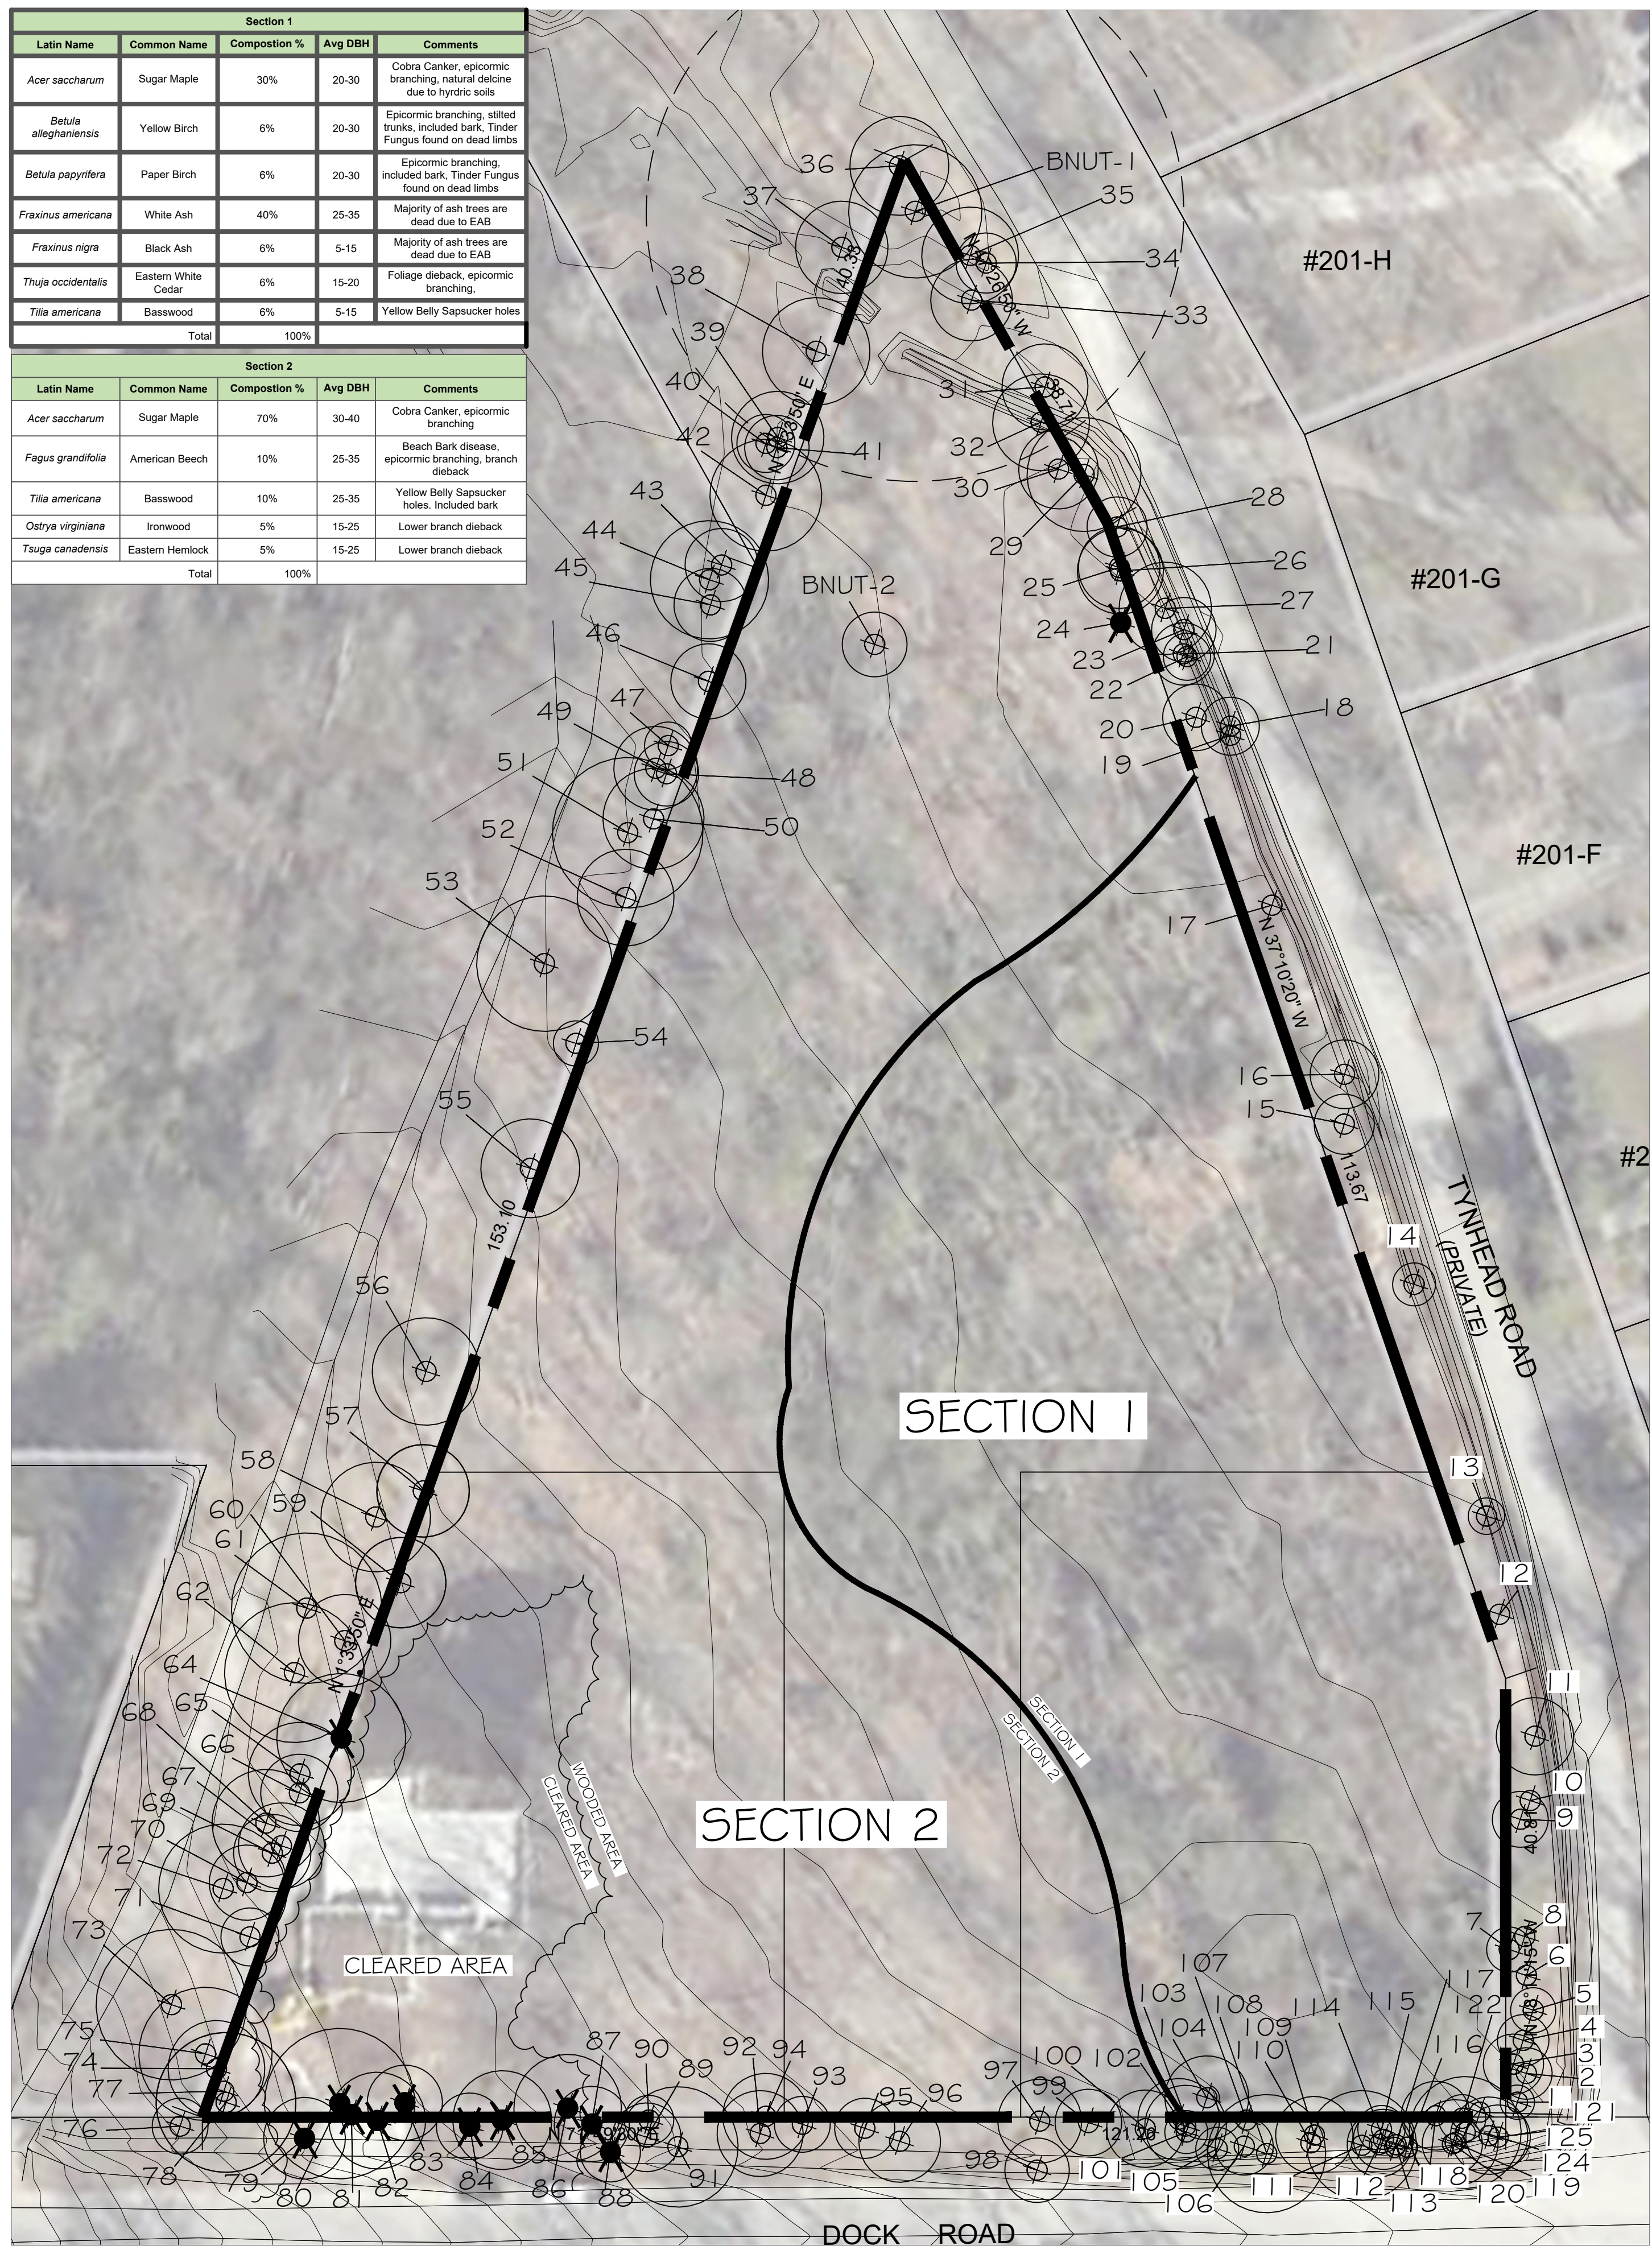
| Section 1 | | | | |
|---|---|---|---|---|
| <i>Acer saccharum</i> | Sugar Maple | 30% | 20-30 | Cobra Canker, epicormic branching, natural decline due to hydric soils |
| <i>Betula alleghaniensis</i> | Yellow Birch | 6% | 20-30 | Epicormic branching, stilted trunks, included bark, Tinder Fungus found on dead limbs |
| <i>Betula papyrifera</i> | Paper Birch | 6% | 20-30 | Epicormic branching, included bark, Tinder Fungus found on dead limbs |
| <i>Fraxinus americana</i> | White Ash | 40% | 25-35 | Majority of ash trees are dead due to EAB |
| <i>Fraxinus nigra</i> | Black Ash | 6% | 5-15 | Majority of ash trees are dead due to EAB |
| <i>Thuja occidentalis</i> | Eastern White Cedar | 6% | 15-20 | Foliage dieback, epicormic branching |
| <i>Tilia americana</i> | Basswood | 6% | 5-15 | Yellow Belly Sapsucker holes |

| Section 2 | | | | |
|---|---|---|---|---|
| <i>Acer saccharum</i> | Sugar Maple | 70% | 30-40 | Cobra Canker, epicormic branching |
| <i>Fagus grandifolia</i> | American Beech | 10% | 25-35 | Beach Bark disease, epicormic branching, branch dieback |
| <i>Tilia americana</i> | Basswood | 10% | 25-35 | Yellow Belly Sapsucker holes, included bark |
| <i>Ostrya virginiana</i> | Ironwood | 5% | 15-25 | Lower branch dieback |
| <i>Tsuga canadensis</i> | Eastern Hemlock | 5% | 15-25 | Lower branch dieback |

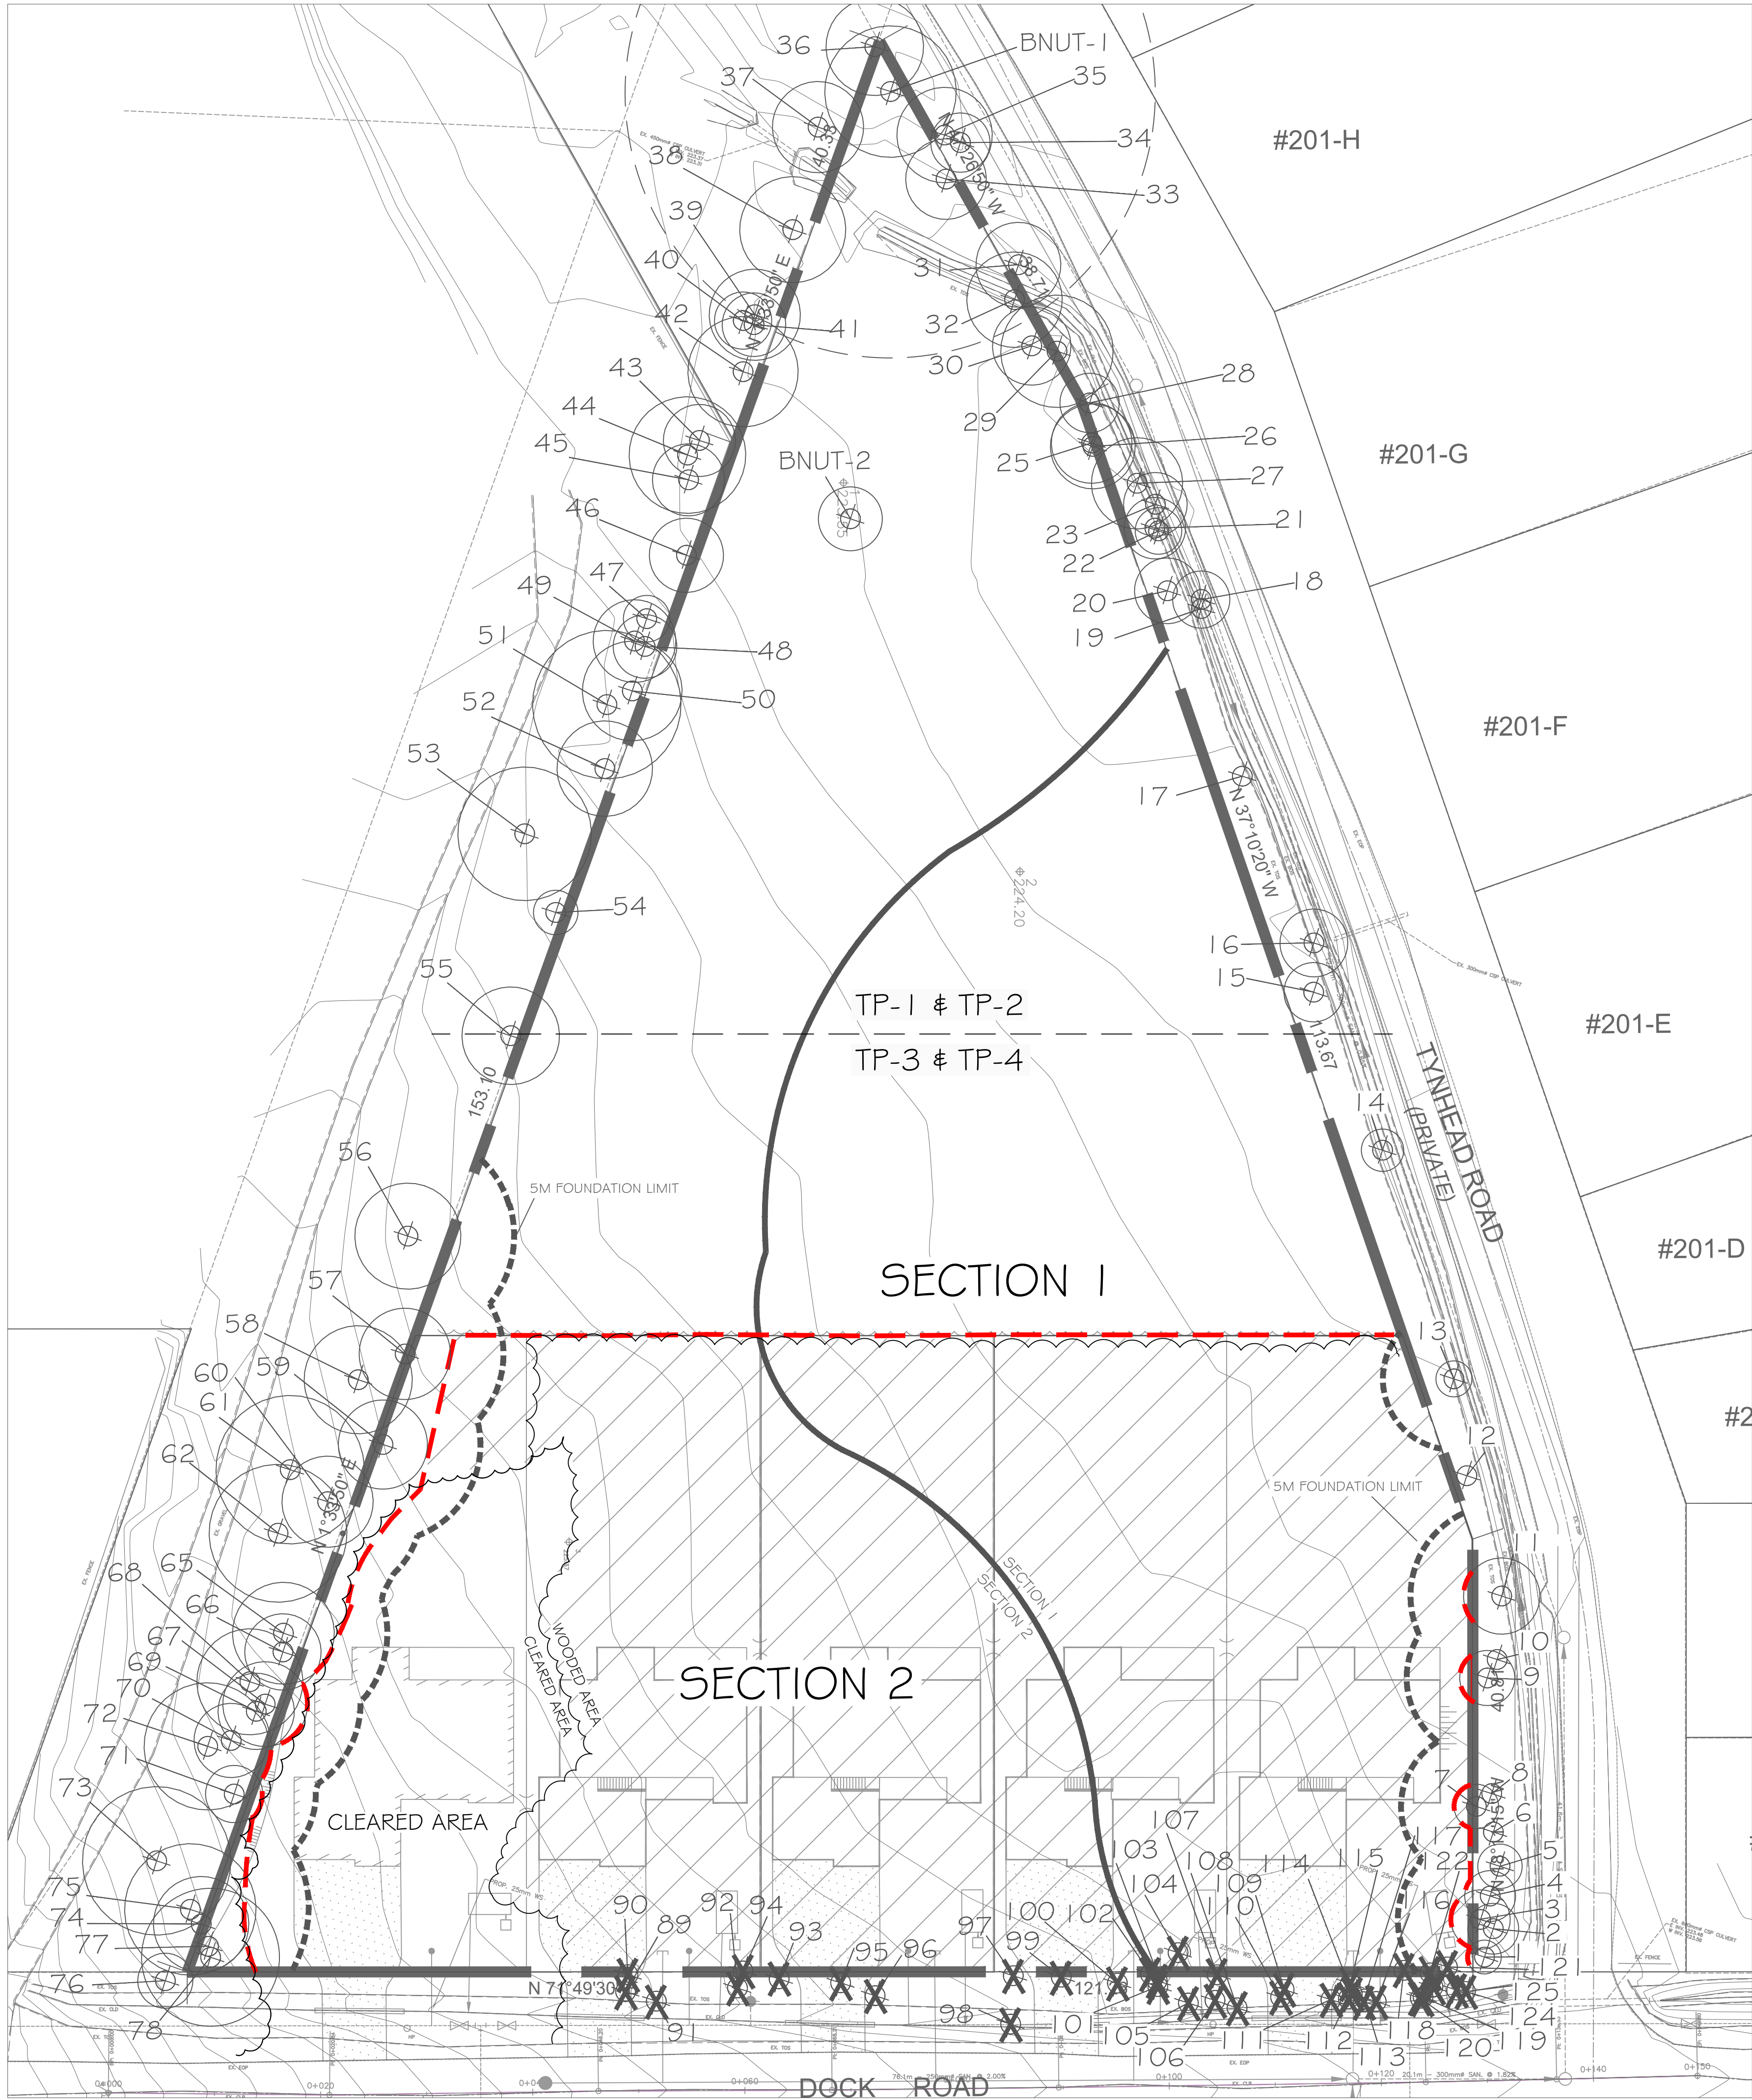
| DRAWING No.:<br>TP-1 | |

\*TWO BUTTERNUT TREES WERE LOCATED AND ARE LABELLED AS BNUUT-1 & BNUUT 2. BNUUT-2 WAS FOUND TO BE NON-RETAINABLE. (SOURCED FROM JOHN D.BELL ASSOCIATES LTD. FILE 1134A-17. DWG TP-1)

| Key | Latin Name | Common Name | Tree DIA (cm dbh) | Comments | Assessment | Canopy Radius (m) | Remove/ Preserve |
|---|---|---|---|---|---|---|---|
| 1 | <i>Acer saccharum</i> | Sugar Maple | 17.6 | exposed root, girdling roots offsite | 1 Poor | 1.6 | Preserve |
| 2 | <i>Acer saccharum</i> | Sugar Maple | 29.5 | epicormic branching, damaged root flare | 3 Fair | 2.4 | Preserve |
| 4 | <i>Acer saccharum</i> | Sugar Maple | 16.4 | exposed root, damage to root flare, epicormic branching | 1 Poor | 2.4 | Preserve |
| 24 | <i>Fraxinus americana</i> | White Ash | 34.5 | hazard tree, dead leaning to road | 0 Dead | 0.0 | Removed |
