157 ARDAGH ROAD RESIDENTIAL DEVELOPMENT

TREE INVENTORY, ANALYSIS, AND PRESERVATION PLAN

157 ARDAGH ROAD

OUR FILE: LA 590-21

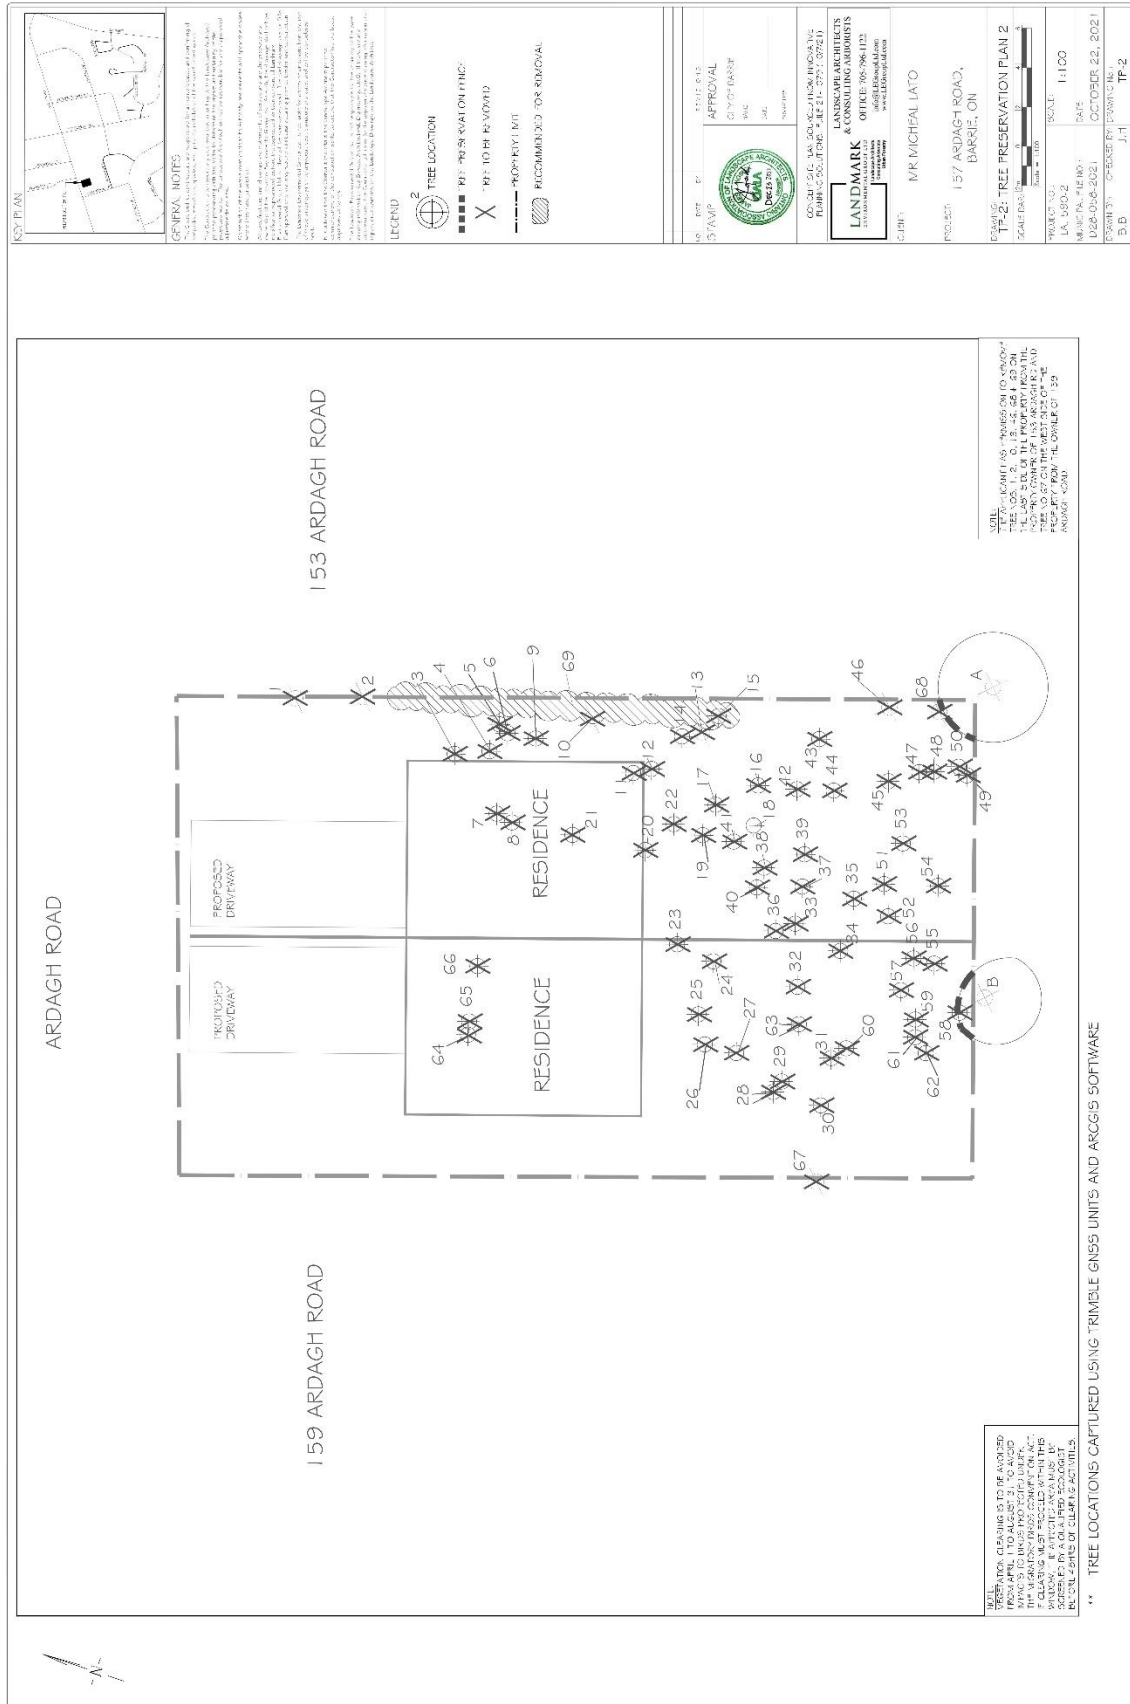
Tree Preservation Plan 2 (TP-2)

Regarding boundary tree vegetation, LEGroup staff observed eight trees (Tree Nos. 1, 2, 10, 13, 46, 67-69) that are considered boundary trees as they have trunks crossing over the property line. Tree 69 is an Eastern White Cedar hedge located along the east property line with a portion of its canopy found to be crossing the property line (see **TP-1 & TP-2**).

The applicant has acquired the consent to remove these trees along the east property line from the owner of 153 Ardagh Road. The recommendations for removal noted above can be reviewed in **TP-1 & TP-2, Appendix B**.
