# 403 COX MILL ROAD RESIDENTIAL DEVELOPMENT

## TREE INVENTORY, ANALYSIS, PRESERVATION REPORT

403 COX MILL ROAD, BARRIE  
ONTARIO, COUNTY OF SIMCOE

DECEMBER 2018

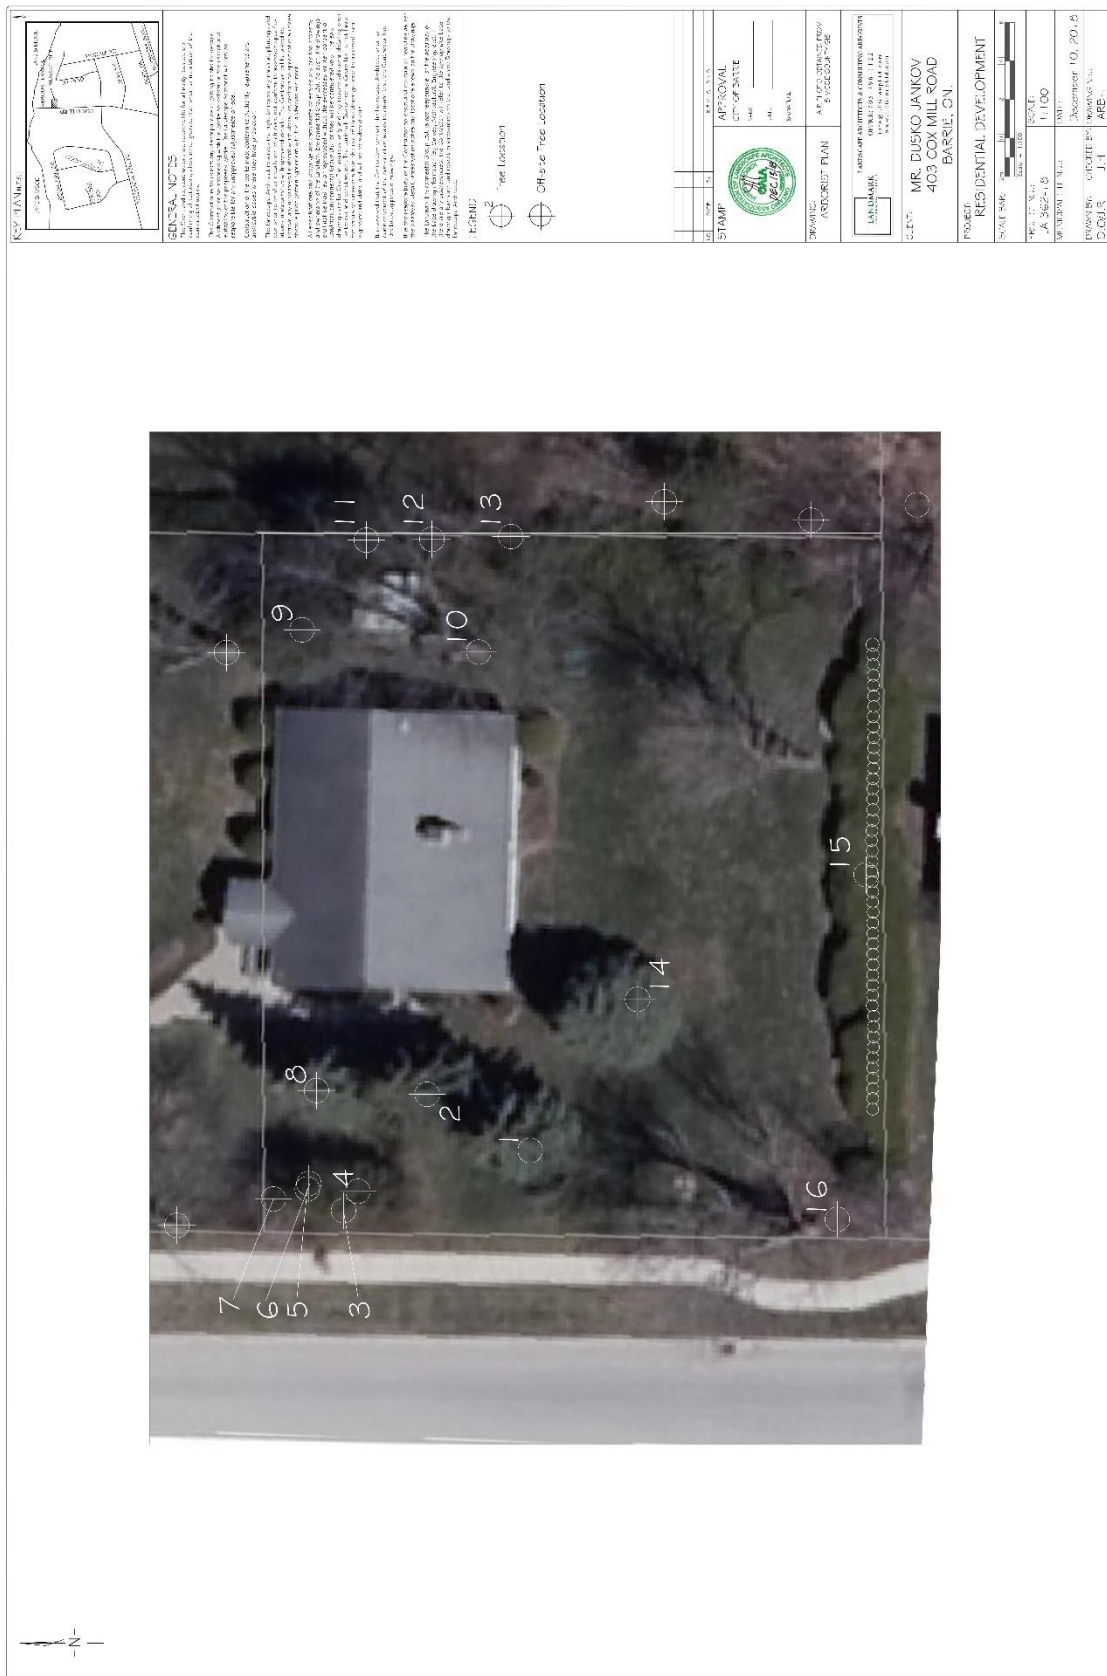
## Appendix B: Tree Inventory, Preservation and Detail (ARB-1, ARB-2, ARB-3, D-1)

Five trees exterior to the site are observed with canopy crossing the boundary of the subject site. They appear to be generally in good health. The location of these trees can be seen in Drawings **ARB-1**, **ARB-2** (with canopy) and **ARB-3 in Appendix B**.
