GUIDING SOLUTIONS IN THE
NATURAL ENVIRONMENT

Geomorphic Assessment 664, 674, & 692 Essa Road & 320 Mapleview Drive West Barrie, Ontario

Updated November 2022 22212

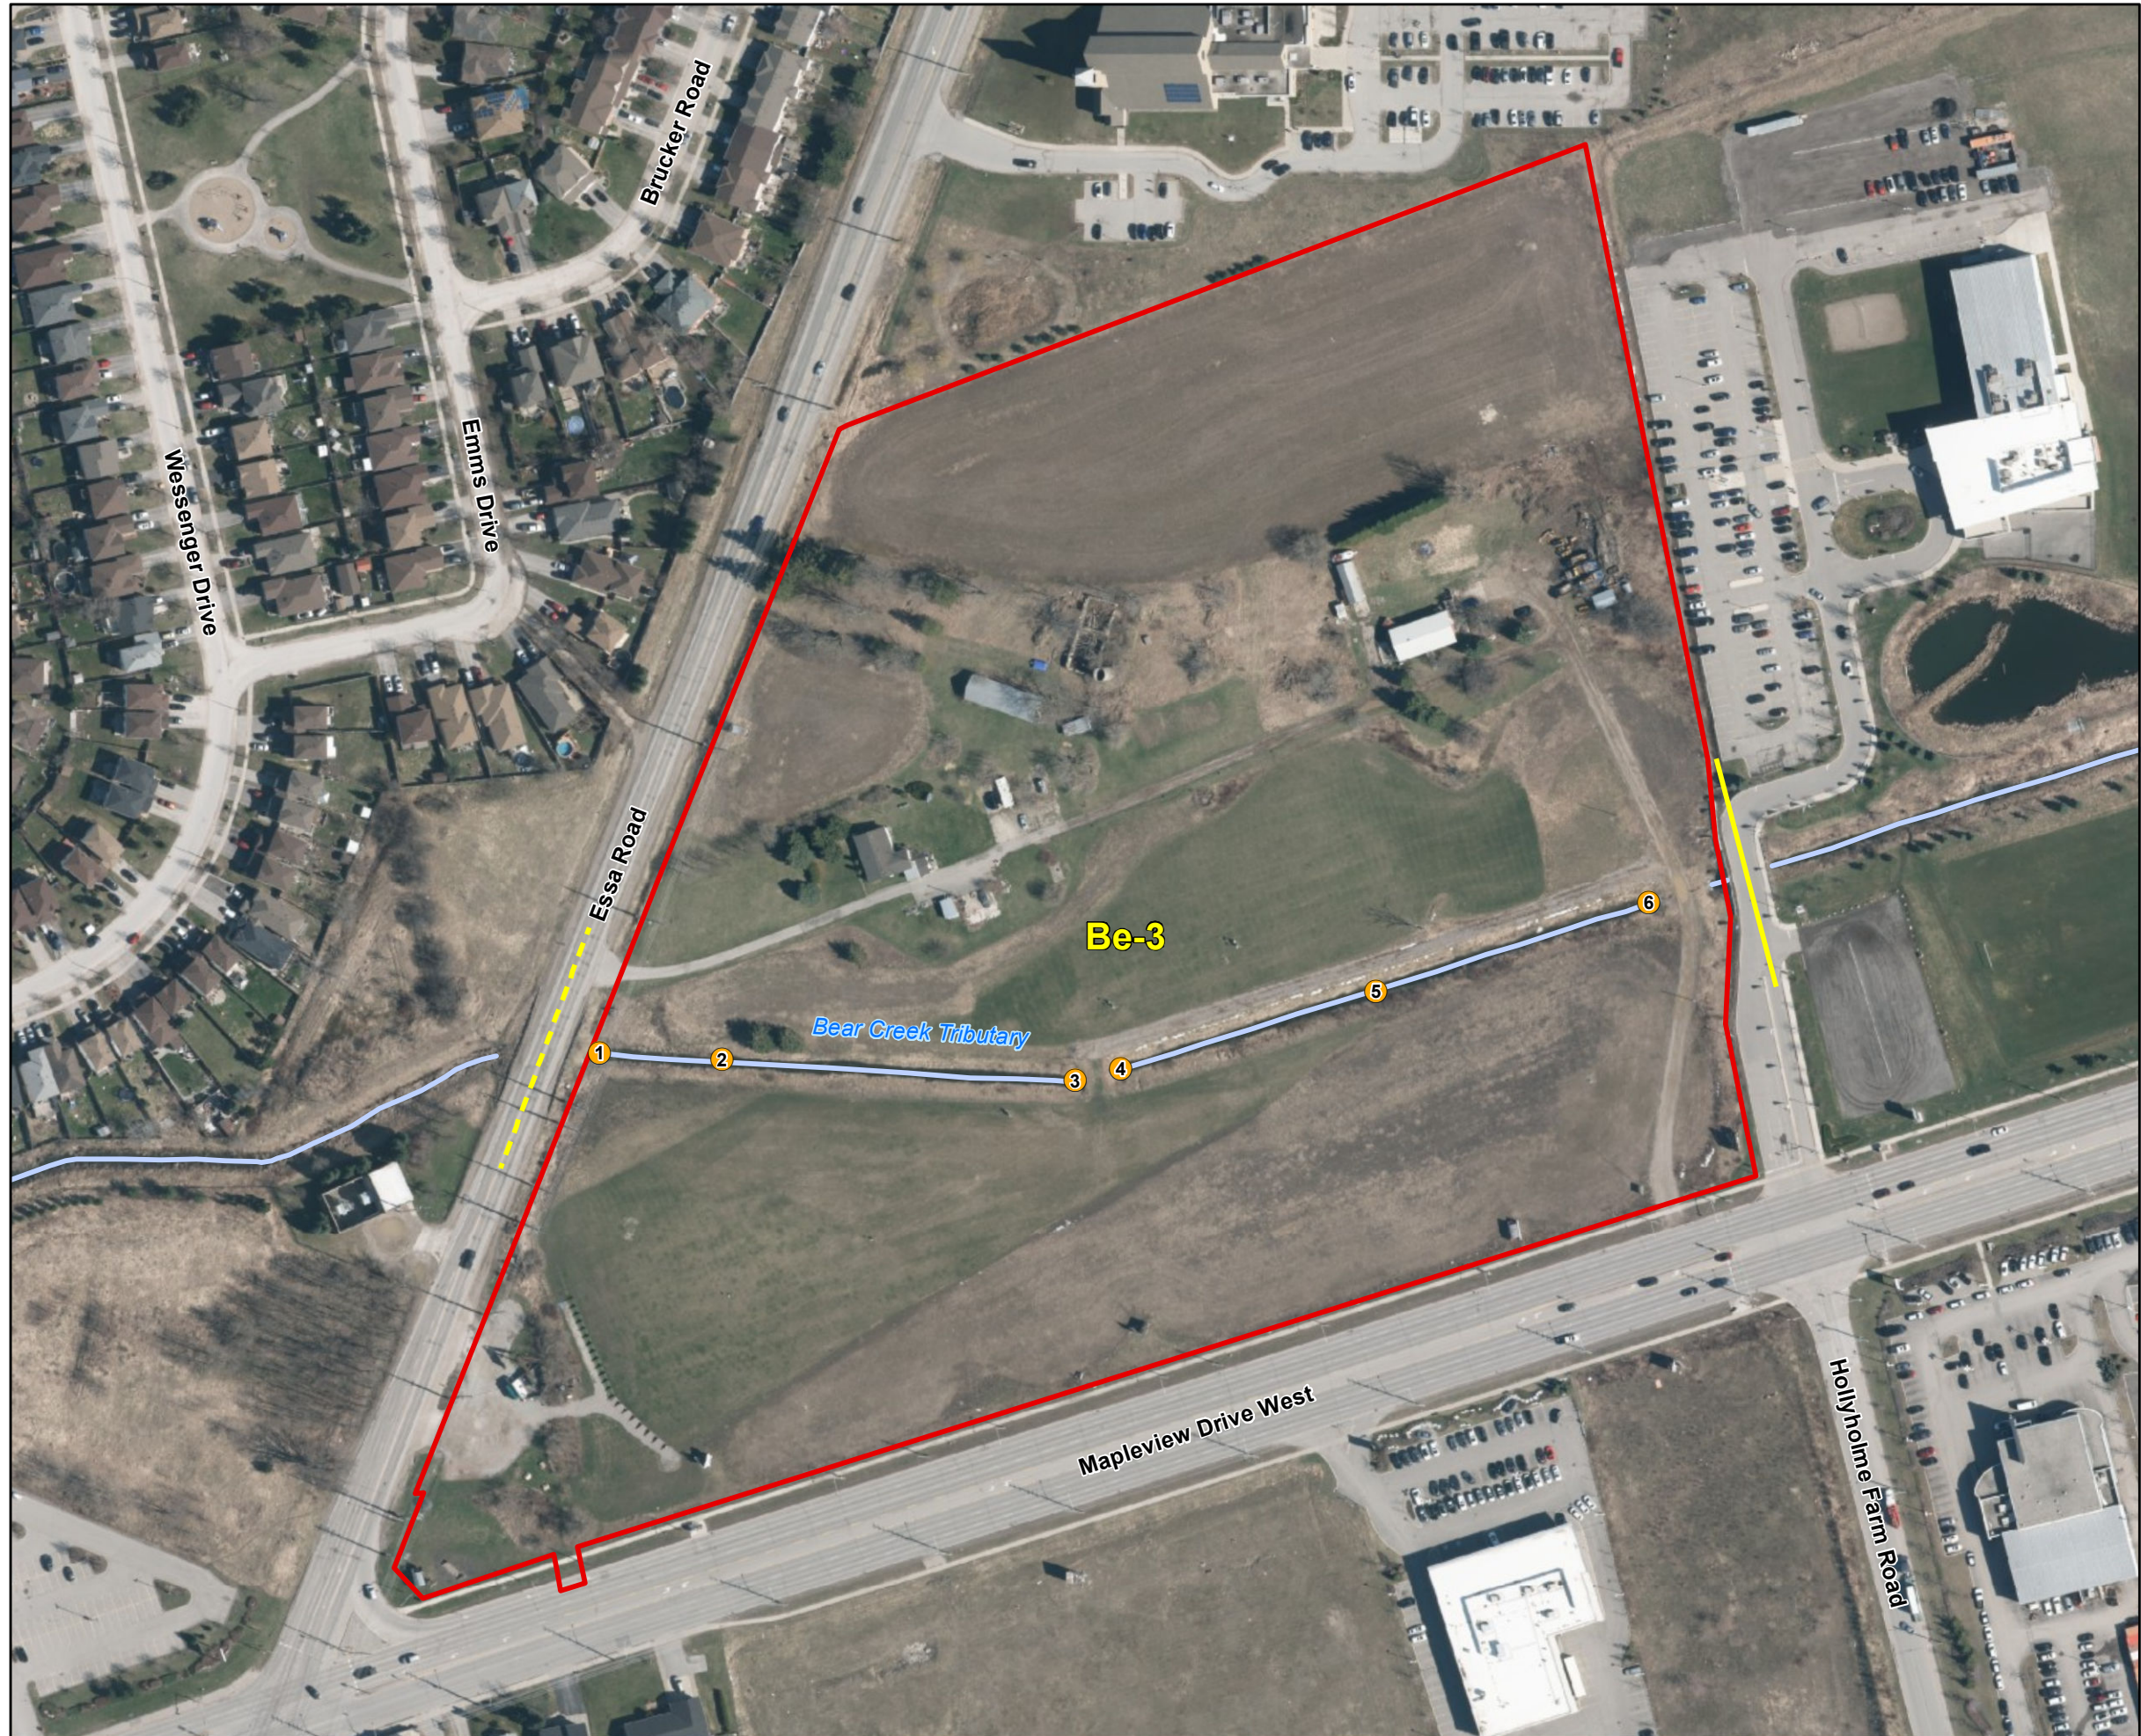
Reach and Photo Location **Figure 3**

For the purposes of this study, the reach delineation followed by Waters Edge for the Drainage Master Plan was maintained. The reach within the subject property was labelled as Be-3 (**Figure 3**), which extends beyond Essa Road to Mapleview Drive. This delineation was confirmed during the field visit.

Development of riffle and pool morphology was not observed; generally, channel morphology consisted of run features. Channel substrate consisted of clay and silt with organic material. Bankfull widths ranged between 3.3 - 4.0 m, widening to 5.1 m near Essa Road. Bankfull depths ranged between 0.40-0.50 m, with depths in the range of 0.70 m noted near the Essa Road crossing. Wetted widths and depths at time of assessment ranged between 3.0-3.7 m and 0.25-0.30 m, respectively. Channel disturbances consisted of three crossings: a triple (1000 mm diameter) CSP culvert at the upstream extent of the reach, a 1200 mm CSP culvert mid-reach, and a box culvert at Essa Road with gabion baskets along the banks.

Rapid assessment results indicated that Reach Be-3 was stressed ('in transition'), with a score of 0.23. Aggradation was the dominant mode of adjustment. This condition is typical of ditched channels that have been over-excavated and subsequently adjust through deposition and re-working of sediment over time towards developing an active (bankfull) channel and floodplain zone. Evidence of aggradation included embedded coarse materials in riffles, siltation in pools, and poor longitudinal sorting of bed materials. An RSAT score of 18 indicated a 'fair' degree of overall ecological health, with channel scouring/sediment deposition, physical instream habitat, water quality, and riparian habitat conditions identified as the primary limiting factors. The Downs model reflected the RGA evaluation of this reach through a classification of D – 'depositional' based on sediment deposition on the bed, sediment deposition along the banks, little evidence of bank erosion and no alluvial terrace.
