City of Barrie

Culvert Inspection Memo

Hewitts Secondary Plan Area (SPA)

H353997
Rev. A
November 21, 2016

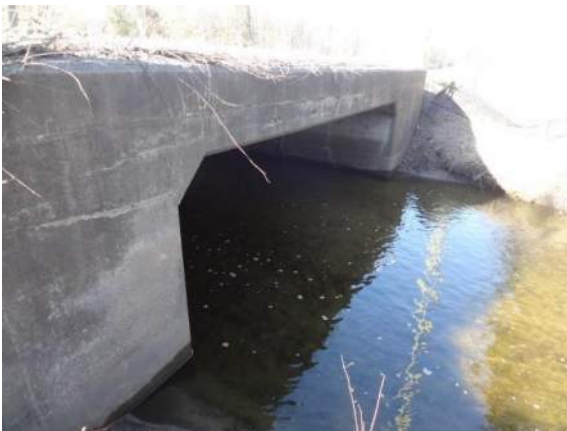
#3 – Inlet End

Open bottom concrete box culvert. Side wall thickness is around 2.5m. Top slab thickness is 0.3m. Insufficient depth of cover. Observed cracks, buckling and spalling. Minor debris accumulation at stream bed. Noted bank erosion and flow scour.

Recommend to repair erosion/scour.

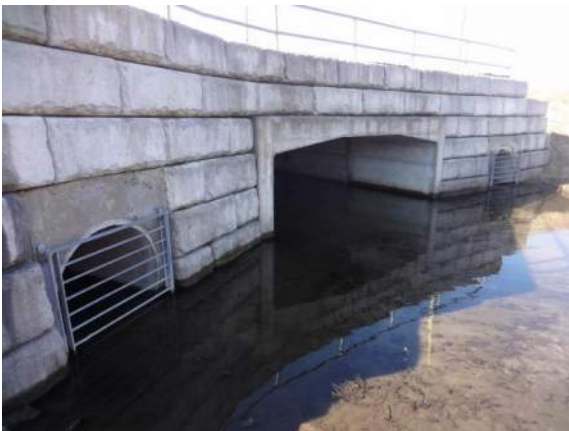
#5 –Outlet End

Top slab has a thickness of 0.5m. Side wall thickness is measured to be 0.3 m. Measured water level at outlet is around 0.25m.

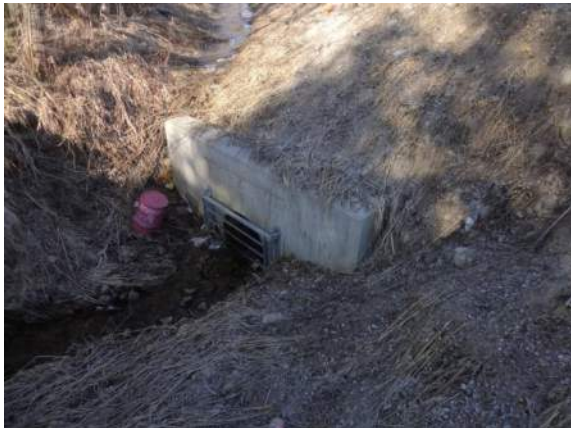
#3 – Inlet End

External drainage ditch flow from super-critical to sub-critical condition. CSP extension at outlet are near fully submerged. Observed bank erosion and debris accumulation at inlet end.

Recommend to be upsized.

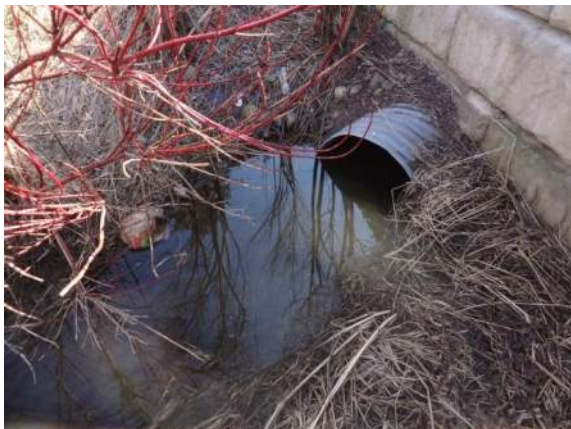
#5 – Outlet End

Outlet are placed under a 1 meter height retaining wall. Downstream bankfull width of 1.2 m with measured water elevation around 0.3 m.

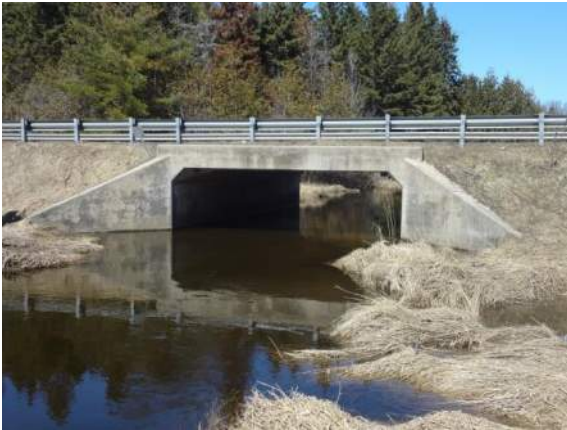
#3 – Inlet End

Observed bank erosion and flow line scour at inlet end.

Recommend to repair and extend.

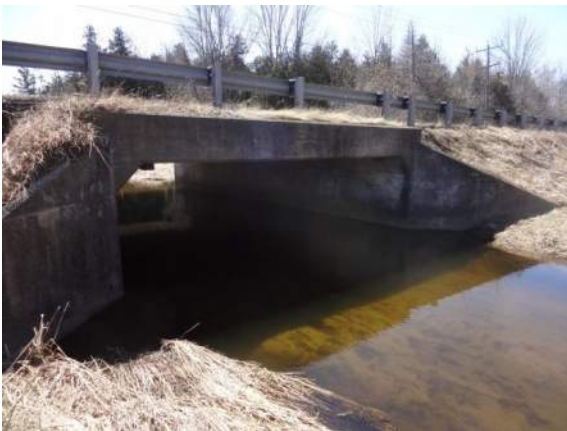
#5 –Outlet End

Measured water level at outlet is around 0.4m.

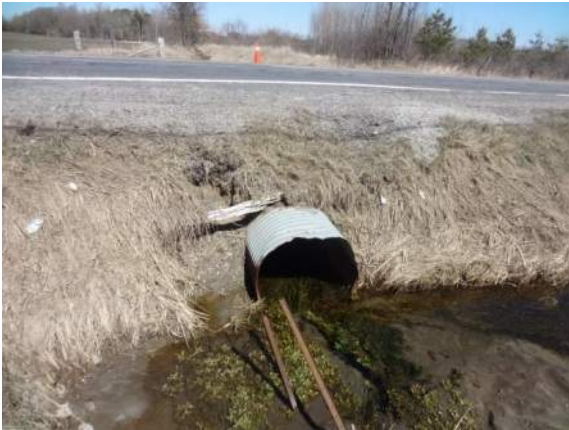
#3 – Inlet End

900 mm diameter CSP culvert. Observed sever bank erosion. Evidence of over topping.

Recommend to replace.

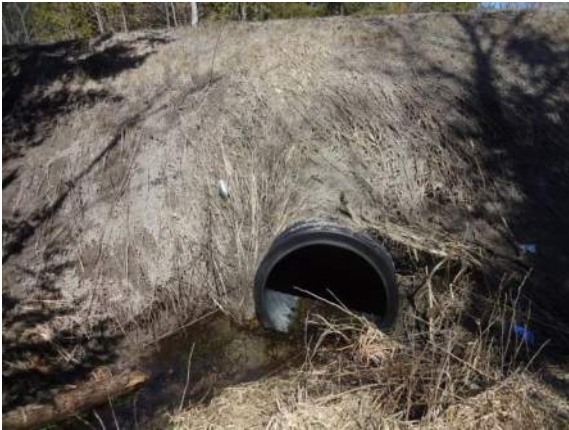
#3 – Inlet End

900 mm diameter HDPE pipe. Heavy vegetation growth noted near inlet. Observed bank erosions and flow line scour.

Recommend to retain and extend.

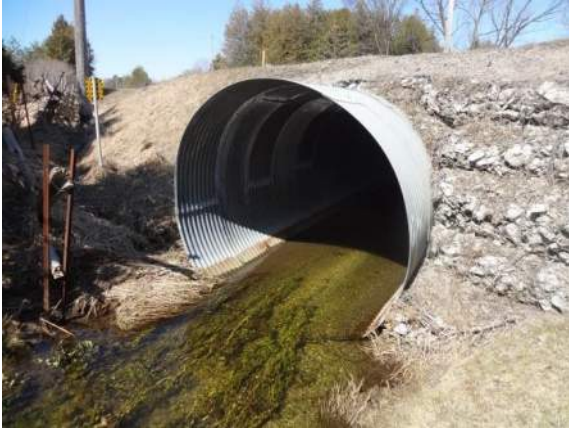
#3 – Inlet End

2440 mm diameter CSP culvert. Observed deformation at gabrion.

Recommend to repair/replace and Extend.
