Municipal Stormwater Management System Annual Report 2024

Appendix F – Laboratory Analysis – SWMFs

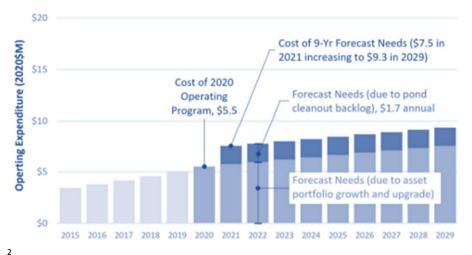
- The total stormwater asset value was \$1,245,000,000.
- 41% of SWMFs were designed for enhanced water quality treatment, without which stormwater will carry higher levels of pollutants into creeks, streams, and lakes, including Lake Simcoe.
- Figure 2 illustrates the projected funding required to operate and maintain the stormwater assets in a state of good repair to maintain the performance standards.
- Operations and maintenance needs associated with a growing asset portfolio will increase operating funding expenditures. For example, the identified SWMF cleanout backlog will result in poor water quality and failure to meet regulatory requirements if not addressed.¹

The Stormwater AM Plan concluded that the City of Barrie has historically underinvested in stormwater assets, noting that underinvestment is unsustainable and will result in more risk in the form of flooding events, infrastructure failures and loss of service.

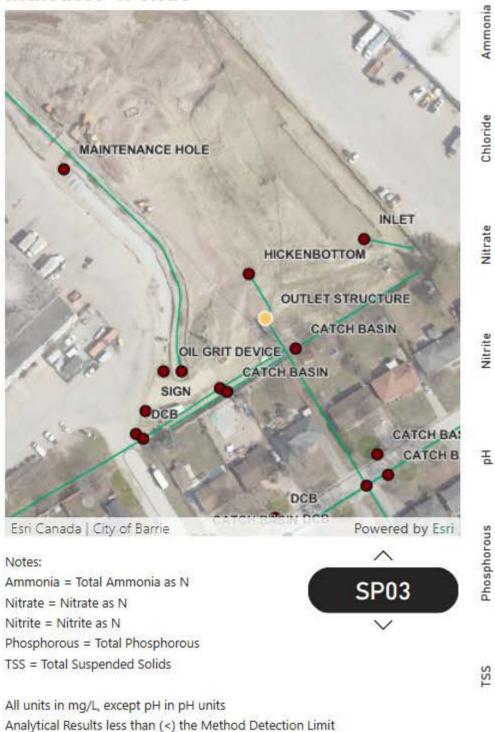
All units in mg/L, except pH in pH units

Analytical Results less than (<) the Method Detection Limit

(DL) are represented on the graphs at the detection limit for illustration purposes.

Each graph is scaled based on the data presented

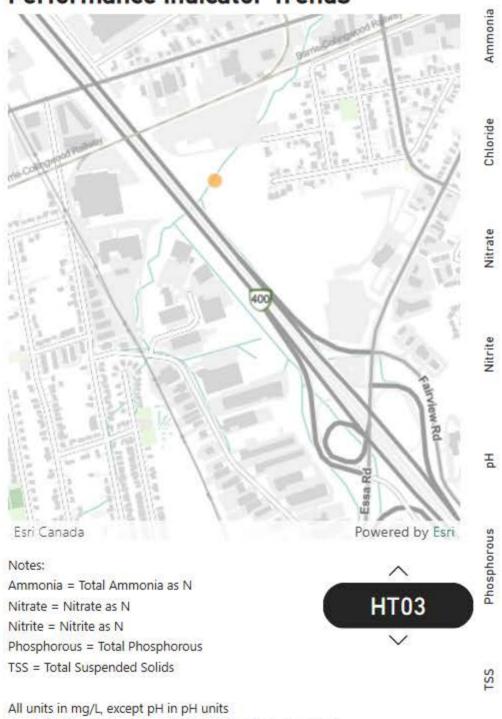
All units in mg/L, except pH in pH units

Analytical Results less than (<) the Method Detection Limit

(DL) are represented on the graphs at the detection limit for illustration purposes.
