Proposed Long Term Care Facility & Retirement Homes

Preliminary Geotechnical Investigation – Final Report

Yonge Street and Country Lane, Barrie, Ontario

GTR-21023592-A0

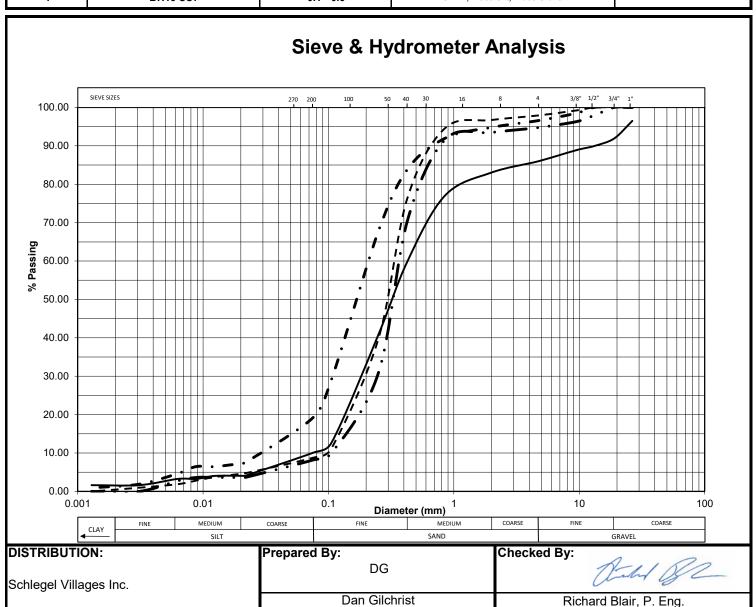
Client: Schlegel Villages Inc. Date Sampled: Jan. 17 to 28, 2022

SAMPLE INFORMATION				
Material	Borehole No. and Sample No.	Sample Depth (m)	Material Description	Graph Line Type	
1	BH1 SS7	6.1 - 6.5	SAND, Some Gravel, Trace Silt, Trace Clay		
2	BH3 SS6	4.6 - 5.0	SAND, Trace Silt, Trace Gravel		
3	BH13 SS9	9.1 - 9.5	SAND, Some Silt, Trace Gravel, Trace Clay		
4	BH15 SS7	6.1 - 6.5	SAND, Trace Silt, Trace Gravel

Drawing 1 - Borehole Location Plan
Figure 1 - Notes on Sample Descriptions
Figures 2 to 21 - Log of Boreholes
Figure 22 - Grain Size Analysis Report
