# CULTURAL HERITAGE **EVALUATION REPORT**

125 Dunlop Street West and 50 Bradford Street

**September 2017**

**HIP Developments Inc.**

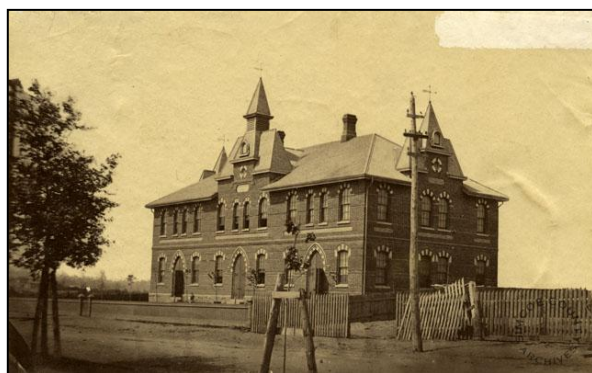
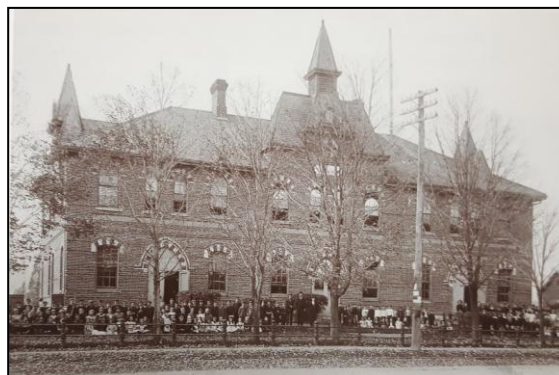
**Figures 6 & 7** - (left) West Ward School, (nd), (right) West Ward School, approximately 1890 (Source: Murdoch, 2005).

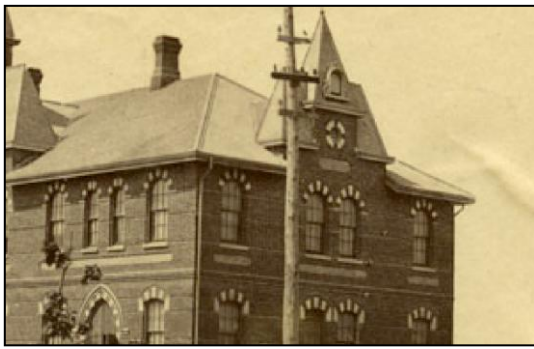
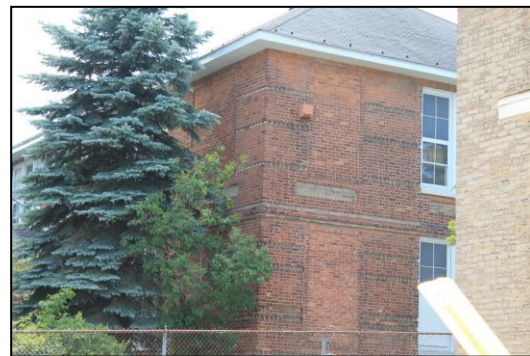
**Figures 8 & 9** - (left) West Ward School (nd), (right) View of Prince of Wales School, looking south-west (Source: MHBC July, 2016)

When comparing photographs of the original school building to what currently exists demonstrates that some of the original architectural detailing still exists, such as string courses and ornamental brickwork. Also, that the location of windows and their arrangement have changed (most likely in the 1920s), some of which have been bricked-over (See Figures 8 & 9).

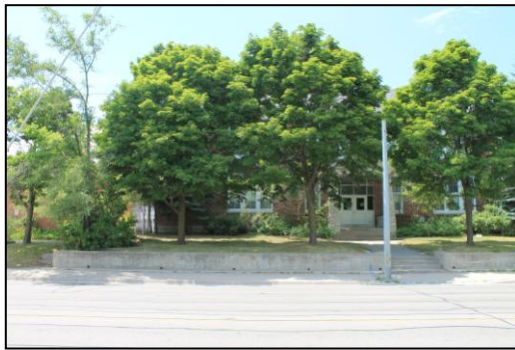
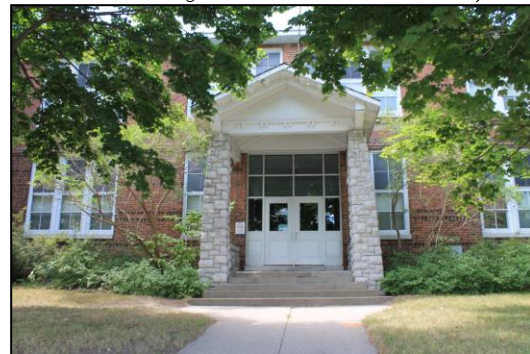
**Figures 10 & 11** - (left) Prince of Wales School, view of front (east elevation) looking west (right), Detail of front elevation (Source: MHBC July, 2016)

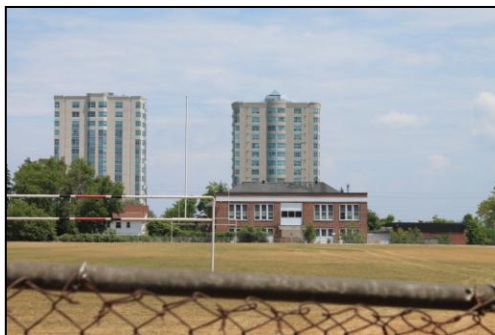
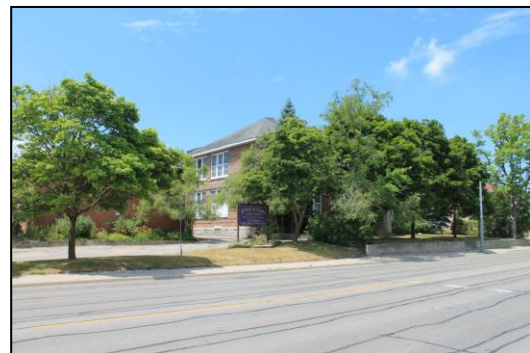
**Figures 12 & 13** - (left) Prince of Wales School, view of rear (west elevation) looking east (right), View of Prince of Wales School looking north-west (Source: MHBC July, 2016)
