REFER TO TREE ASSESSMENT REPORT FOR FURTHER INFORMATION

DATE: APRIL 2019	9CALE: AS NOTED	DRAWING No.
ORAUN: KLA Inc.	CHECKED BY: RHK	T — 1
PROJECT No.	125Ln

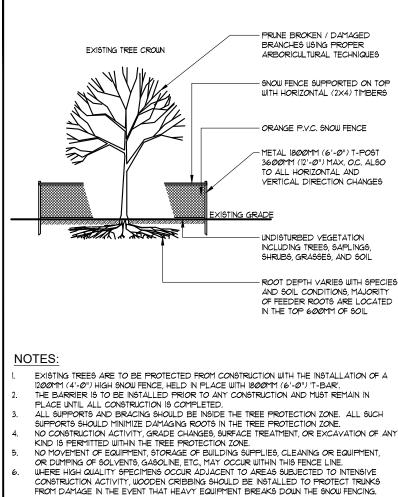
TEMP. TREE PROTECTION BARRIER - N.T.S.

FENCE TO BE INSPECTED BY ENVIRONMENTAL CONSULTANT ON A REGULAR BASIS AND BE MAINTAINED BY THE SUBDIVIDER / BUILDER.

- I. PRIOR TO ANY CONSTRUCTION ACTIVITY OR TREE REMOVAL OPERATIONS, TREE PRESERVATION FENCING IS TO BE INSTALLED AS PER THE ATTACHED TREE PRESERVATION DRAWINGS AND DETAIL. SEE APPENDIX A AND B.
