TREE INVENTORY NOTES

| PROJECT | 126 BRADFORD STREET<br>BARRIE, ONTARIO | | |
| FILE NAME | TREE INVENTORY,<br>PROTECTION, AND<br>REMOVALS | | |

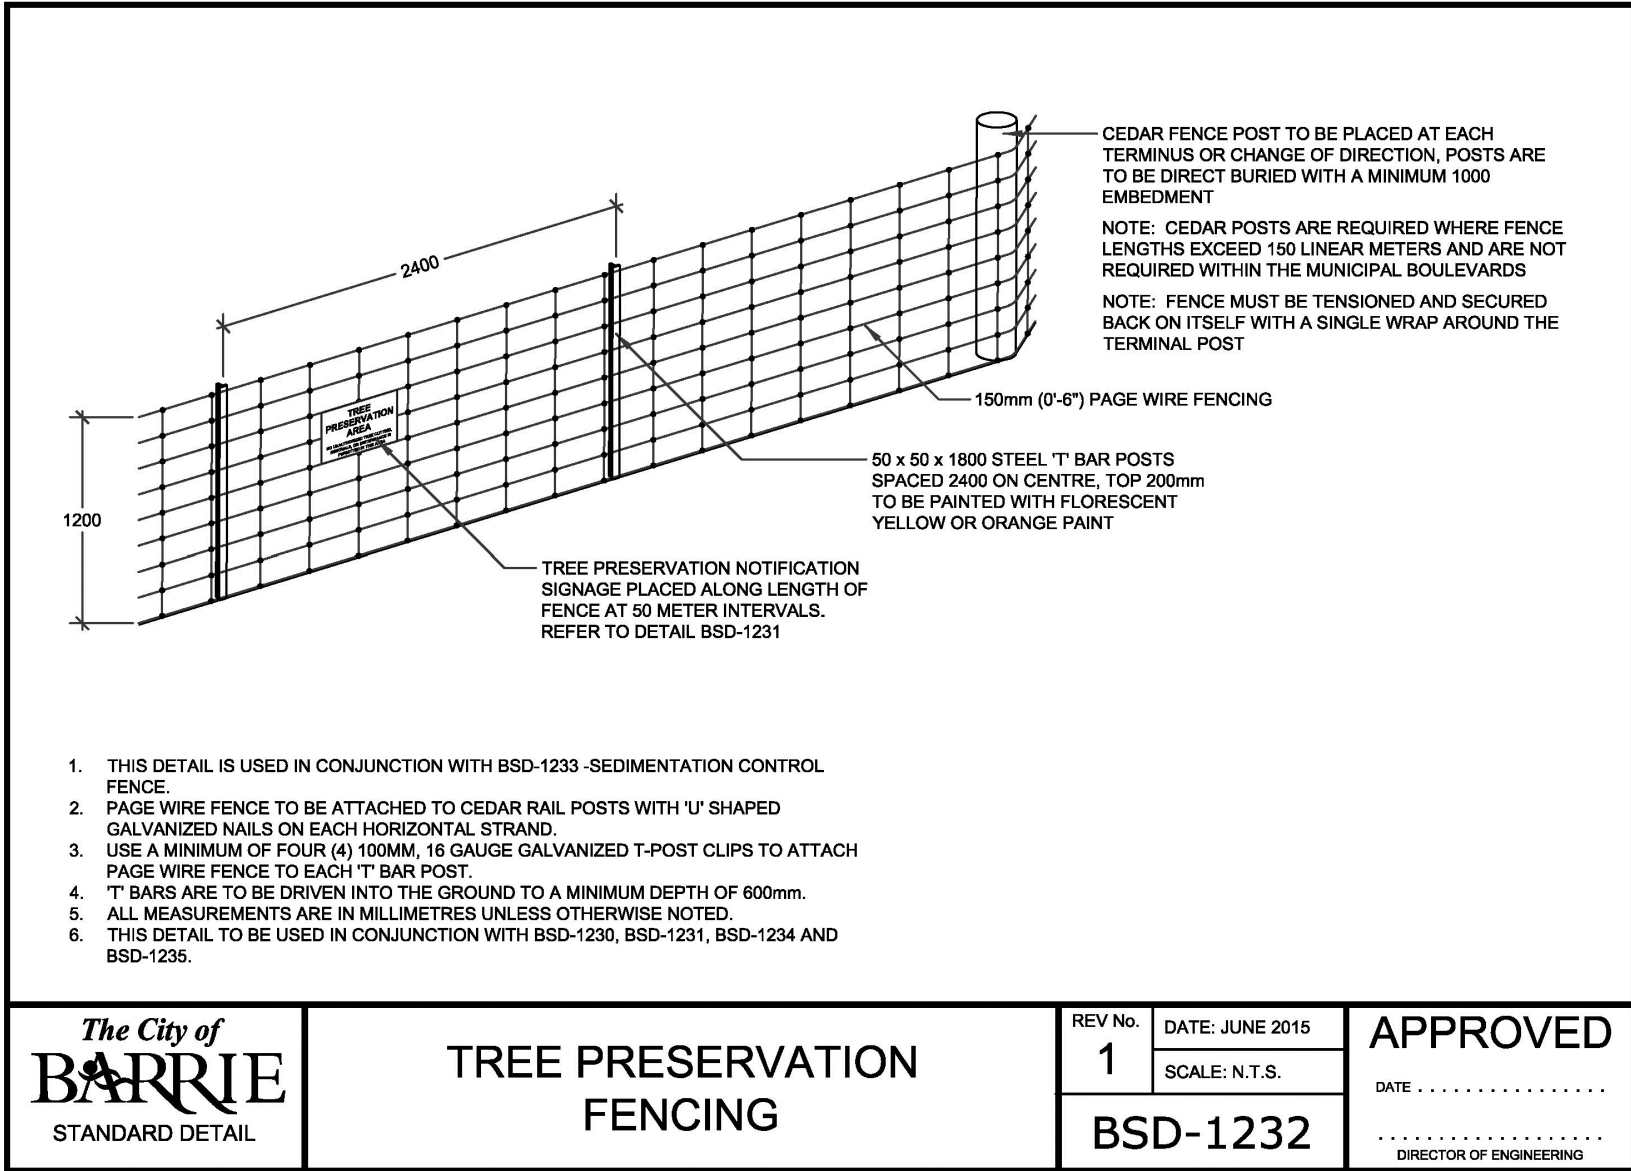
1  
TI-2

TREE PRESERVATION FENCING DETAIL

CITY OF BARRIE STANDARD

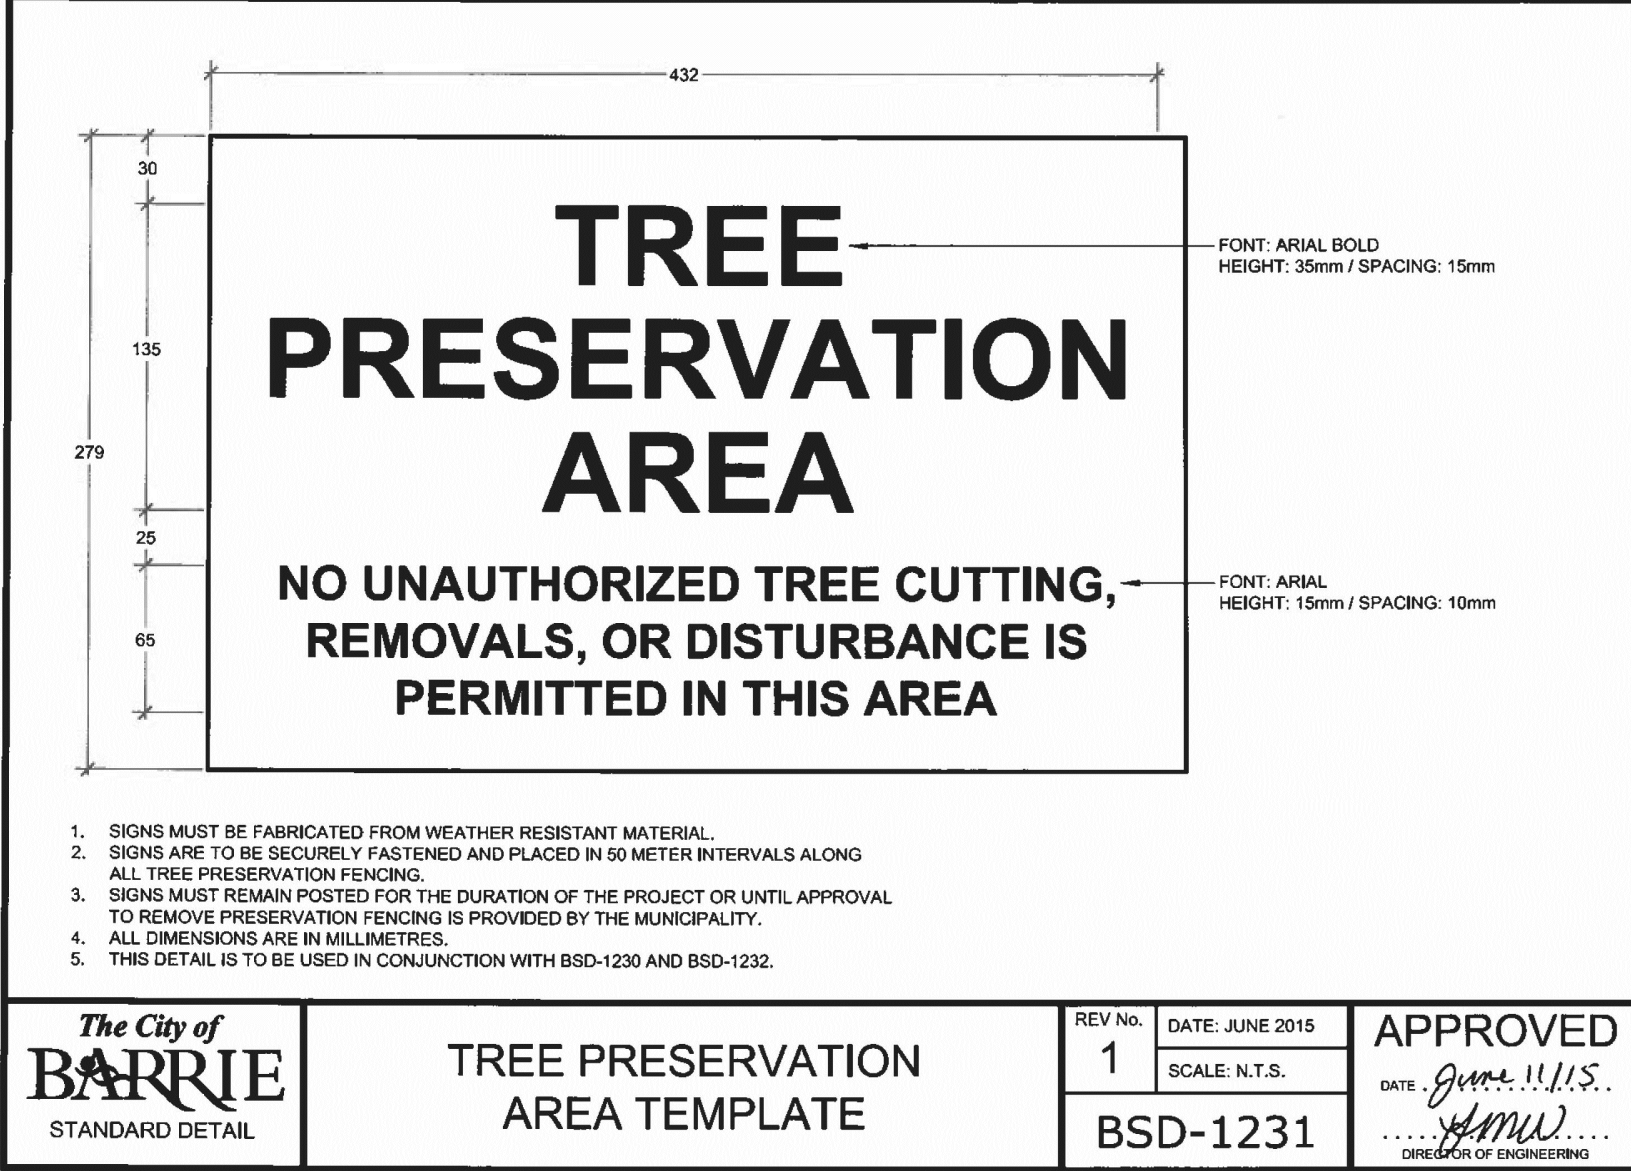
3  
TI-2

TREE PRESERVATION AREA TEMPLATE

CITY OF BARRIE STANDARD
