# **Phase One Environmental Site Assessment**

17-27 Jacobs Terrace  
Barrie, ON

**DS Project No :** 21-018-100  
**Date:** 2021-11-23

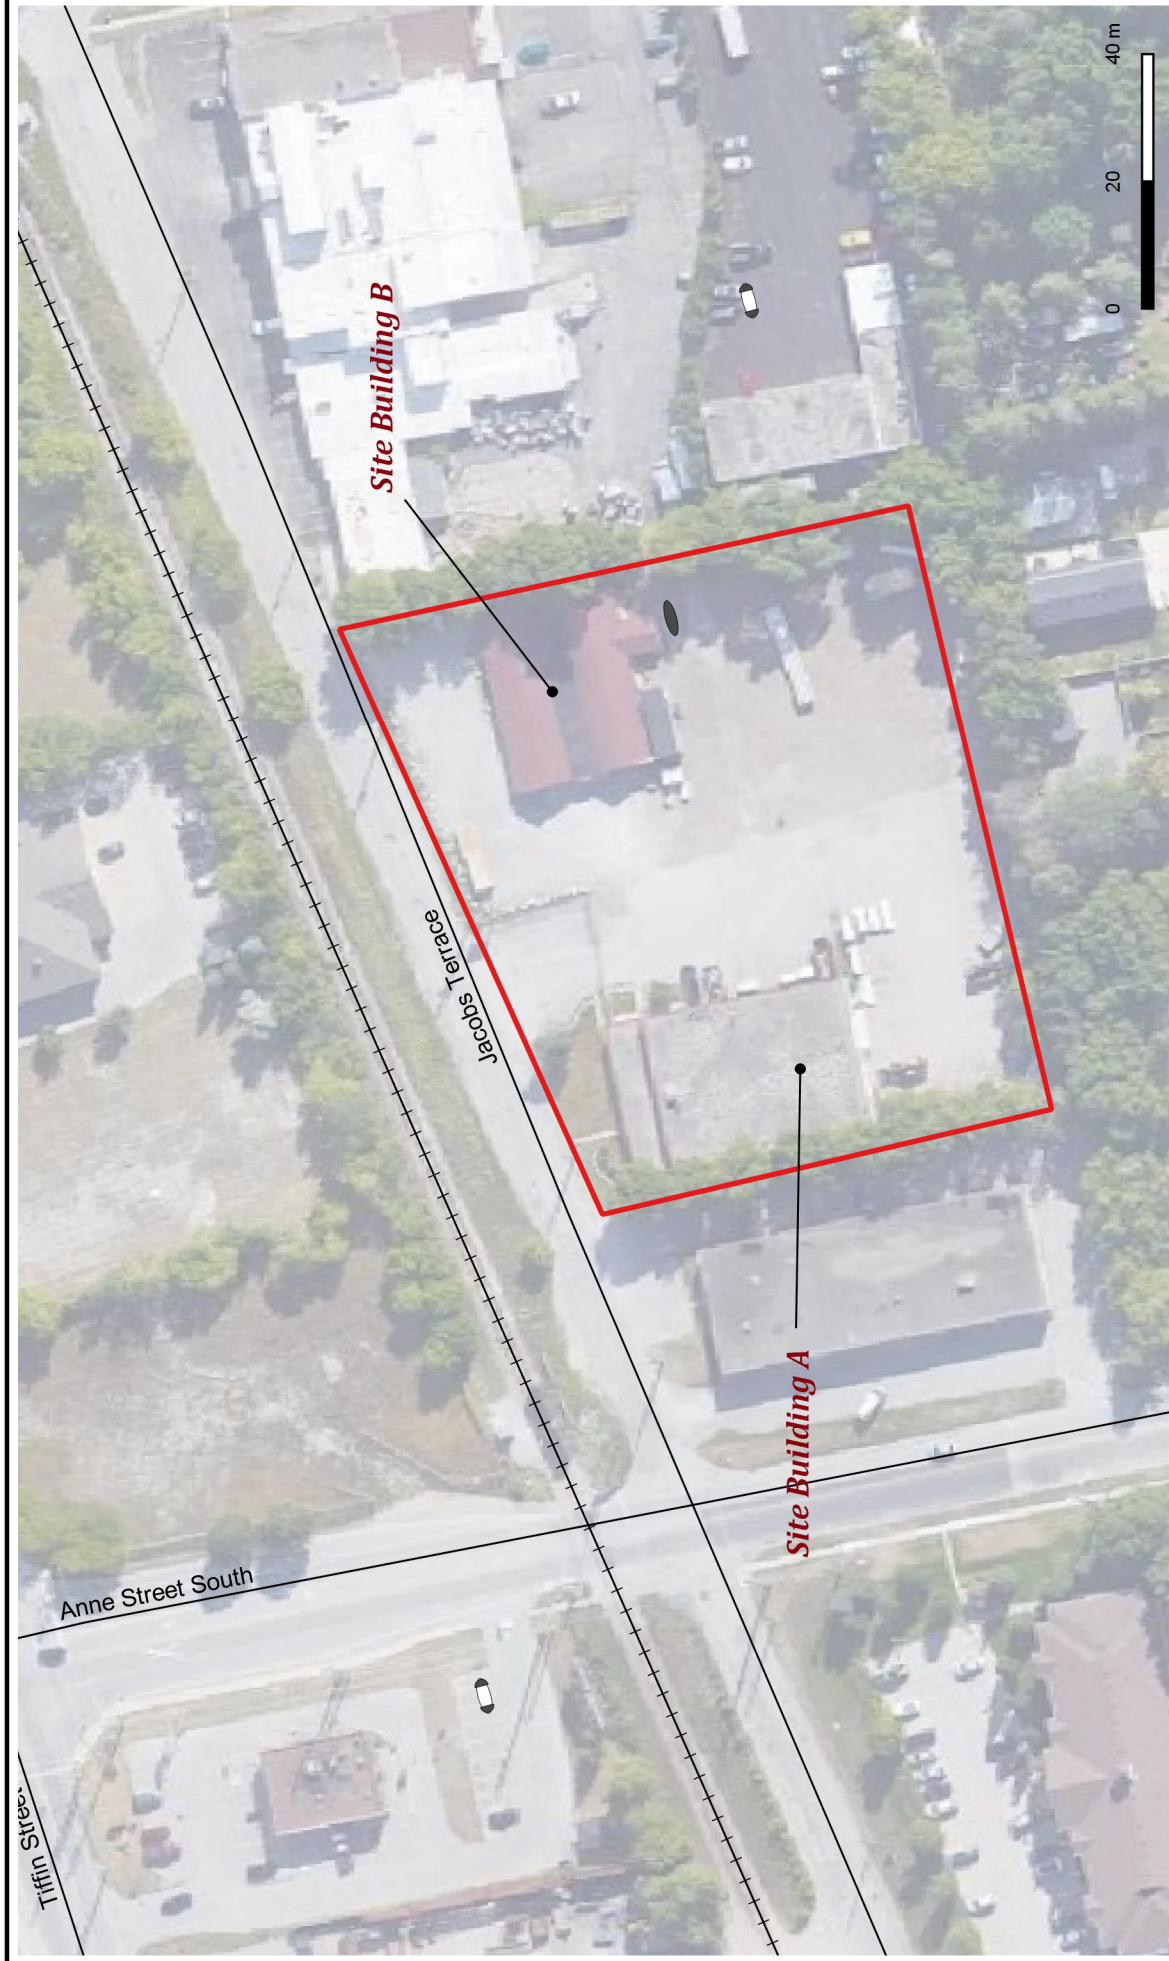
Date: November 2021  
Figure No.: 2

- Approx Property Boundary
- Abandoned Tank
- Historic USTs

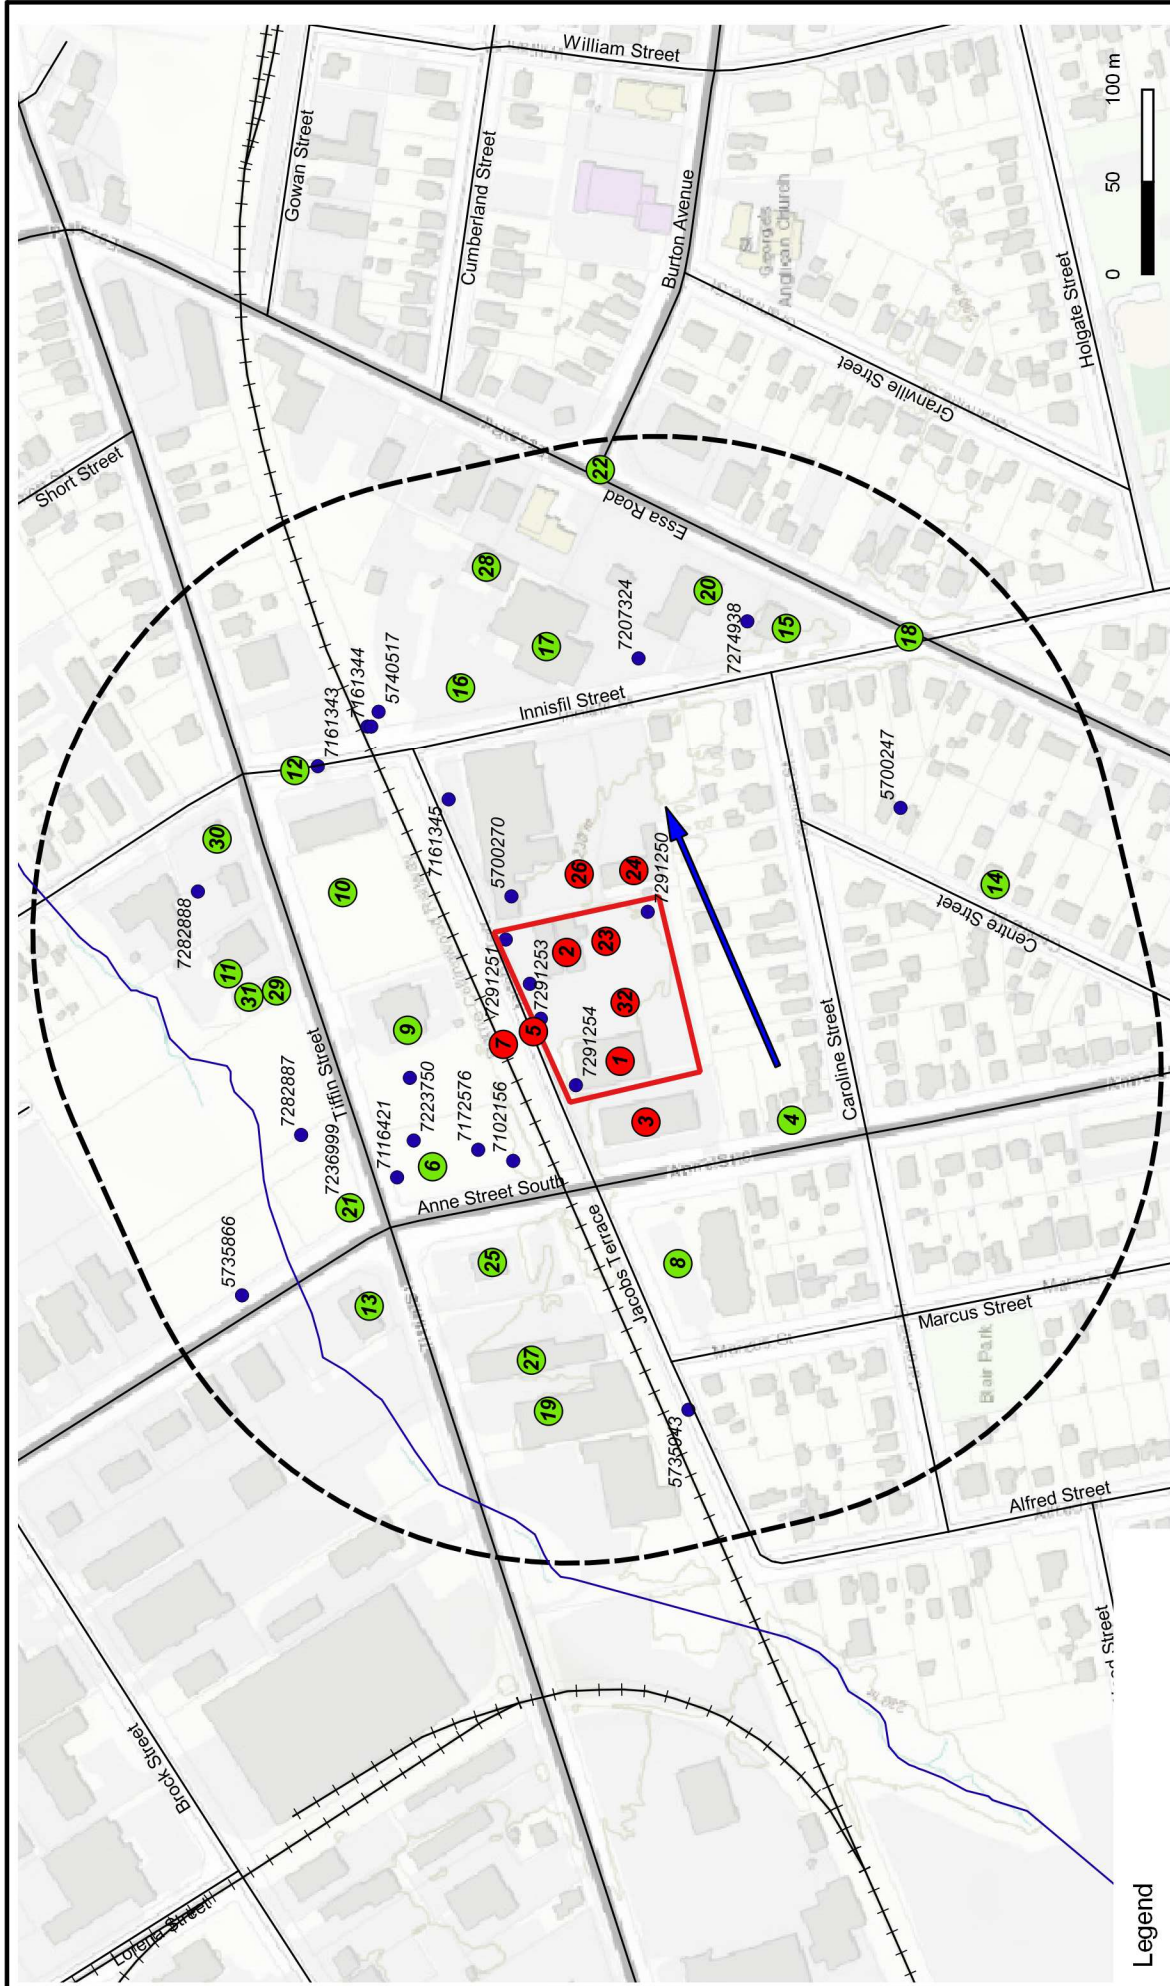
Figure No.: 4

- Approx Property Boundary
- 250m Buffer
- Registered Water Well (MECP WWR)
- ➔ Groundwater Flow Direction
- PCA not contributing to APEC
- PCA contributing to APEC

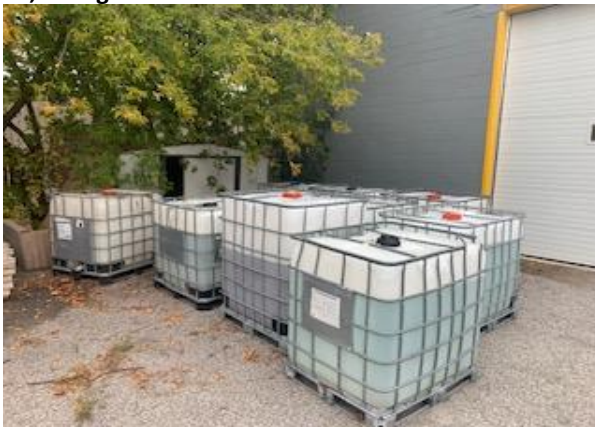
**Picture 3: View of anti-freeze drums at south exterior of Site Building A, facing north.**

| Details of drums, totes and bins at the Phase One Property | Several plastic drums containing ethylene glycol (antifreeze) for the ice rink operation were noted to be present at the southern exterior of Site Building A |

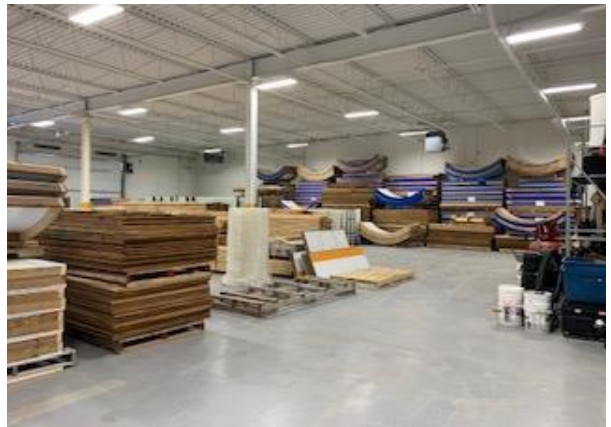
**Picture 4: View of interior of Building A, used as storage of material and supplies for First Line Rinks.**

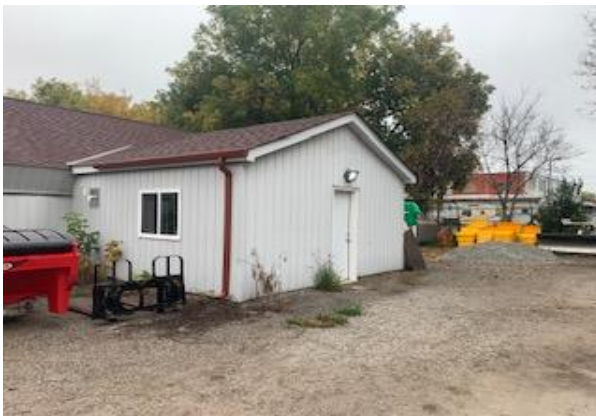
**Picture 9: View of southern exterior of Site Building B, where the former AST was historically located, facing east.**

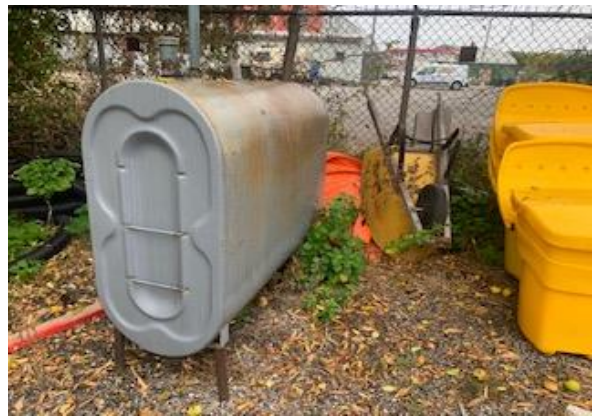
**Picture 10: View of the former 910L fuel oil AST, located south of Site Building B, facing east.**

- ◆ Based on the previous reports reviewed as part of this investigation, one (1) 910 L fuel oil AST was historically present on the Phase One Property. During the Site reconnaissance, the former AST was observed at the exterior of Site Building B but was disconnected (**PCA-23**).

| xiv. | Potentially contaminating activity | One (1) former fuel oil AST, with a capacity of 910 L, was observed at the exterior of Site Building B ( <b>PCA-23</b> ). |

| By-products and wastes at the Phase One Property | One (1) former fuel oil steel AST, with a capacity of 910L, was observed at the southern exterior of Site Building B. |

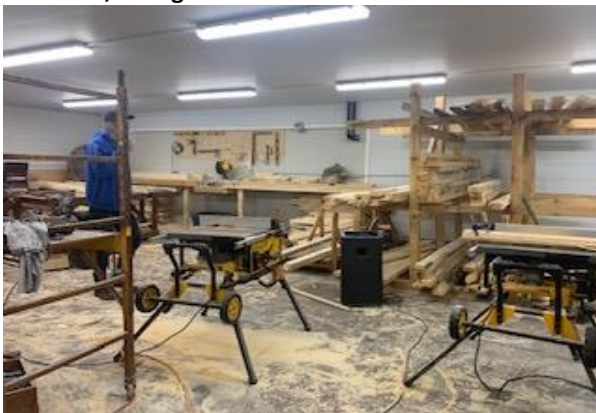
**Picture 11: View of workshop in the interior of Site Building B, occupied by Cara Panel Systems.**

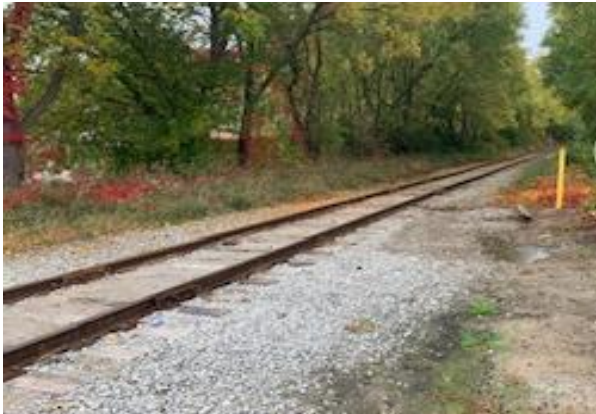
**Picture 13: View of the railway line, located 20 m north of the Site, facing east.**

| x. | Details of current or former railway lines or spurs and their locations | A railway line was observed north of the Site. |
