PHASE ONE ENVIRONMENTAL SITE ASSESSMENT 79 COLLIER STREET, BARRIE, ONTARIO

Prepared By: SIRATI & PARTNERS CONSULTANTS LTD.

Project: SP20-666-00 August 19, 2020

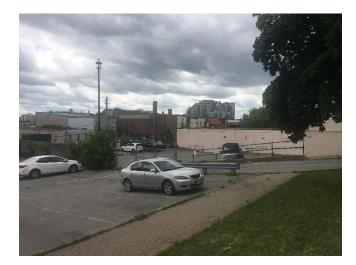
View of the site Description:

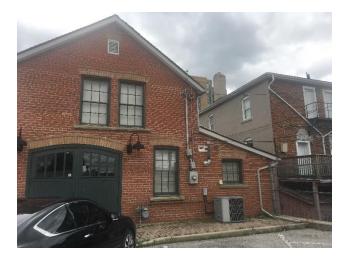
Photograph 2

Northwest Portion of the Location:

View of northwest portion of the Description:

Site

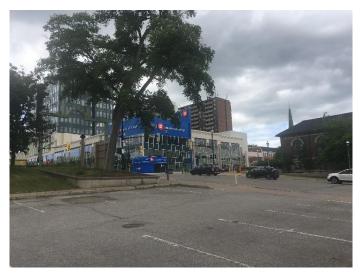
Photograph 5

Location: Adjacent property to the north

Description: properties to the north of the Site; the elevation difference can be

observed.

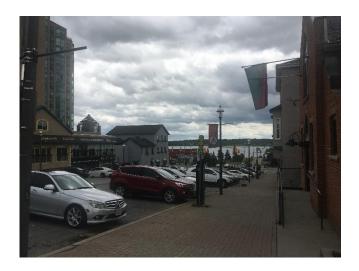
Photograph 6

Location: East portion of the Site

Mulcaster Street located on the east of the site; and the Site

gently slopes towards south
