# **Preliminary Geotechnical Investigation Report - 505 Yonge Street, Barrie, Ontario**

2021-12-15

Prepared for:  
Core Group

© Cambium 2019 Reference No.: 9574-004

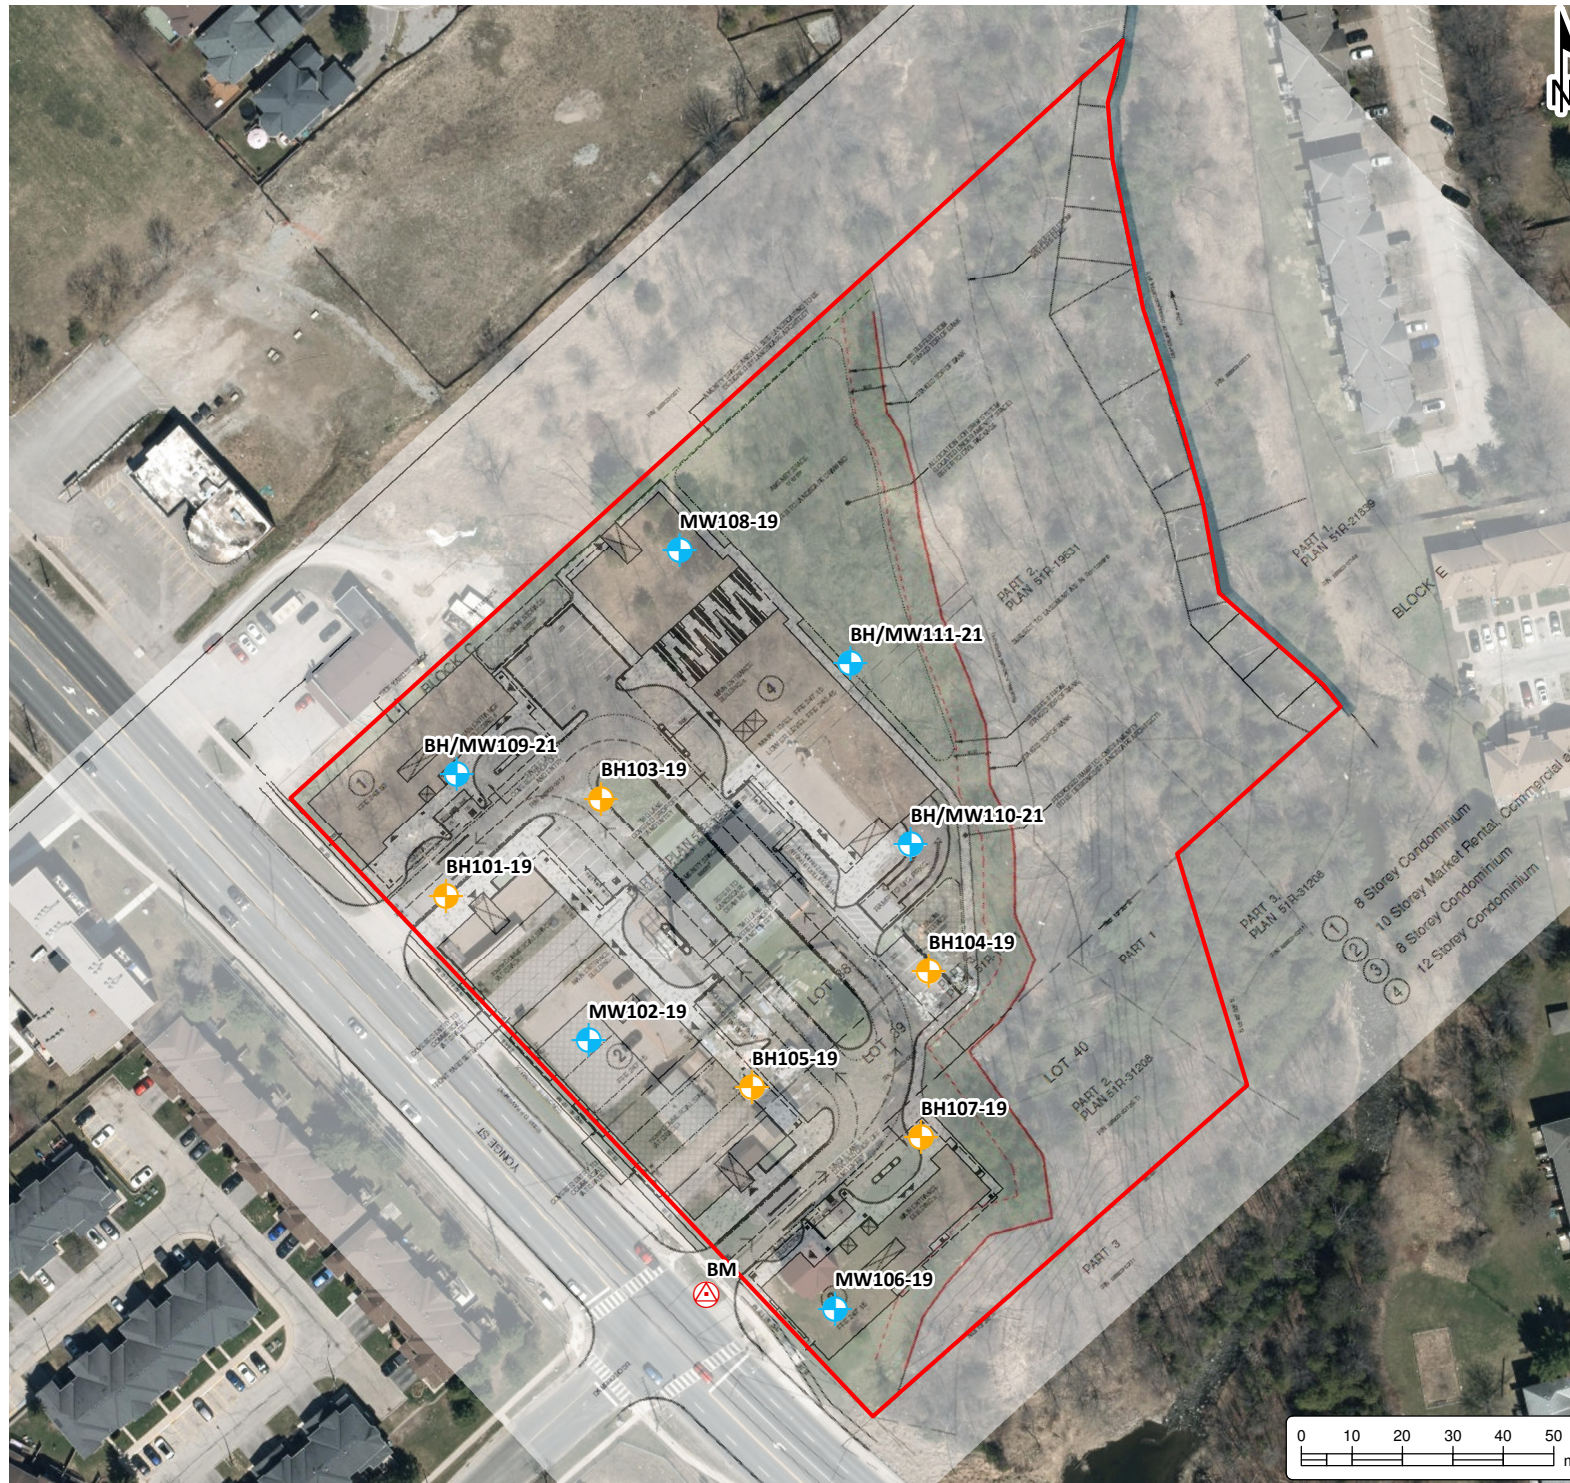
| Figure: | | | <b>1</b> |

O:\GIS\MD\9500-9599\9574-004 Renaissance Retirement Barrie Trust - Geo & Hydro G-505 Yonge Street, Barrie\2021-12-15 FIG 1 - Borehole Location Plan.mxd

Borehole logs are provided in Appendix A. Site soil and groundwater conditions are described and geotechnical recommendations are discussed in the following sections of this report.
